REGULATED MATERIALS SURVEY – VOLUNTARY SEISMIC RETROFIT

**Good Shepherd Center
4649 Sunnyside Avenue
Seattle, Washington**

MGI Project No: Z0083

Subject: Regulated Materials Survey
Good Shepherd Center – Voluntary Seismic Retrofit
4649 Sunnyside Avenue, Seattle, Washington

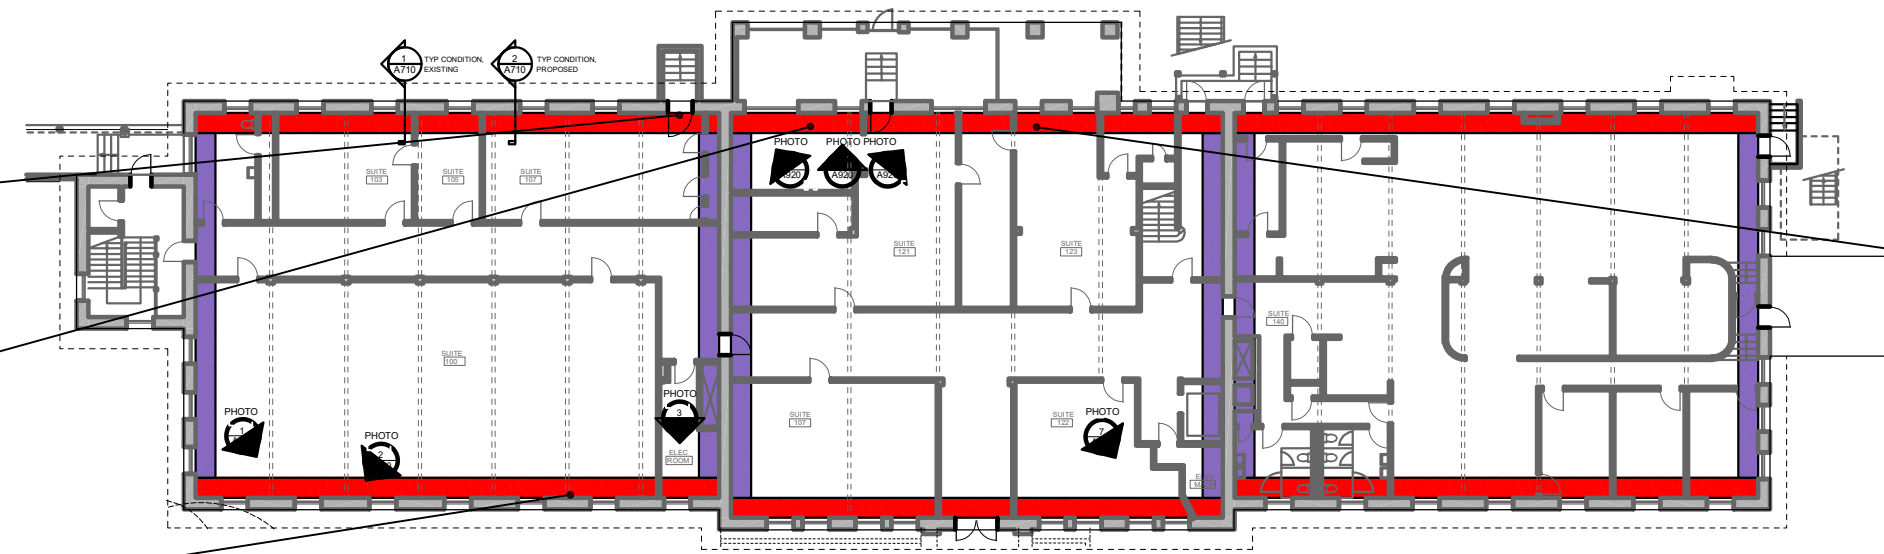
1 FIRST FLOOR PLAN
A100 SCALE: 1/8" = 1'-0"

0083-01-2,
0083-02-2,
0083-Pb-2

0083-03-1

0083-01-1,
0083-02-1,
0083-Pb-1

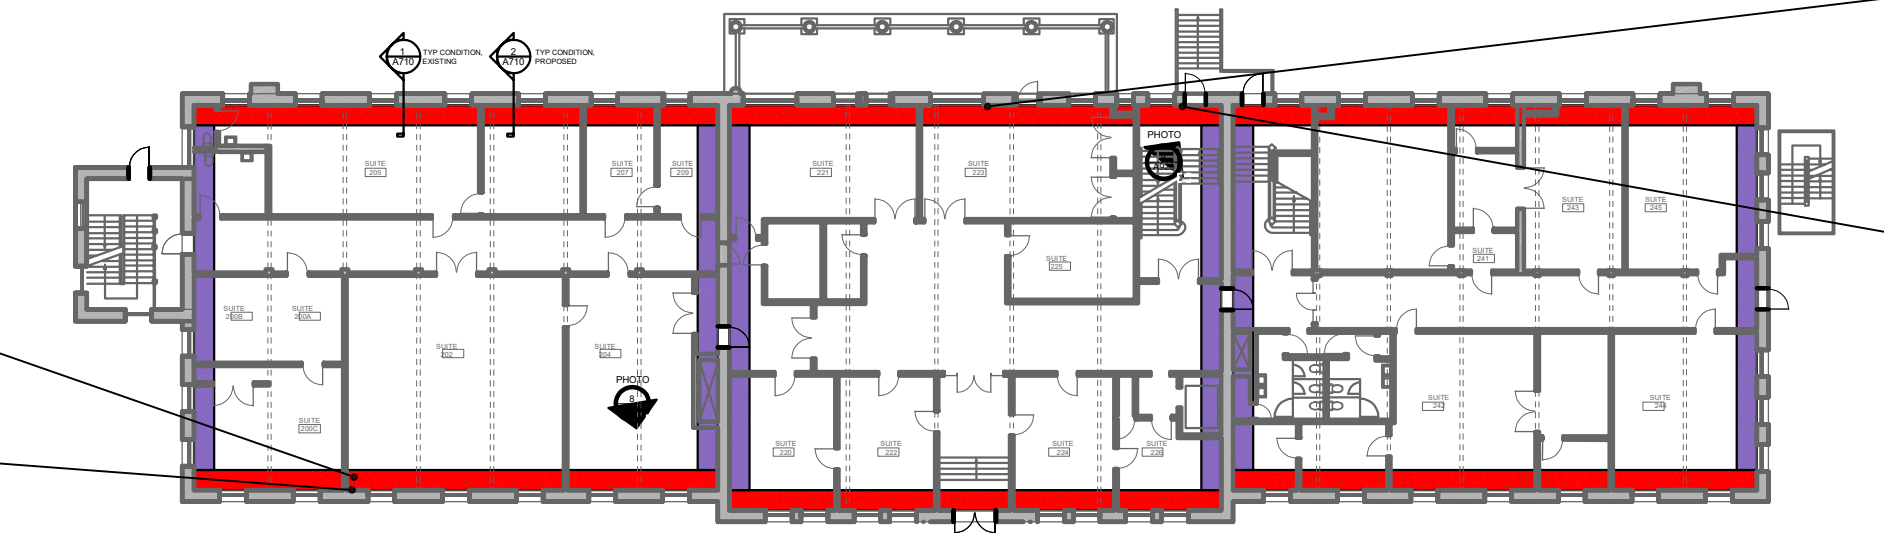
1 SECOND FLOOR PLAN
A101 SCALE: 1/8" = 1'-0"

0083-02-3

0083-05-1,
0083-Pb-4

0083-01-4,
0083-Pb-5

0083-04-1

0083-01-3,
0083-Pb-3

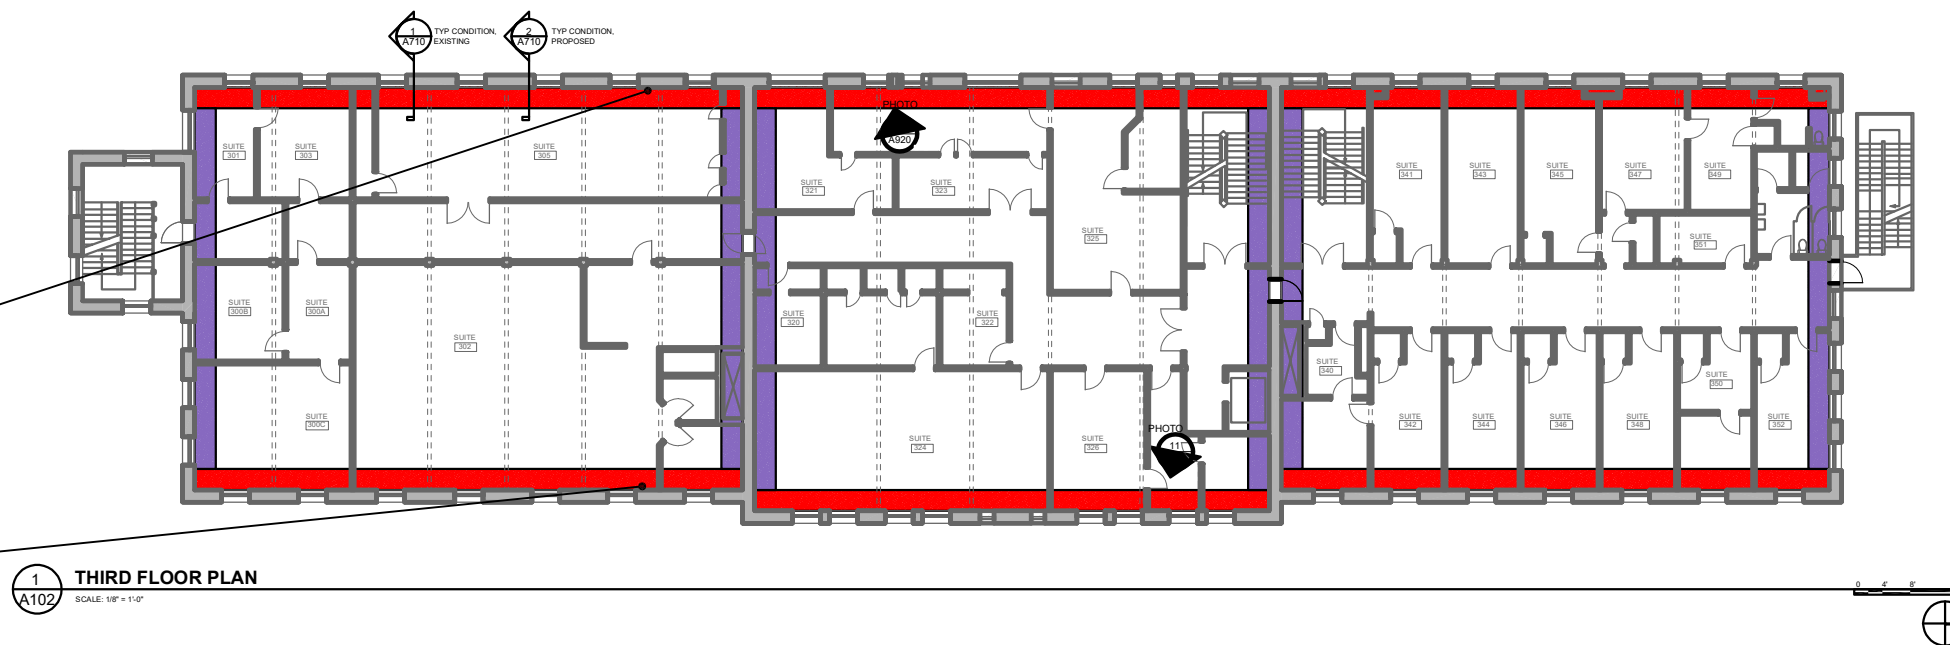
0083-01-5,
0083-Pb-6

0083-01-6

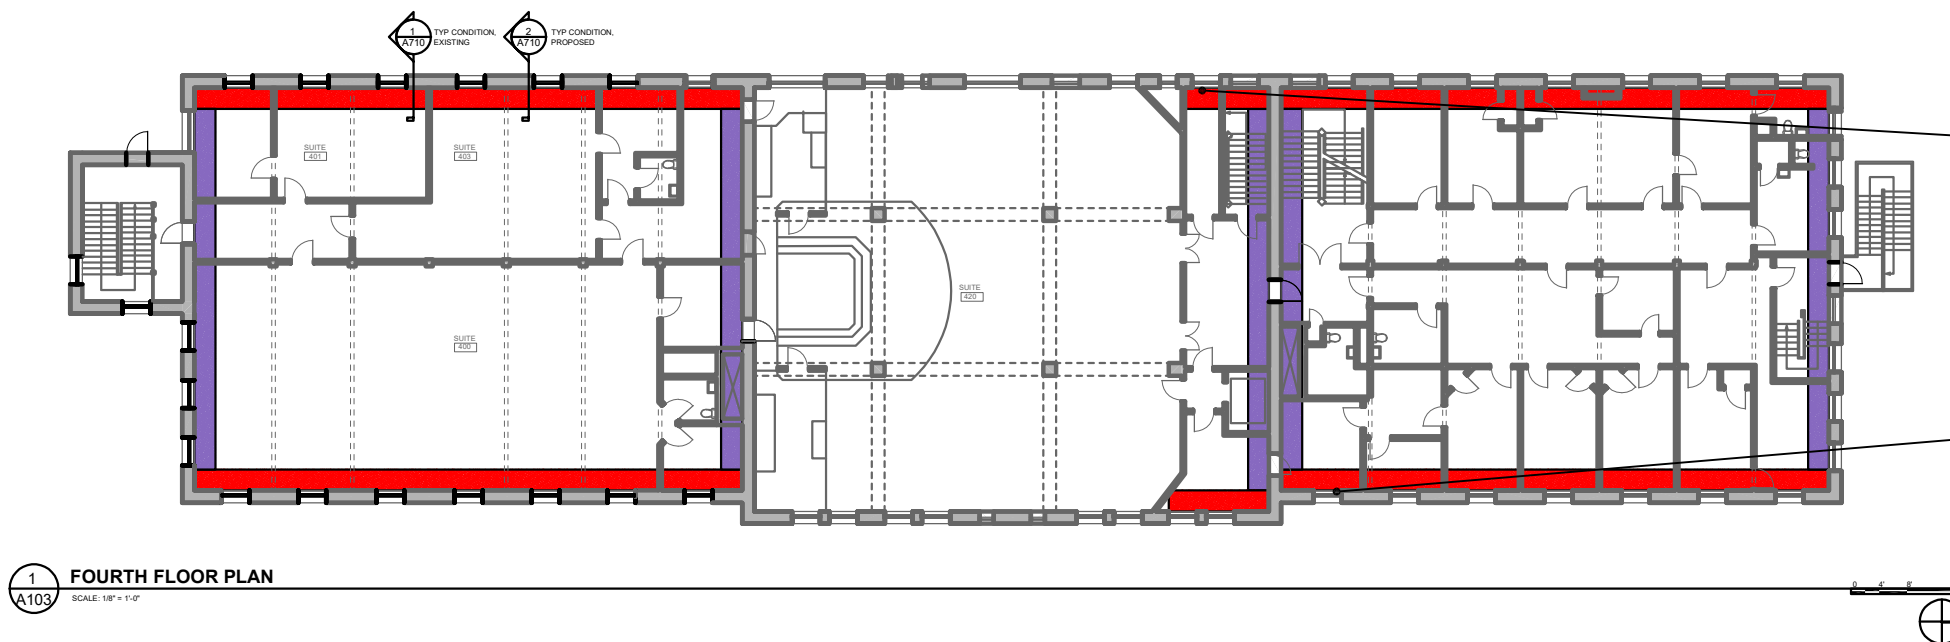
0083-01-7,
0083-Pb-7

0083-01-8

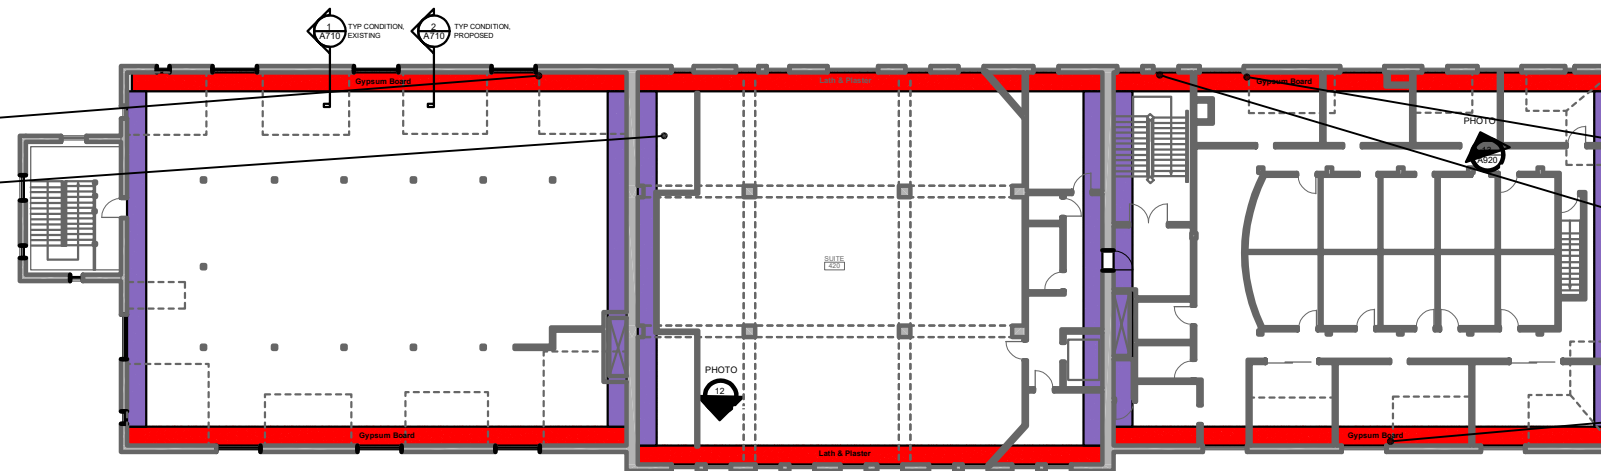
1 FIFTH FLOOR PLAN
A104 SCALE: 1/8" = 1'-0"

0083-06-1

0083-08-1

0083-Pb-12

0083-10-2

0083-07-1,
0083-Pb-8

0083-01-9

0083-07-2

0083-10-3

0083-16-3,
0083-Pb-13

0083-16-2

0083-16-1

0083-09-1

0083-10-1,
0083-Pb-9

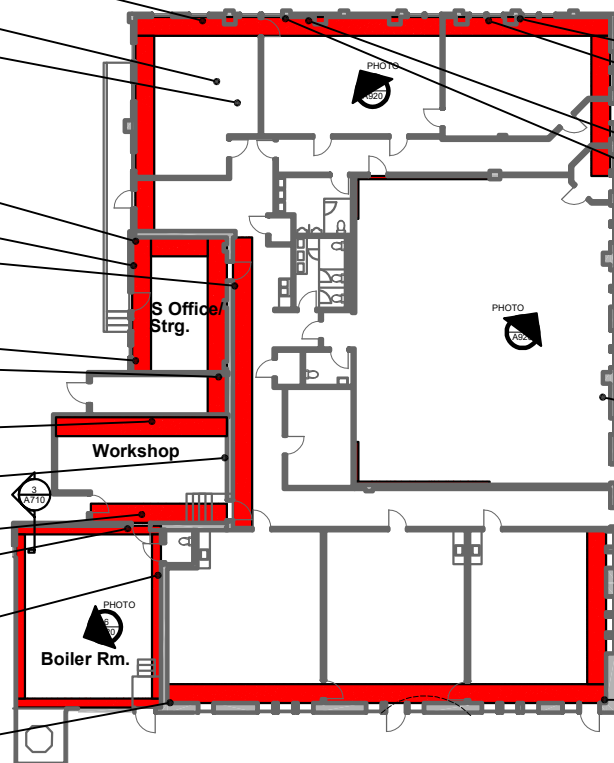
1 FIRST FLOOR SOUTH ANNEX FLOOR PLAN
A105 SCALE: 1/8" = 1'-0"

0083-15-1

0083-Pb-11

0083-12-1,
0083-14-1

0083-13-2

0083-11-1,
0083-Pb-10

0083-13-1

0083-22-1

0083-17-1,
0083-Pb-14

0083-19-1

0083-18-1

0083-21-1,
0083-Pb-15

0083-20-1
