SHOWBOX

1426 First Avenue
AUGUST 8, 2018

The City of Seattle
Landmarks Preservation Board

Name: Show Box, Showbox, Showbox Ballroom, Showbox at the Market **Year Built:** 1917

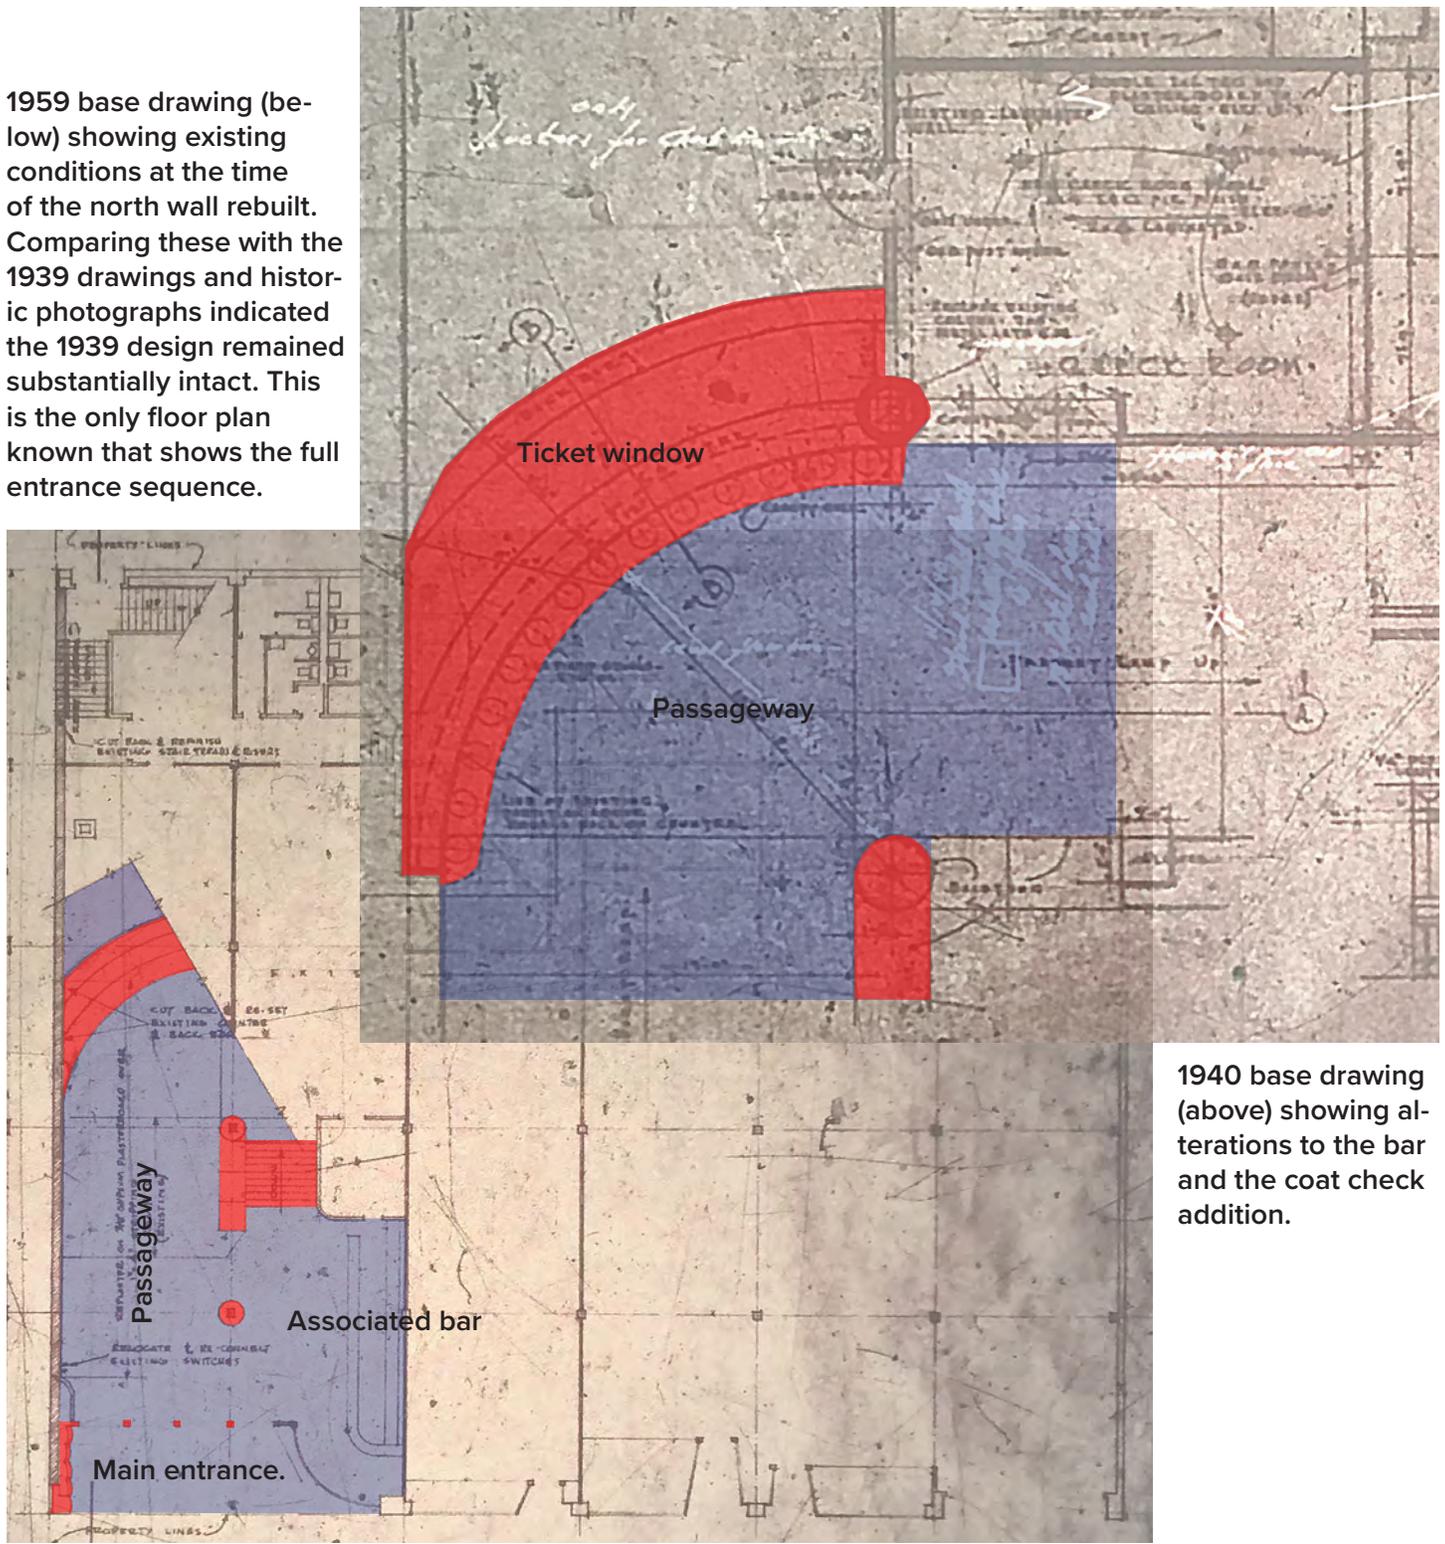
1959 base drawing (below) showing existing conditions at the time of the north wall rebuilt. Comparing these with the 1939 drawings and historic photographs indicated the 1939 design remained substantially intact. This is the only floor plan known that shows the full entrance sequence.

1940 base drawing (above) showing alterations to the bar and the coat check addition.

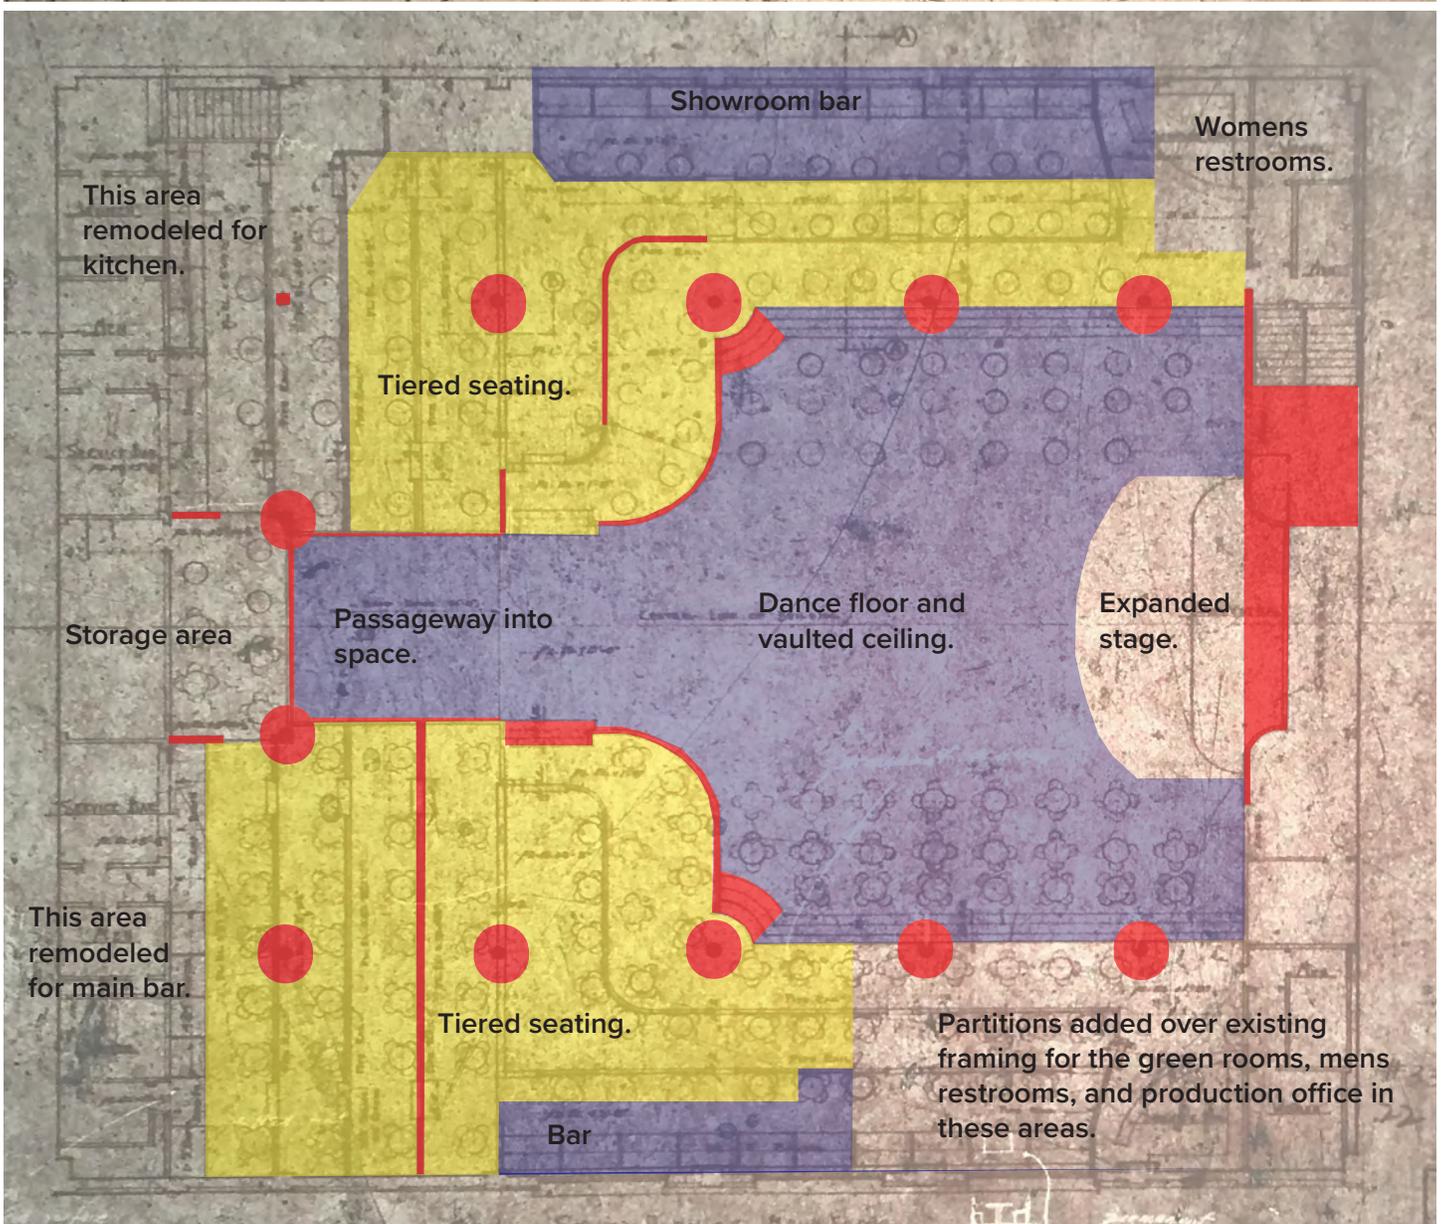
Figure 5. Second floor analysis plan. The 1939 remodel plan is the base drawing with overlaid color coding to show what remains today from the original design. The core volume, dance floor, raised seating, columns, proscenium, and fly loft all remain. Refer to the character defining features and spaces section in the description for a full list of the features.

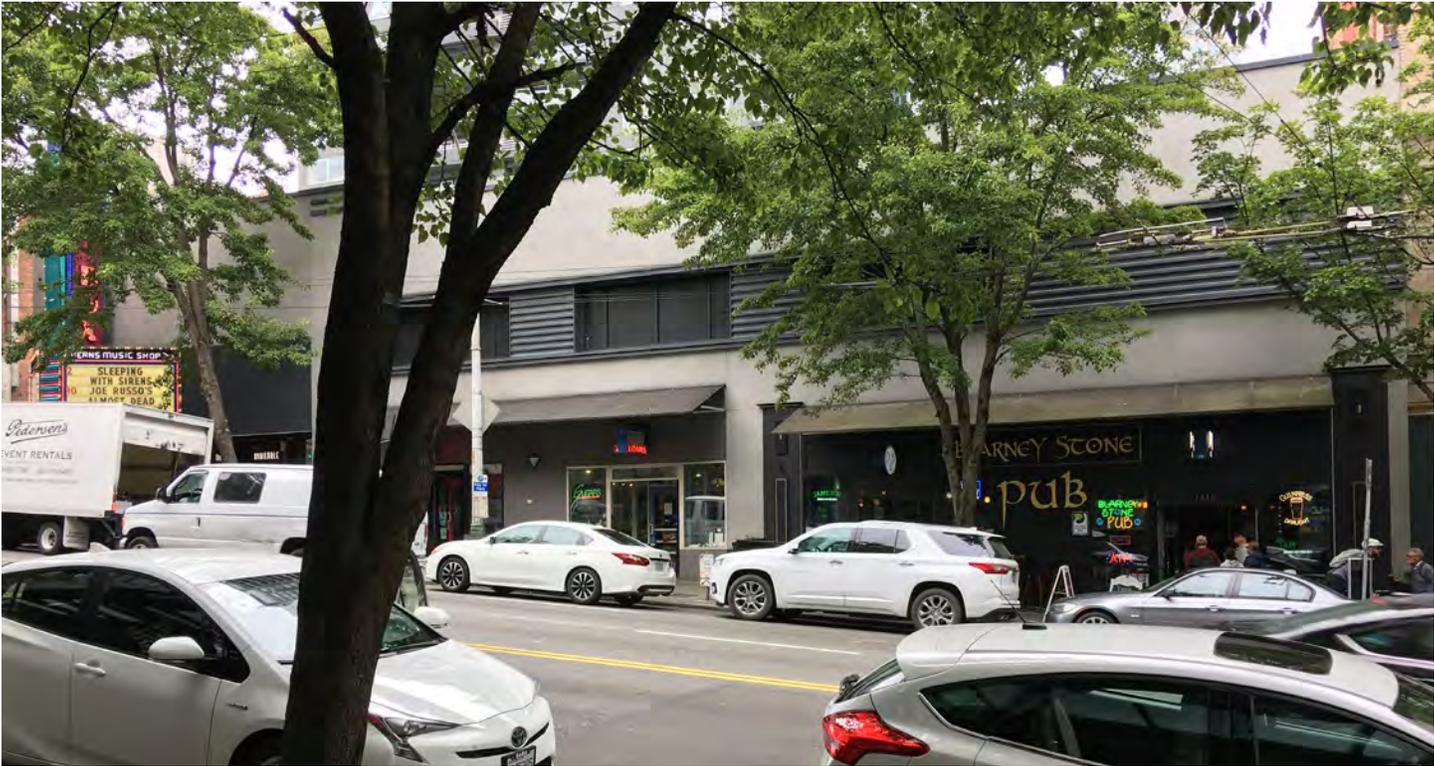
Figure 6. Front, west facade along 1st Avenue.

A masonry foundation supports the building structure with footings below the wood posts. There are no known basement areaways extending below the sidewalk along First Avenue. The building's east and west walls consist of unreinforced, load bearing common bond brick walls with headers every sixth course. These walls are three to four wythes thick for an approximate wall thickness of 12- to 16-inches. Brick piers step out on the interior face of the wall to carry beams supporting the floor framing. The southern third of the east wall at the second story level consists of stacked hollow clay tile, with a brick parapet above. Multiple steel louvers at through-wall openings along the first story level support building mechanical functions. **See Figures 6, 13-15.**

Windows occur on the front west and rear east facades. West facade windows consist of three window openings set in a horizontal band characteristic of the Streamline Moderne style. Each opening consists of two fixed sash flanked by narrow sash having a larger fixed upper and smaller operable lower sash. Window frames are anodized aluminum. The window band is framed by a projecting modernistic border emphasizing the horizontal character of the facade, with painted corrugated metal panels between the windows and at the south end. The border consists of raised outer edges with a central recessed channel. **See Figures 6, 8, 54-55.**

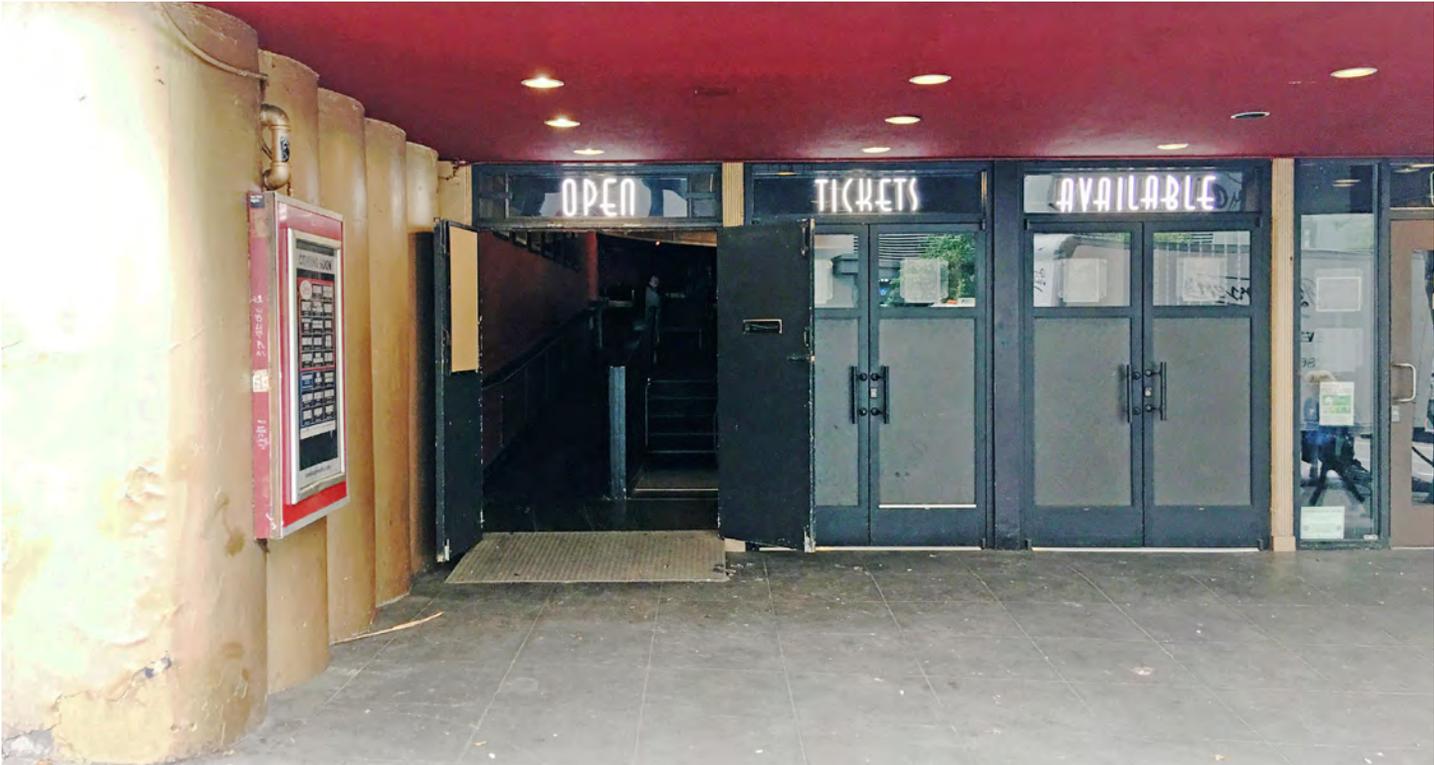
Figure 11. Showbox entrance with the original columns and entrance configuration stemming from the 1939 remodel that created the Showbox.

The performance venue entrance consists of three, two-leaf sets of doors leading from a large recessed foyer to an interior passageway up to the second-floor performance venue. A neon marquee is mounted to the building facade above the entrance. The foyer provides a sheltered waiting area for visitors and arcs outward to the south and slopes slightly downward from north to south, following the sidewalk grade. Scored concrete comprises the flooring. A narrow band and thin aluminum trim along the outer edge of the wall above the entrance mark the transition from the wall plane to the ceiling of the foyer. A flat plaster ceiling with recessed light fixtures extends back to the doorways. A series of five large, round engaged columns results in a "scalloped" wall that defines the north side of the foyer. The fifth storefront described above defines the south arced side of the entrance foyer.

Each of the three doorways consists of a pair of two-panel doors. The northern set has flush panel doors with the other two sets having upper glass lites and a solid recessed lower panel and metal pull bar handles. Each doorway has a narrow transom. The northernmost transom consists of an operable wood hopper transom with 14 lites. Added exterior plexiglass covers the transoms with neon signage at each advertising "Open," "Tickets," and "Available." Between each of the doorways and flanking their outer edges are slender reeded (parallel sets of small convex moldings) engaged columns with low square plinths. This same decorative element repeats on the interior side of the doorways as both engaged columns between the doors and an overall casing wrapping around the entire set of three doorways. Added coverings and metal conduit cover some of these on the interior and one on the exterior. A sign board announcing upcoming artists is mounted to the outer edge of the north foyer wall.

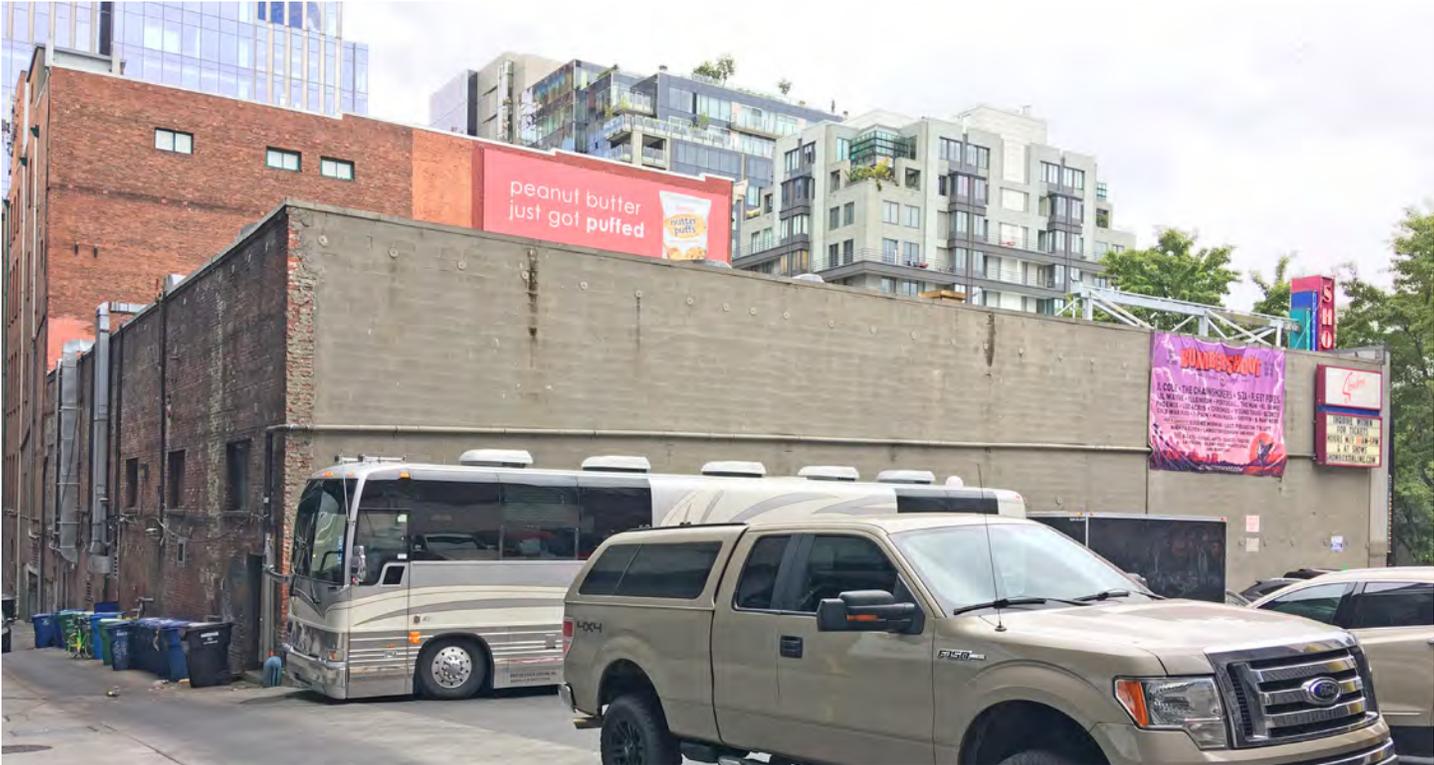
Figure 13. Northeast corner, looking southwest along the alley. The reconstructed north wall is visible.

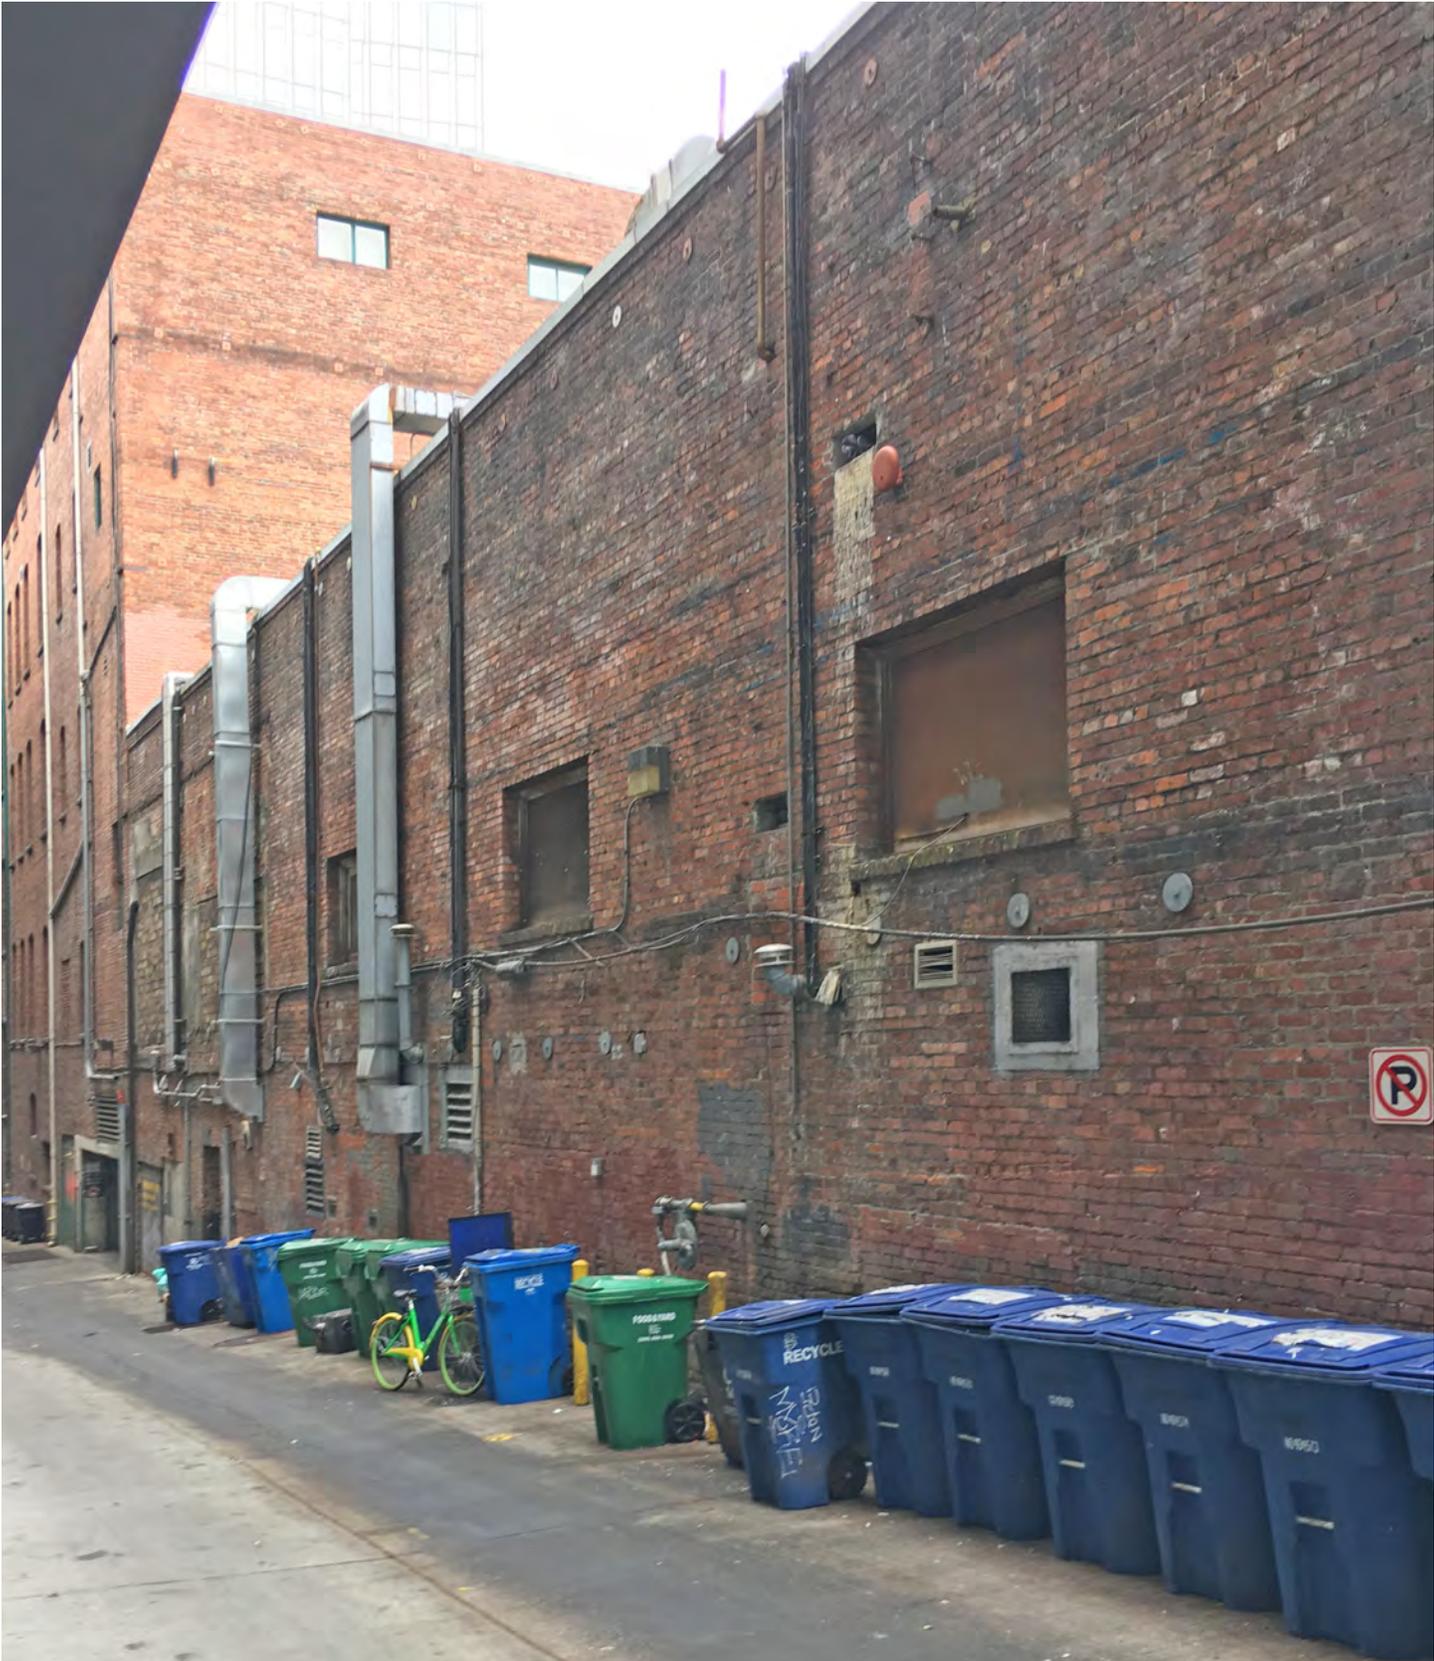
Figure 14. East alley facade looking south. The load bearing brick construction stems from the building's 1916 construction.

The rear alley facade generally retains its original form with some infill of former windows, a doorway in the southeast corner, and the replacement of brick with hollow clay tile in a section of the second story wall at the south end of the facade.

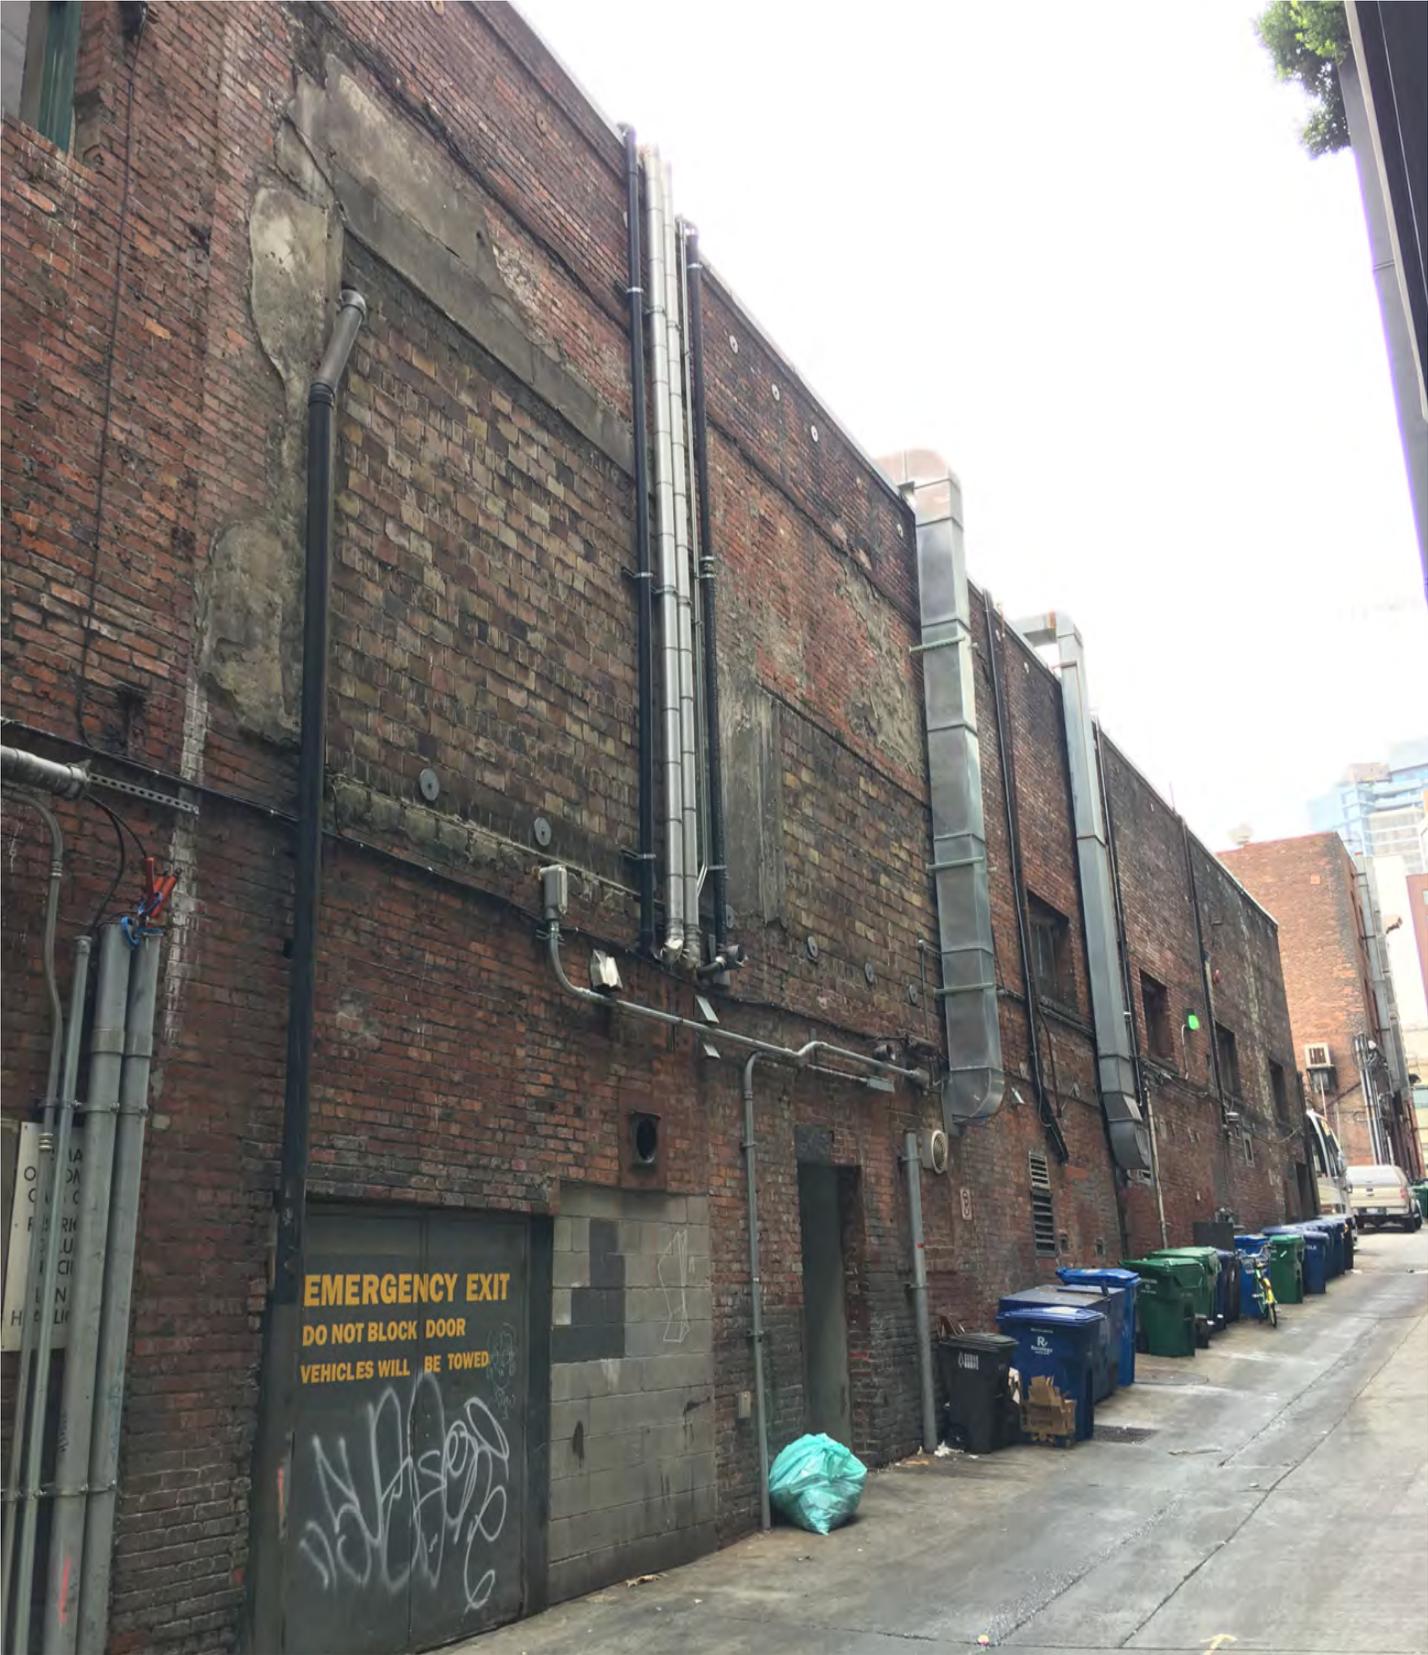
Figure 15. East alley facade, looking north.

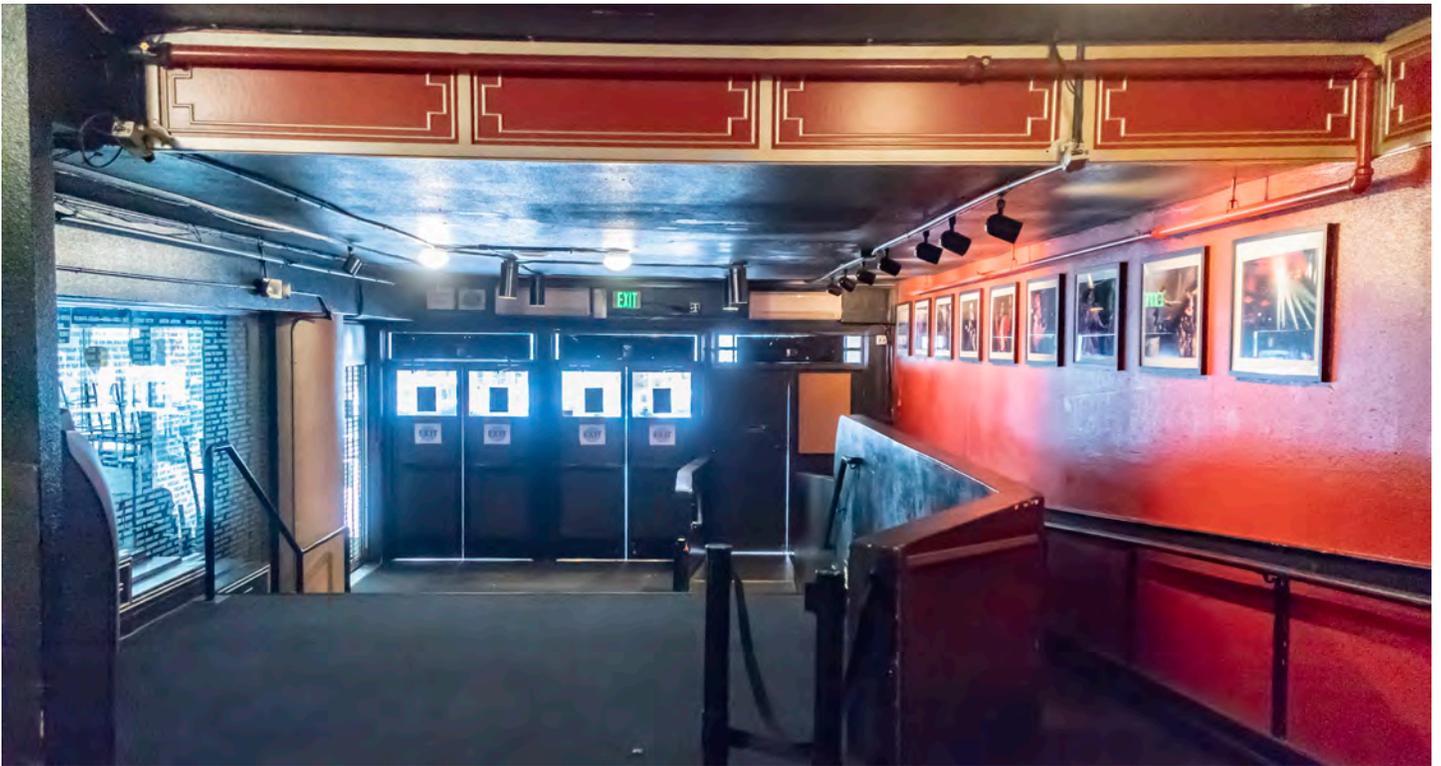
Figure 20. Showbox, looking west along the passageway at the three doorways providing access. The soffit above marks the line of the second floor framing. The volume of this passageway, door surrounds, and the large column at left are original to the 1939 remodel creating the Showbox.

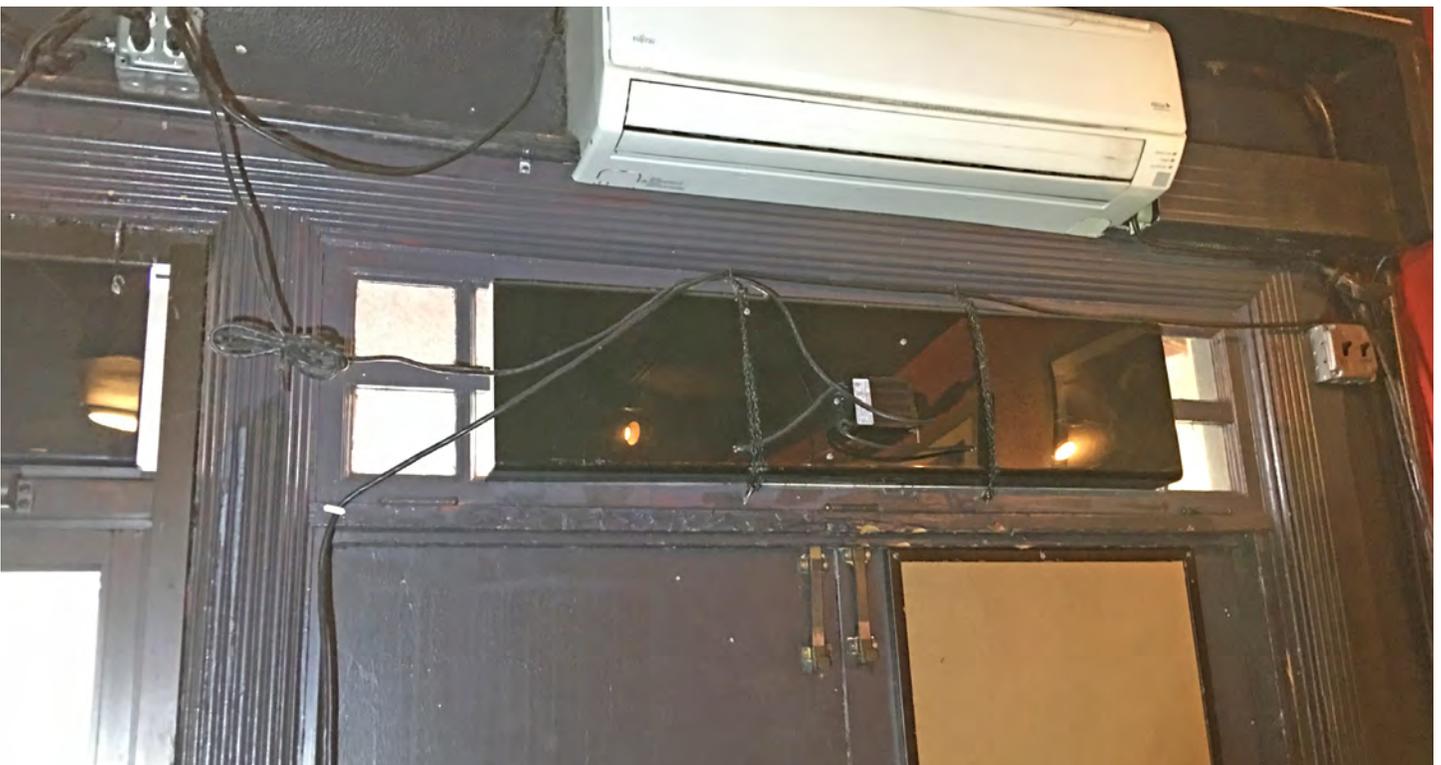
Figure 21. Showbox, detail view of the interior face of the doors showing the reeded detailing original to the 1939 remodel that is replicated on the exterior side of the doorways as well. The wood sash transom is also visible.

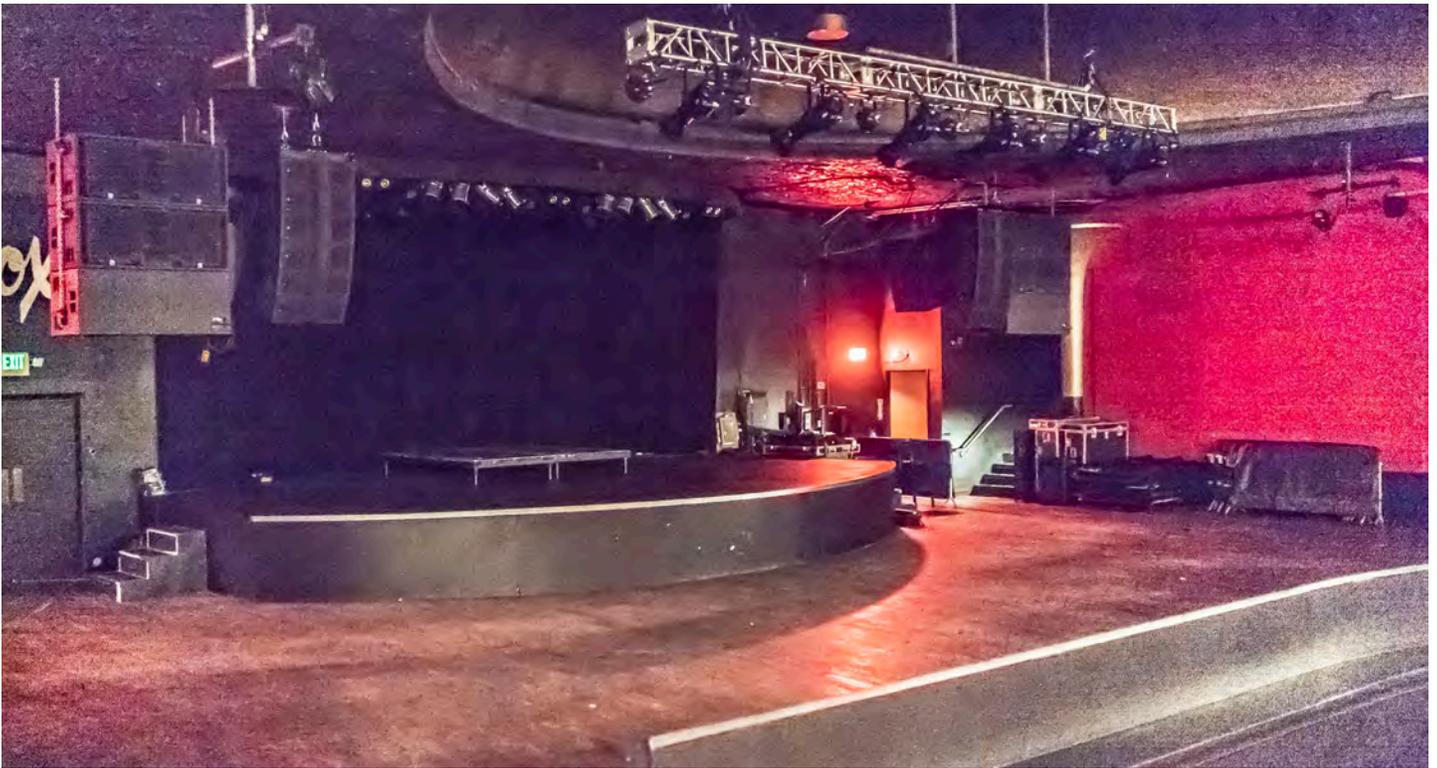
Figure 24. Showbox, looking south at the stage. The proscenium consisting of large rounded corners leading back to a flat back wall are original to the 1939 remodel and remain behind the curtains.

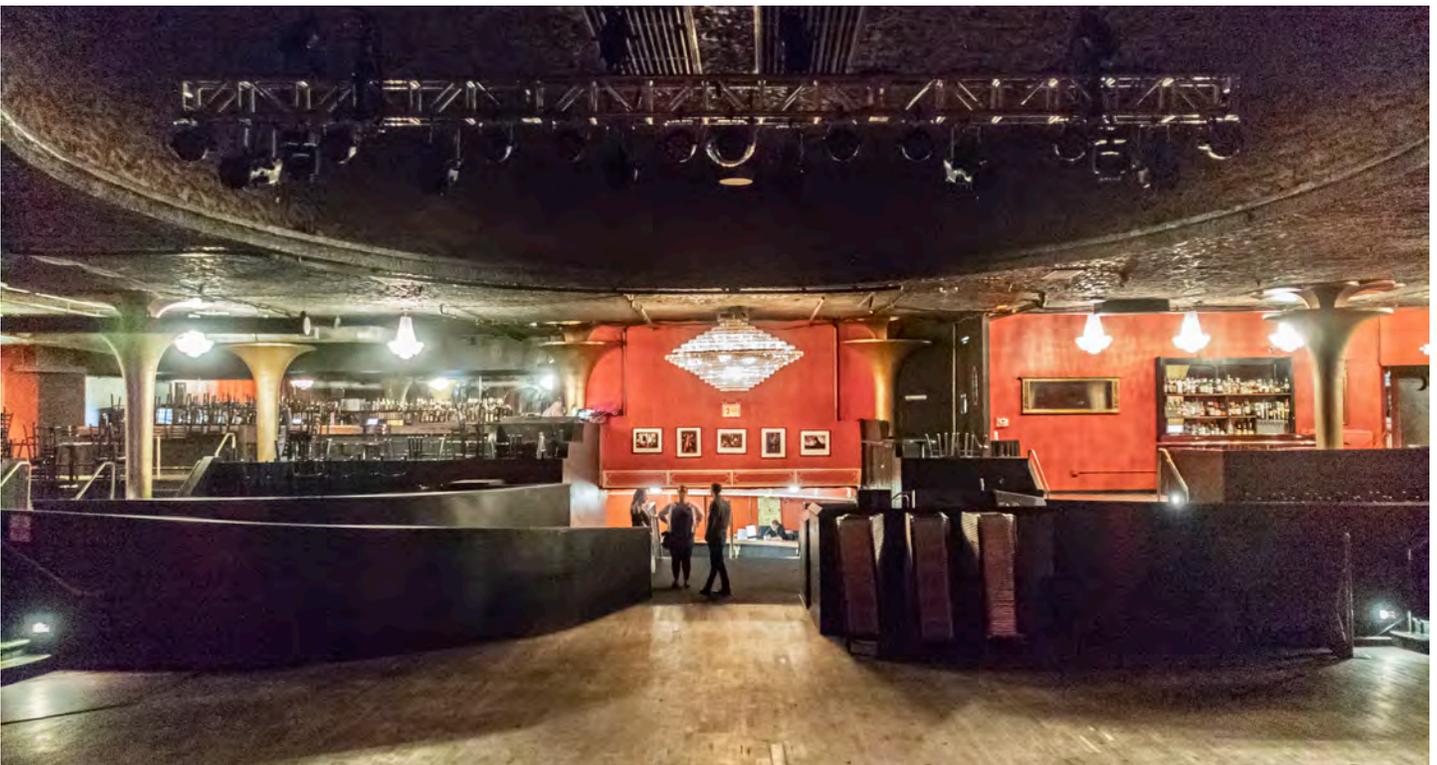
Figure 25. Showbox, looking north from the stage at the passageway entrance to the space. The vaulted ceiling is original to the 1939 remodel.

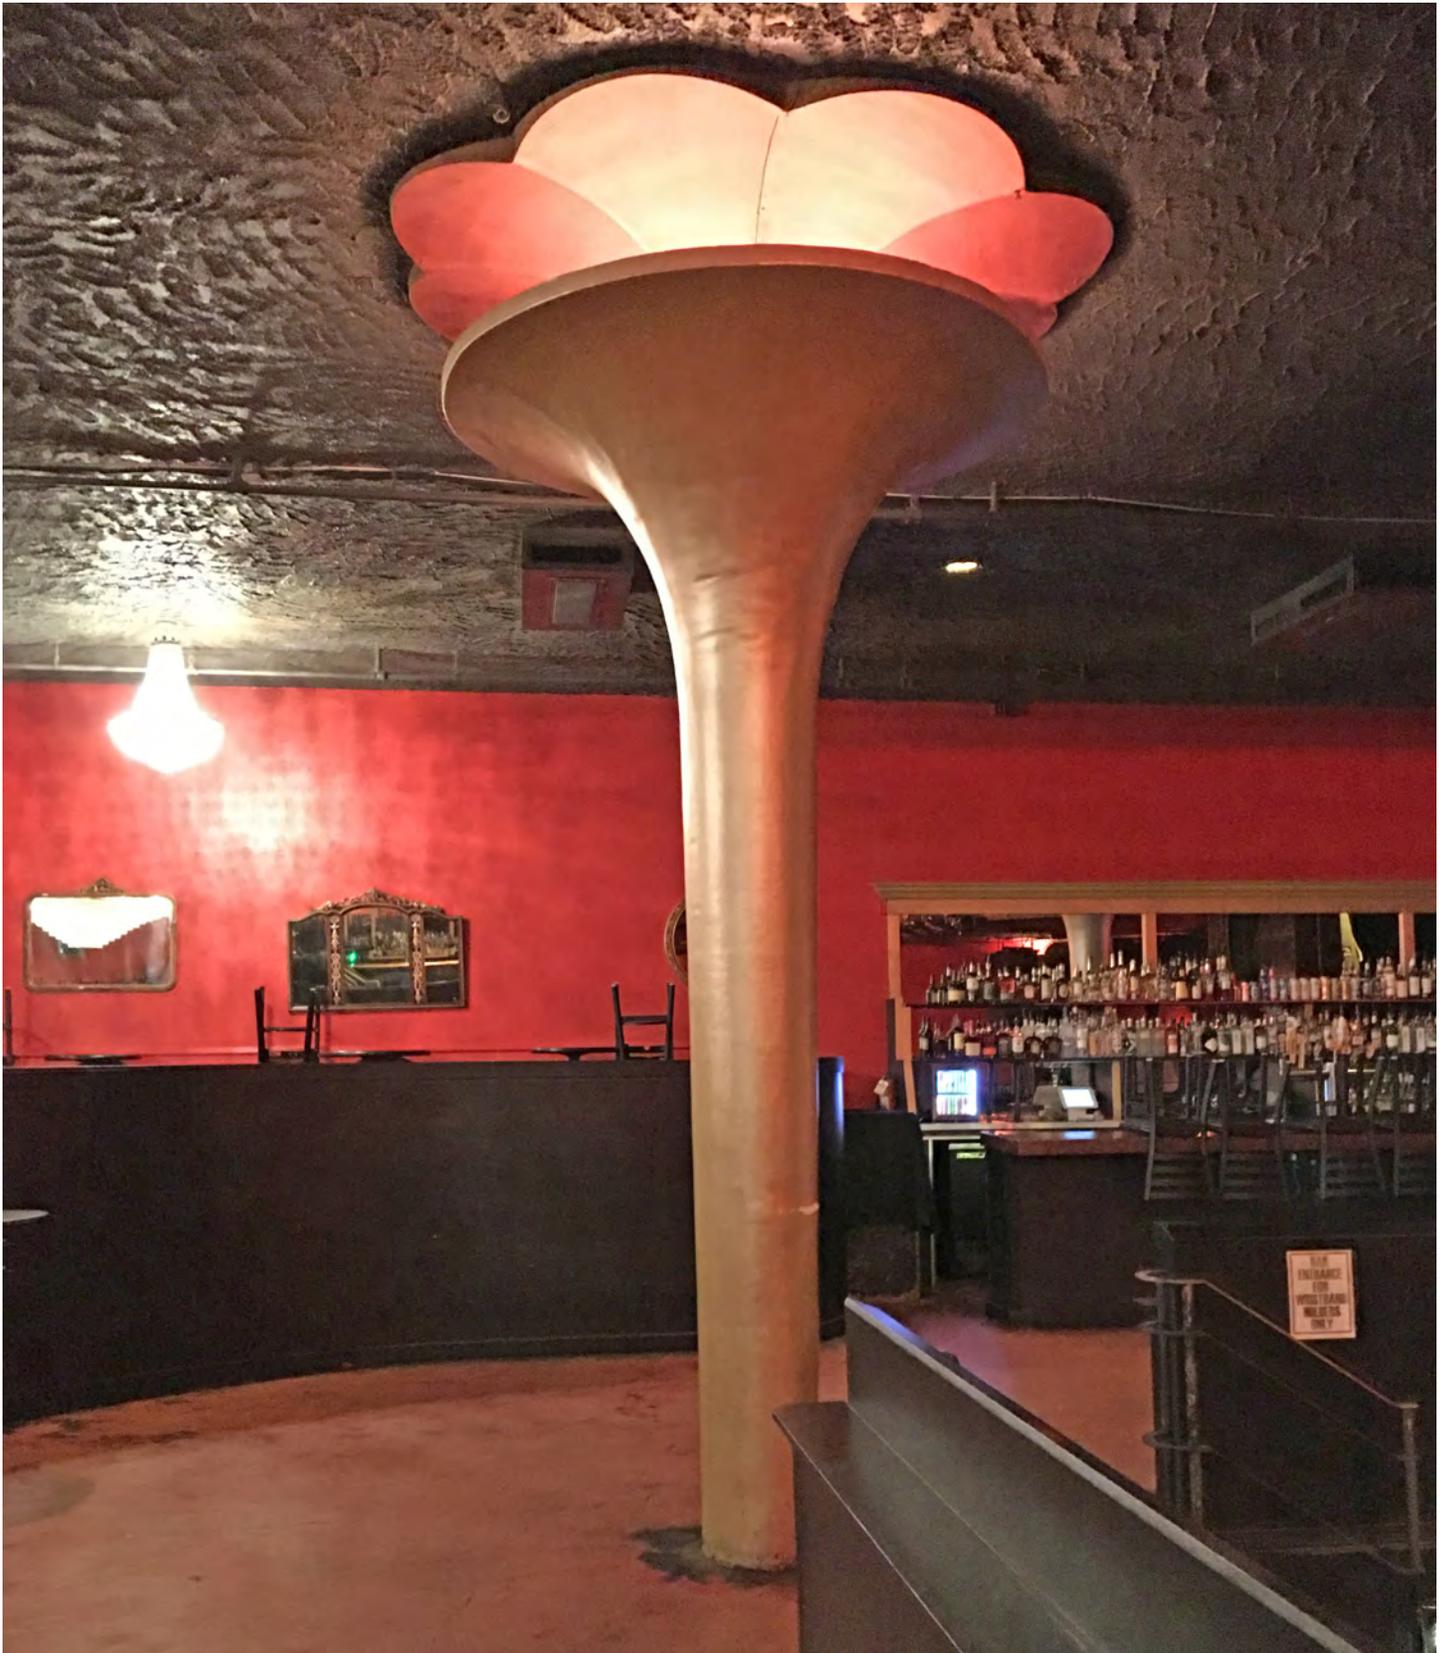
Figure 32. Showbox, detail of column original to the 1939 remodel. The core is a wood post with an outer plaster and wood form.

Interior framing consists of ten- by ten-inch posts set on 22-foot centers that support the floor framing. These wood posts occur at each floor. The posts have chamfered corners and carry massive timber beams (approximately 14- by 14-inches in section) that run east to west. Steel strap ties anchor the beam ends to the outer walls. The first floor consists of a concrete slab with some wood floor sections along First Avenue. The second floor and roof deck consist of nominally two-inch-thick boards set on edge and butted one next to the other. This construction method provides a high load capacity for the flooring system. Steel brackets anchor the posts to the beams. Through-wall steel ties connect the second floor and roof framing to the exterior walls. **See Figure 53, upper right image.**

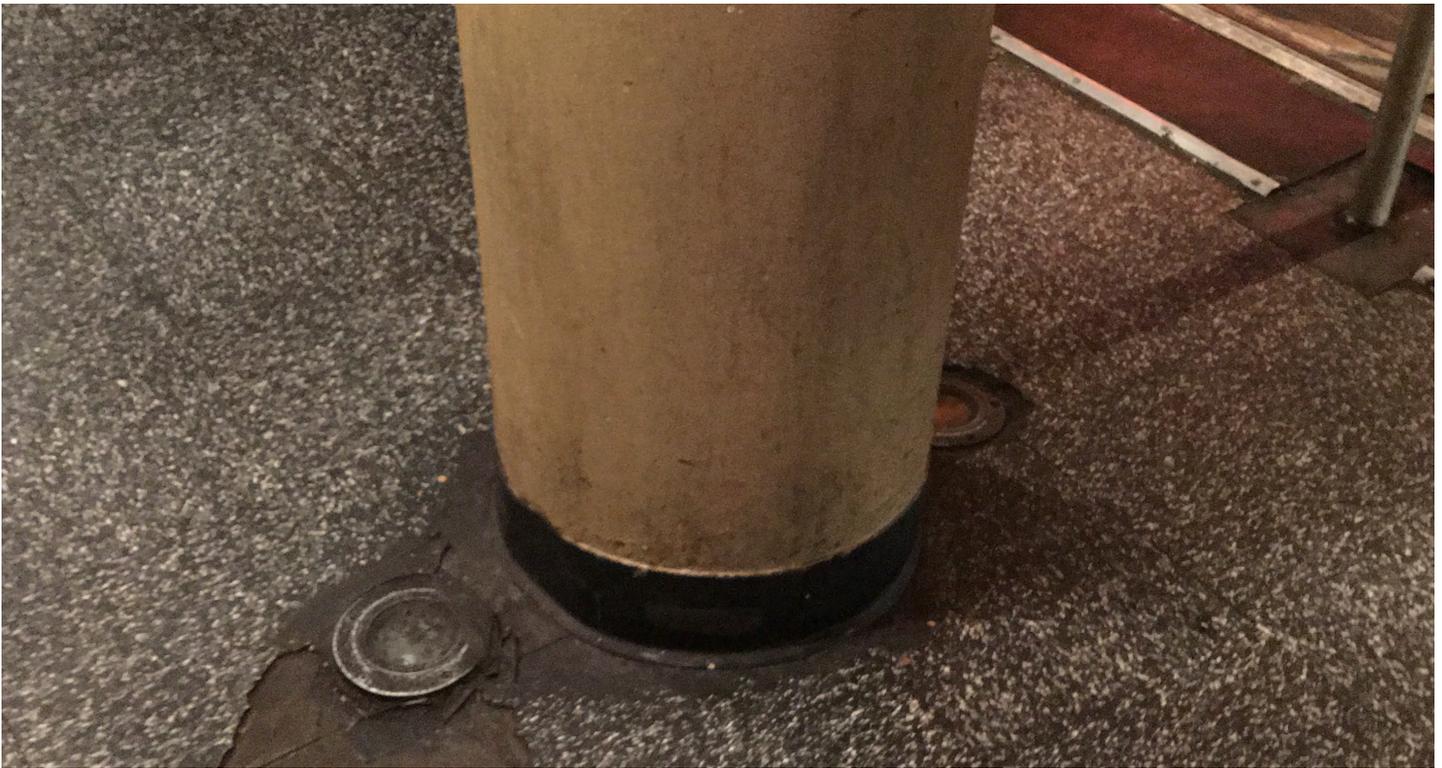
Figure 33. Showbox, detail of the floor lights original to the 1939 remodel that provided a light wash up the column.

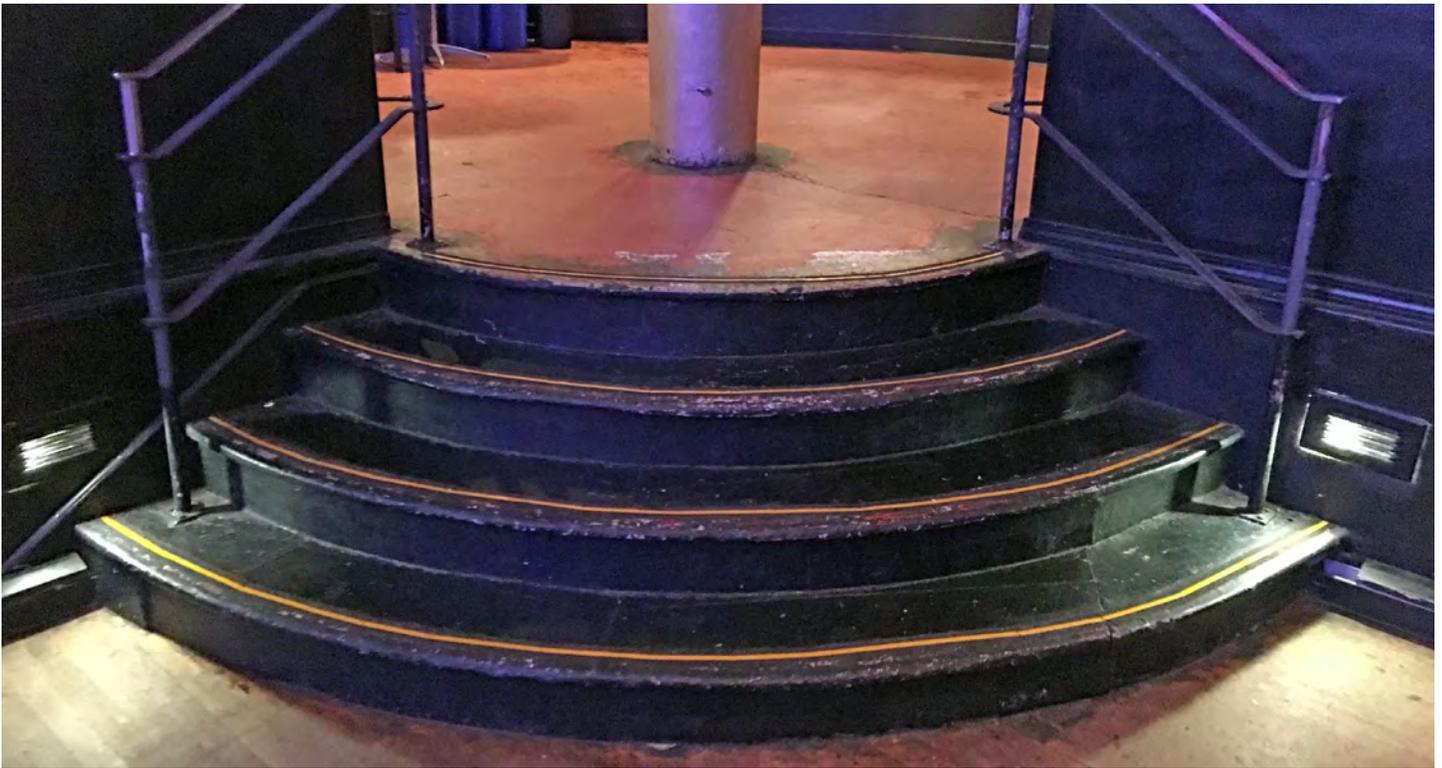
Figure 35. Showbox, detail of curved stairs and metal railings up from the dance floor to the terraced seating that are original to the 1939 remodel.
