SHOWBOX

1426 First Avenue
AUGUST 8, 2018

The City of Seattle
Landmarks Preservation Board

Name: Show Box, Showbox, Showbox Ballroom, Showbox at the Market **Year Built:** 1917

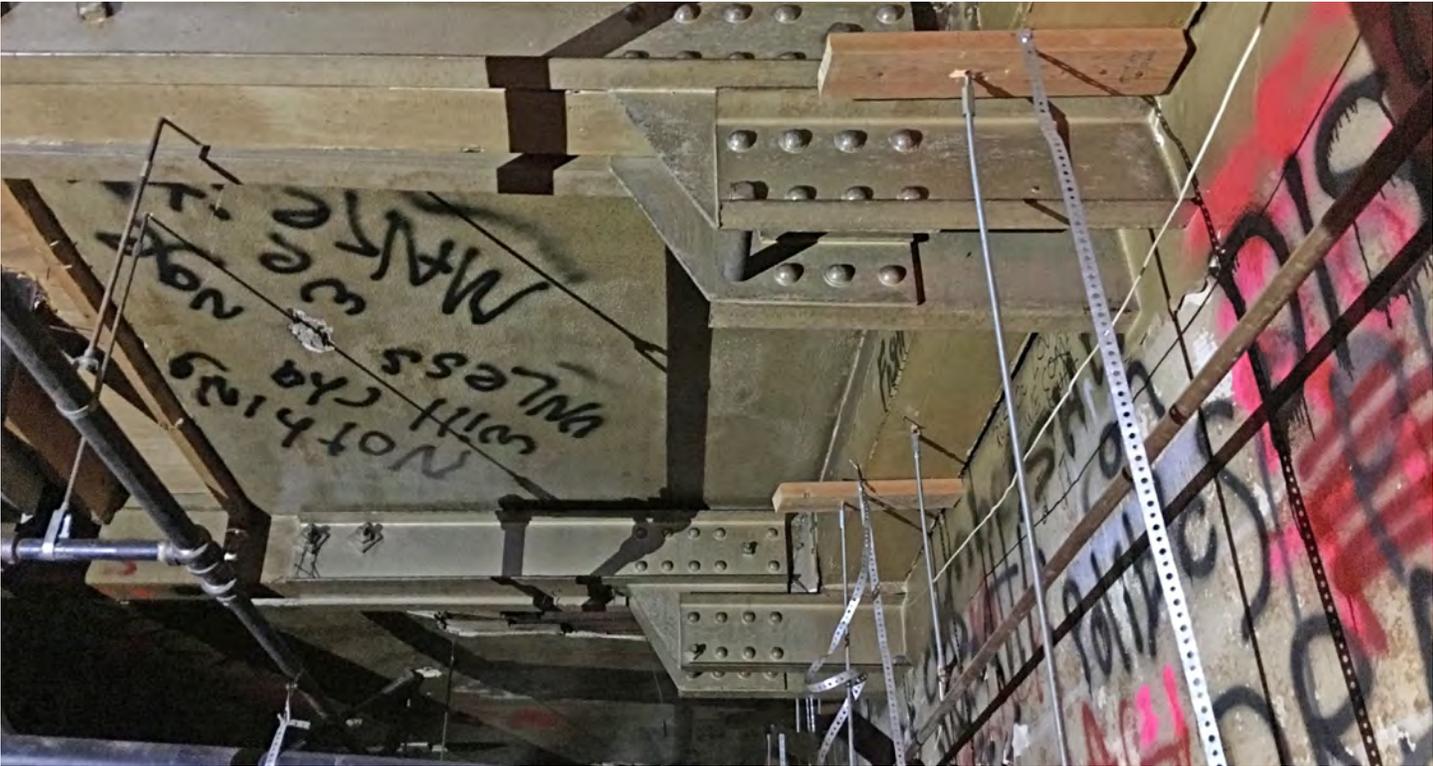
Figure 46. Showbox, fly loft showing the building framing and the graffiti within the space.

The fly loft is located behind the stage and extends to the southeast over the egress stairway. Douglas fir flooring extends throughout the space, with plaster walls. A wood frame ladder provides access to the upper level. The space provides storage for cabling and performance related equipment. The upper portion features graffiti from the multiple bands that played at the venue, including Neil Young and Malfunkshun (one of the forerunners of the grunge scene in the early 1980s and founded by brothers from Bainbridge Island).

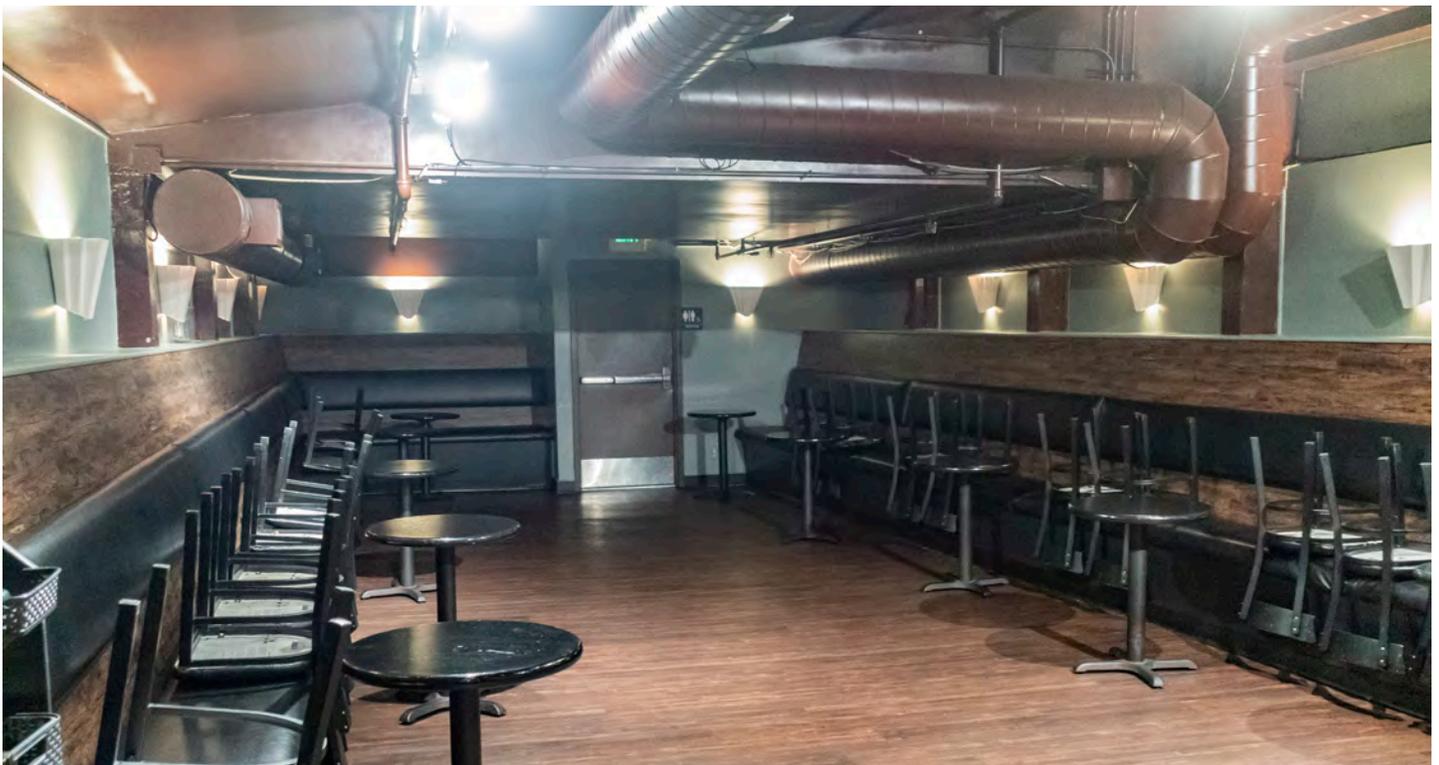
Figure 50. Showbox, looking east through the lower level. Note the sloped ceiling which is original to the 1939 remodel and is the underside of the original ramp up to the performance hall from the ticket counter.

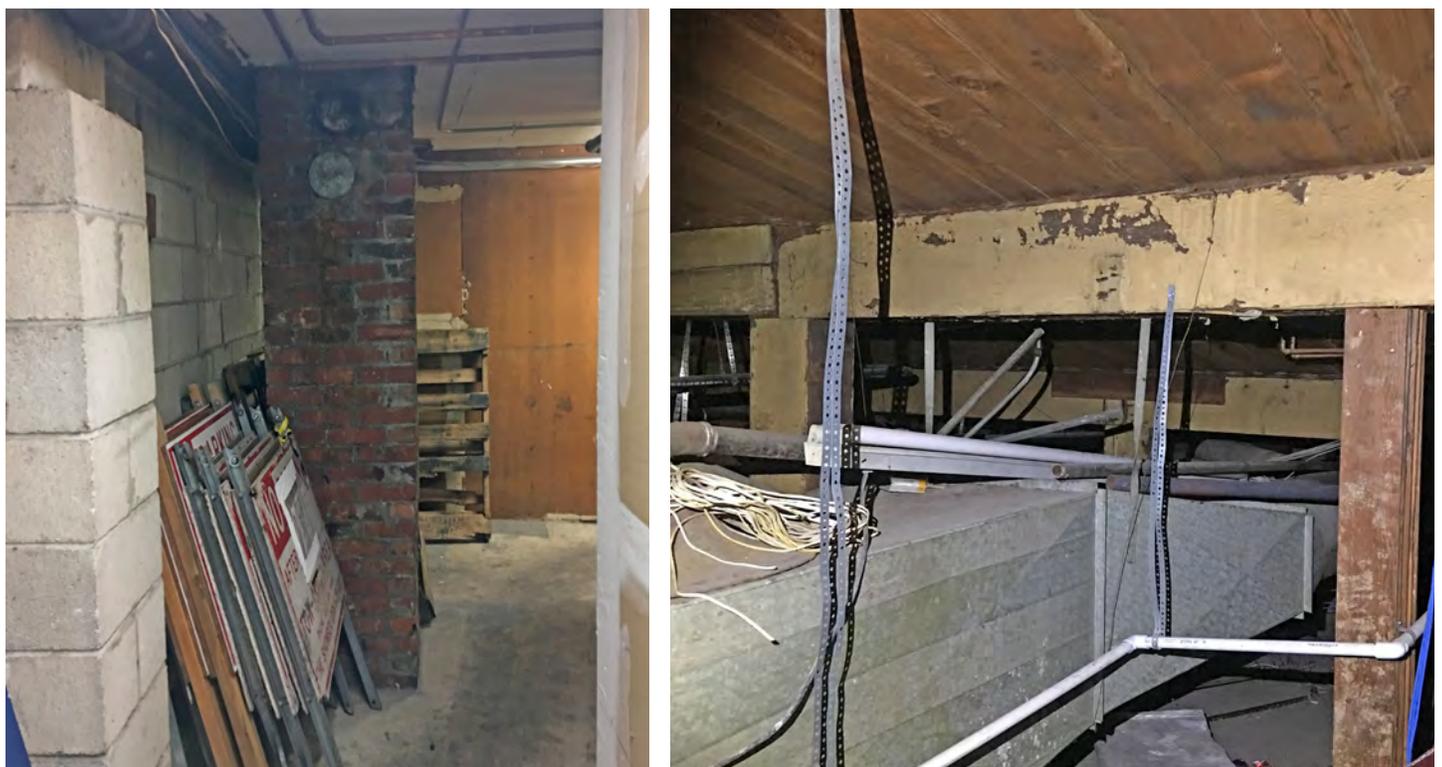
Figure 52. Service area, looking east along the rebuilt north facade. The brick chimney is original to the 1916 construction of the building (above left). A view looking west (above right) below the Showbox passageway showing the framing and ramp that are original to the 1939 remodel.

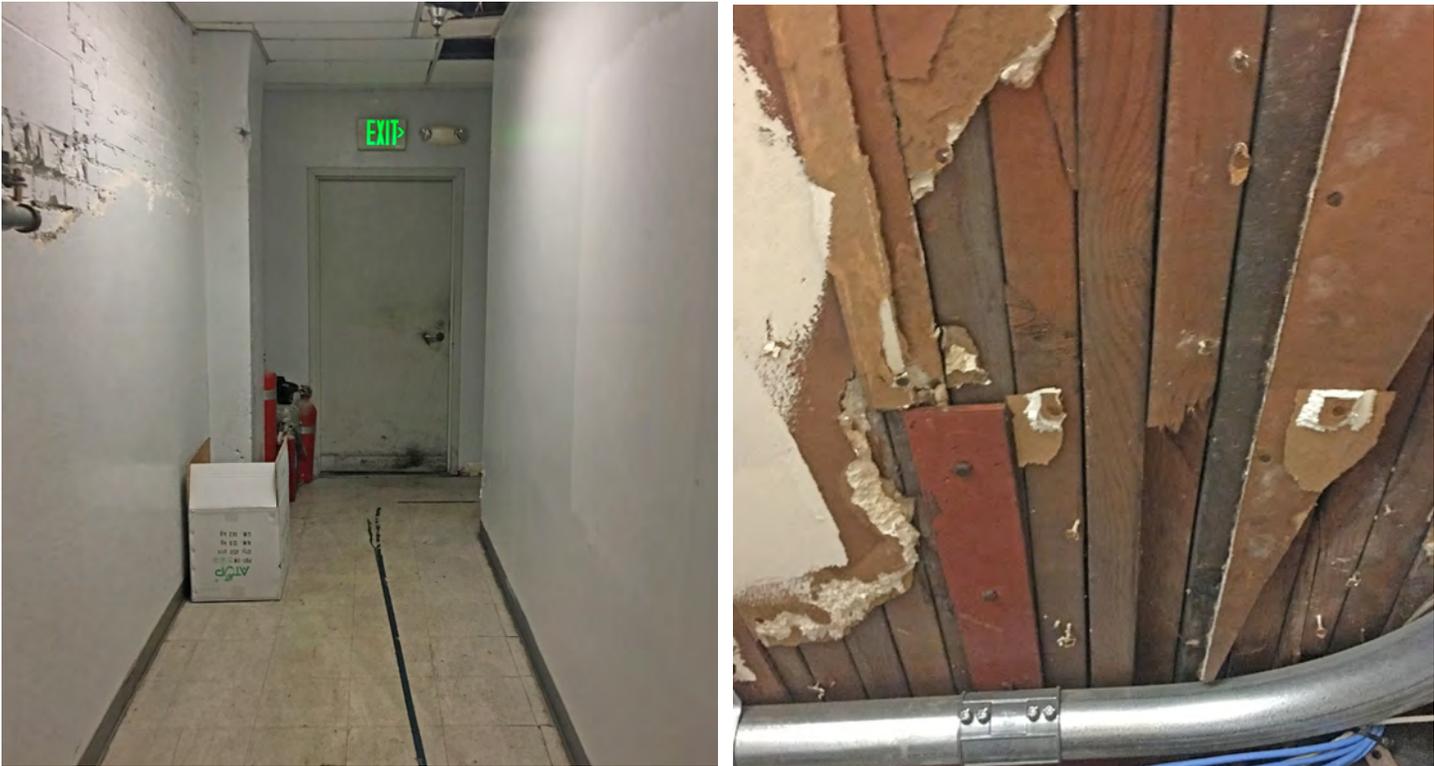
Figure 53. Service area, looking east and showing typical wall finishes (above left). The wall along the left side is the outer brick masonry wall. Note the brick pier that steps out to support the massive east to west beams carrying the second floor. A detail (above right) of the crib construction (2x boards on edge) comprising the floor structure for the second floor.

Interior framing consists of ten- by ten-inch posts set on 22-foot centers that support the floor framing. These wood posts occur at each floor. The posts have chamfered corners and carry massive timber beams (approximately 14- by 14-inches in section) that run east to west. Steel strap ties anchor the beam ends to the outer walls. The first floor consists of a concrete slab with some wood floor sections along First Avenue. The second floor and roof deck consist of nominally two-inch-thick boards set on edge and butted one next to the other. This construction method provides a high load capacity for the flooring system. Steel brackets anchor the posts to the beams. Through-wall steel ties connect the second floor and roof framing to the exterior walls. **See Figure 53, upper right image.**

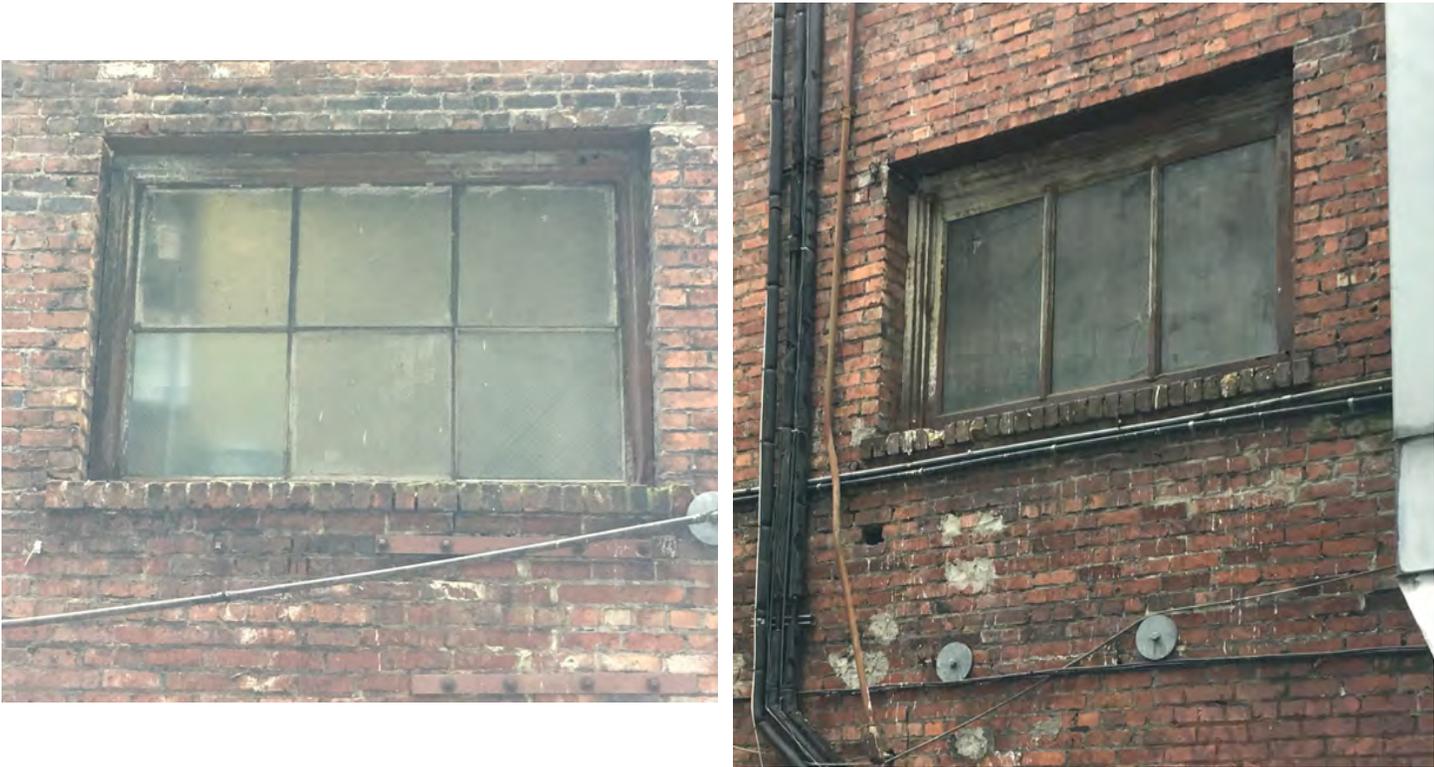
Figure 54. Alley facade, detail of the 6-lite (above left) and 3-lite (above right) sash along this facade.

Windows occur on the front west and rear east facades. West facade windows consist of three window openings set in a horizontal band characteristic of the Streamline Moderne style. Each opening consists of two fixed sash flanked by narrow sash having a larger fixed upper and smaller operable lower sash. Window frames are anodized aluminum. The window band is framed by a projecting modernistic border emphasizing the horizontal character of the facade, with painted corrugated metal panels between the windows and at the south end. The border consists of raised outer edges with a central recessed channel. **See Figures 6, 8, 54-55.**

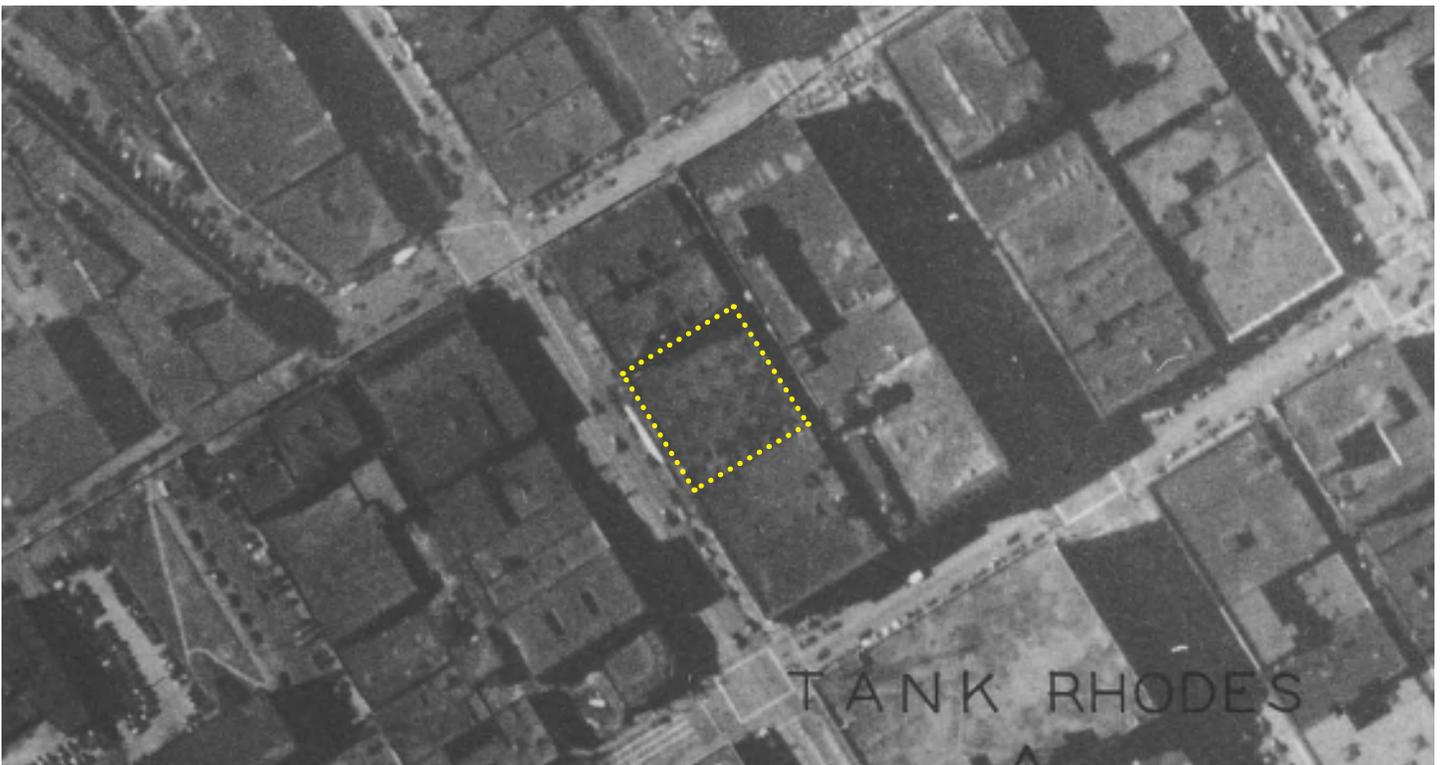
Figure 69. 1937 King County aerial showing the building (outlined in yellow dots) prior to the 1939 remodel. Note the elevated central truss roof portion for the vaulted ceiling at the second floor was part of the 1939 remodel.

A flat roof with composition roofing clads the building. A central low-pitched gable roof portion projects up from the main roof over the second-floor trusses and the domed ceiling. Parapets extend along the west, north, and east sides of the roof with a thin ledge (coping) along the front facade to visually accent the parapet edge and provide a horizontal emphasis to the facade. This ledge is repeated at a step in the parapet height. Sheet metal flashing caps the parapet. A steel armature mounted to the roof framing and supporting the front marquee occupies the northwest corner of the roof behind the parapet. Rooftop mechanical equipment is located around the roof perimeter behind the parapet. Sheet metal ducting and steel enclosed conduit (related to restaurant and performance venue functions) extend up to this equipment along the outer face of the east facade to avoid disrupting the interior performance volume. Metal downspouts extend down from the roof along the east facade, discharging at the alley. An internal brick chimney is in the northeast corner of the building. **See Figures 2, 69.**

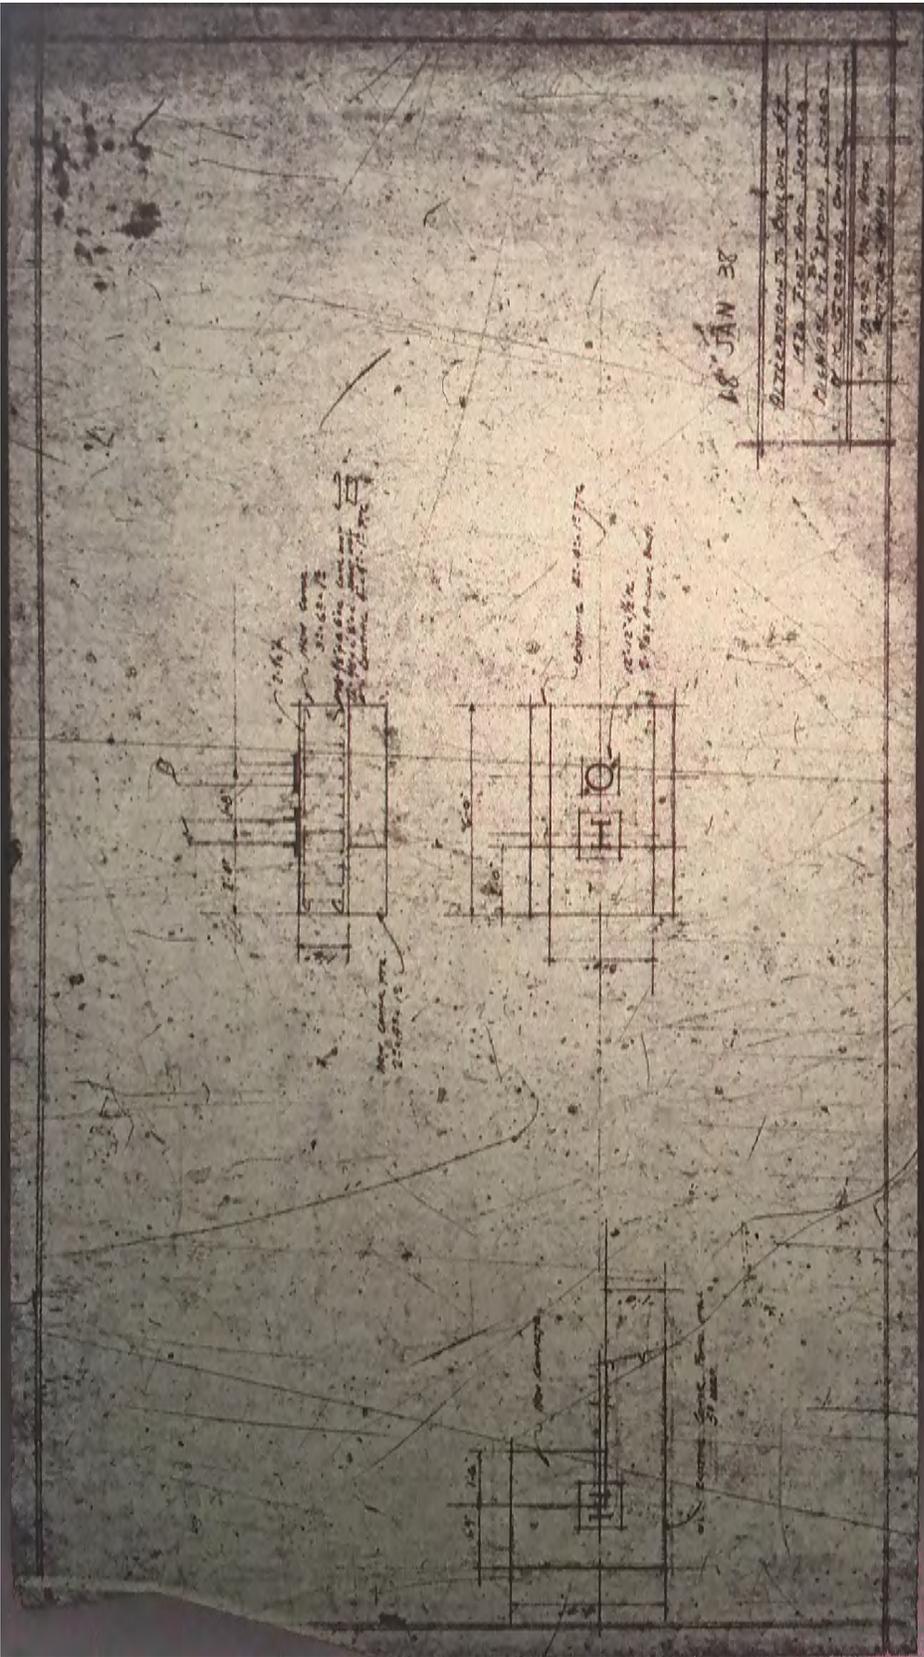
Figure 70. 1938 (January 18) drawing showing foundation upgrades for Michael Lyons (leasing space) and K. Greene (owner) by architect Bjarne Moe. Courtesy Seattle Department of Construction and Inspections microfilm library.

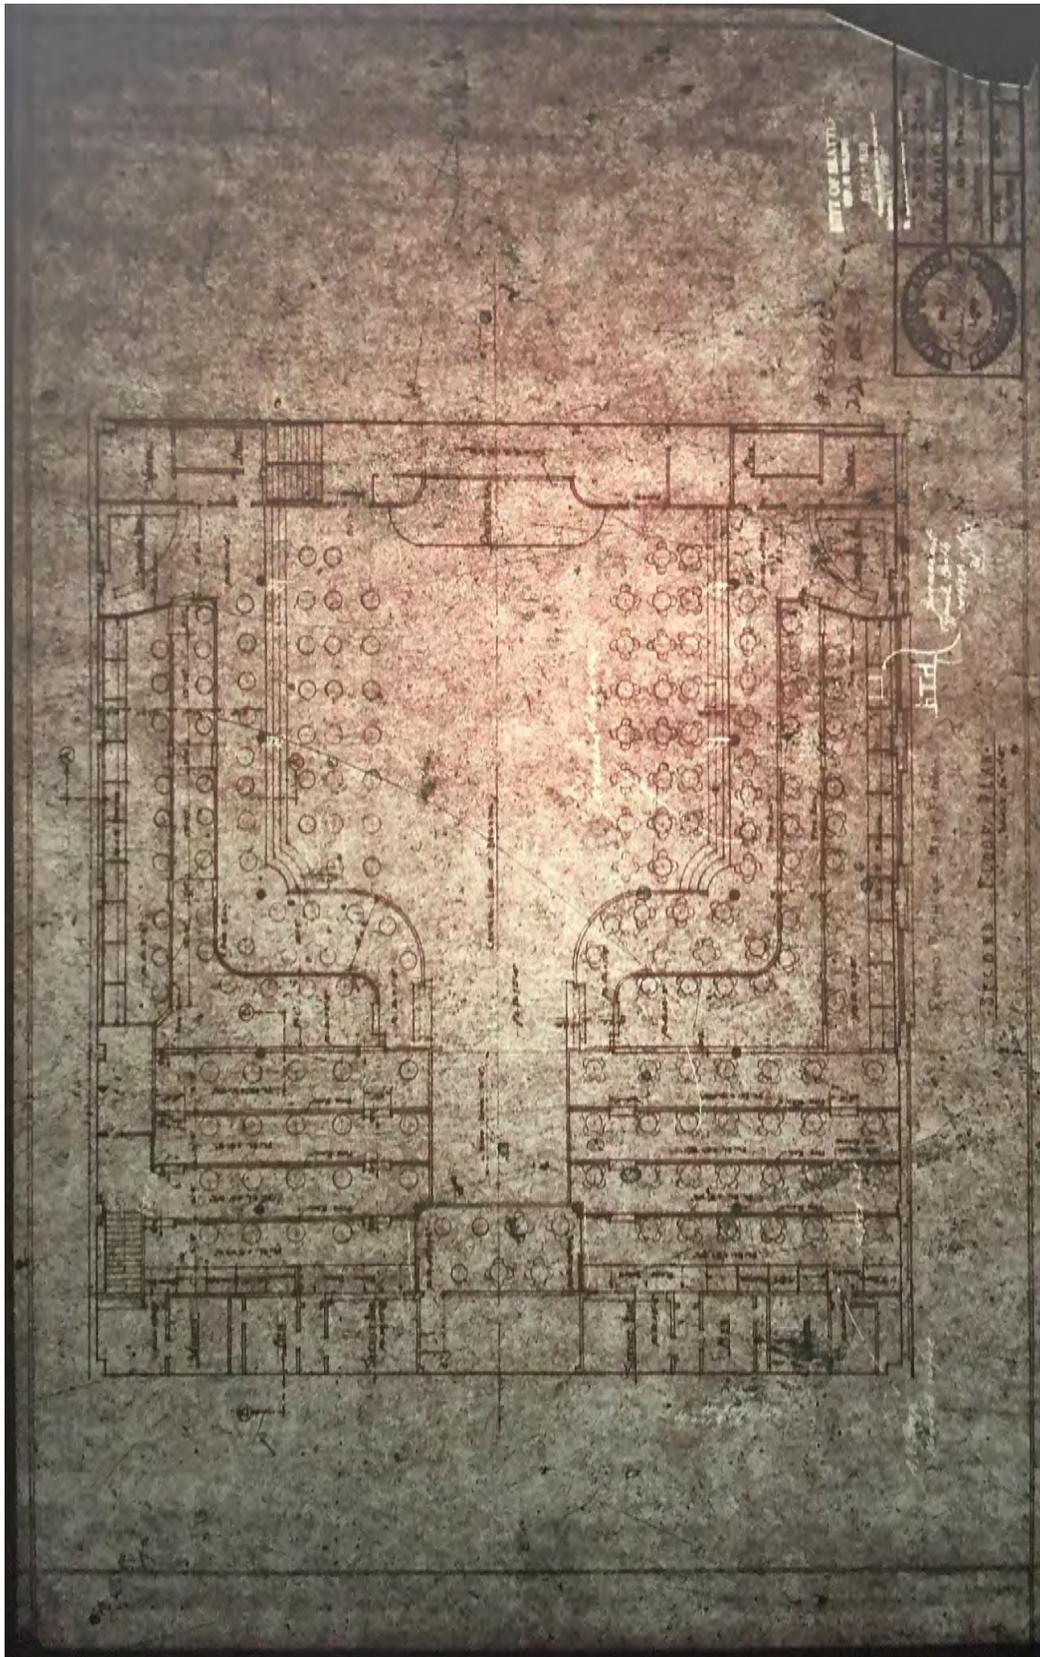
Figure 71. 1939 (December 15) drawing showing the second floor plan for the Showbox remodel for Michael Lyons prepared by architect Bjarne Moe. Courtesy Seattle Department of Construction and Inspections microfilm library.

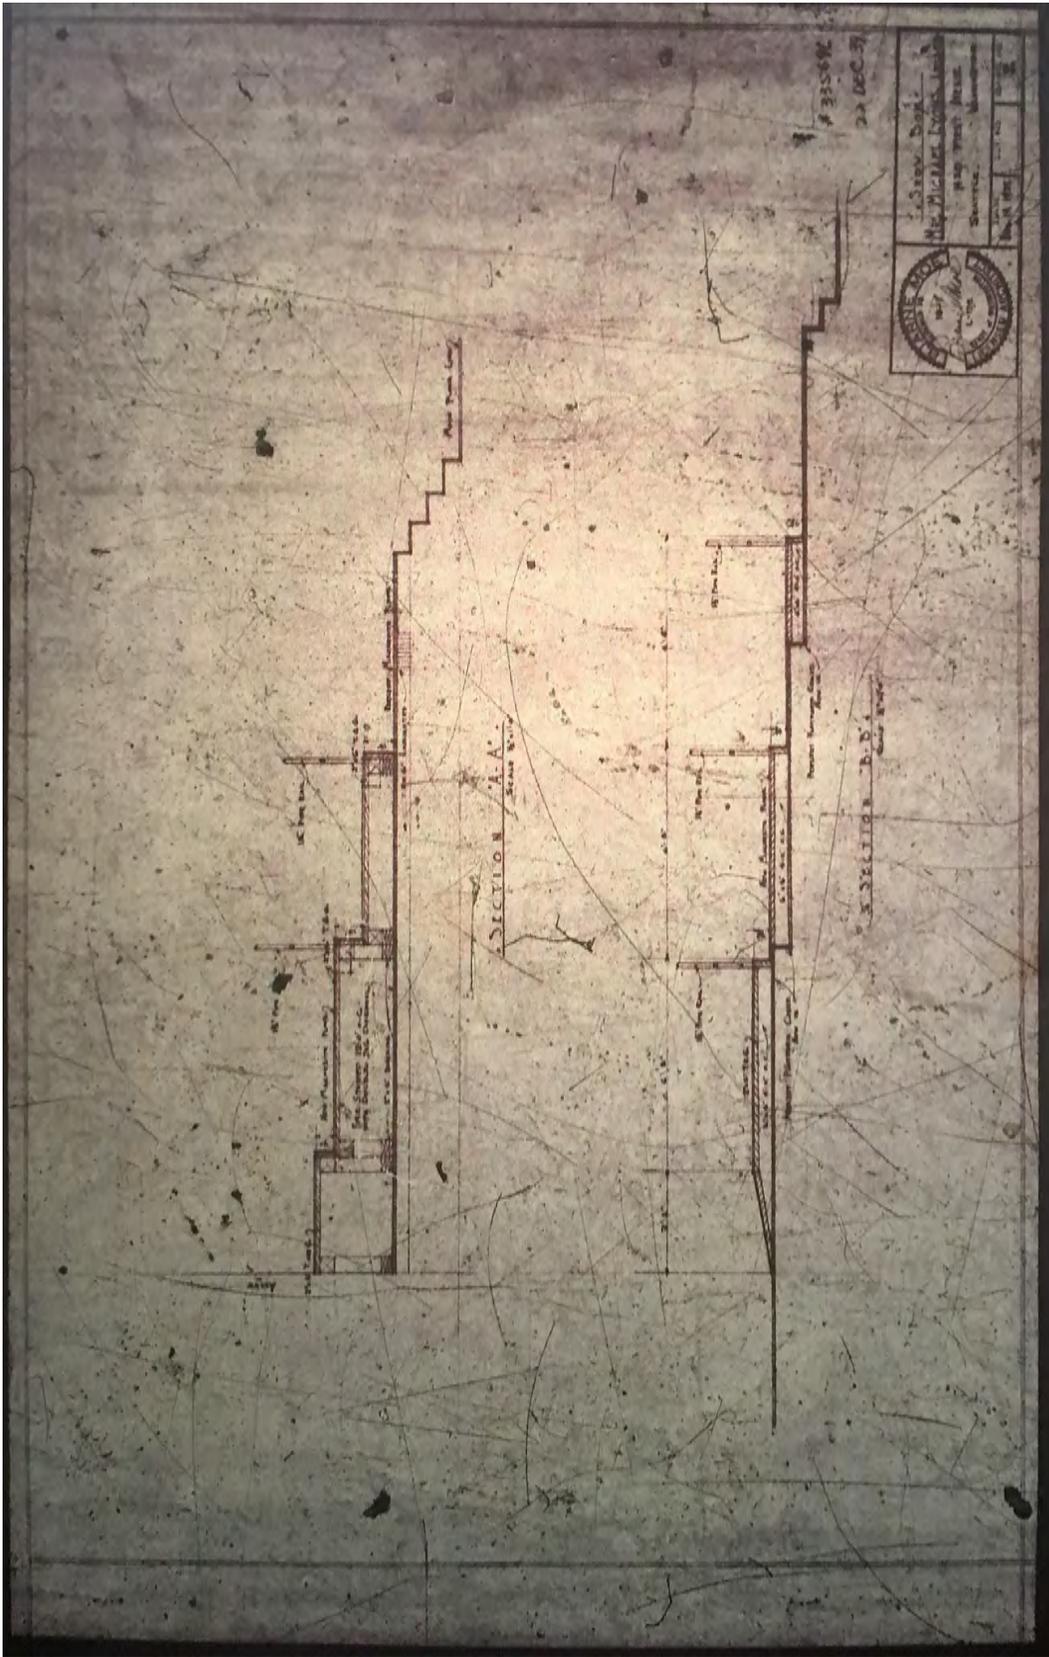
Figure 72. 1939 (December 19) drawing showing the second floor tiered seating design for the Showbox remodel for Michael Lyons prepared by architect Bjarne Moe. Courtesy Seattle Department of Construction and Inspections microfilm library.

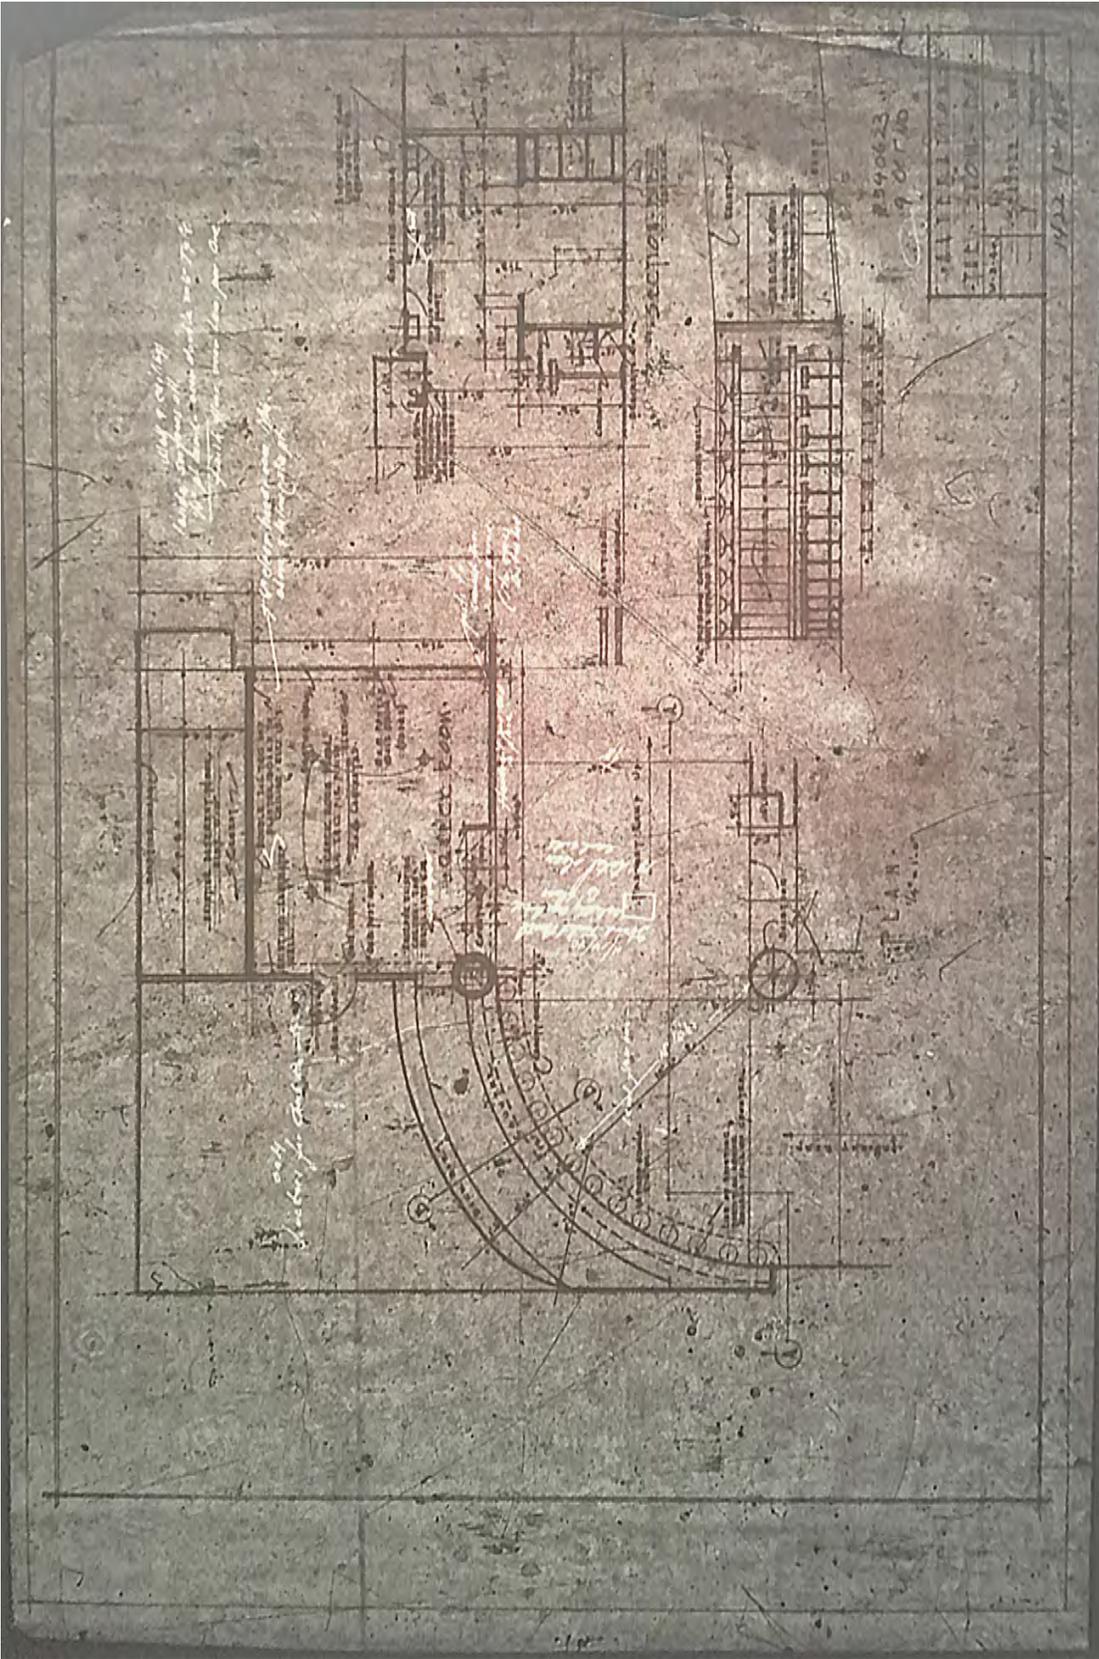
Figure 73. 1940 (October 3) drawing showing alterations to the passageway for the Showbox adding a coat check room and work at the bar for Michael Lyons. Courtesy Seattle Department of Construction and Inspections microfilm library.

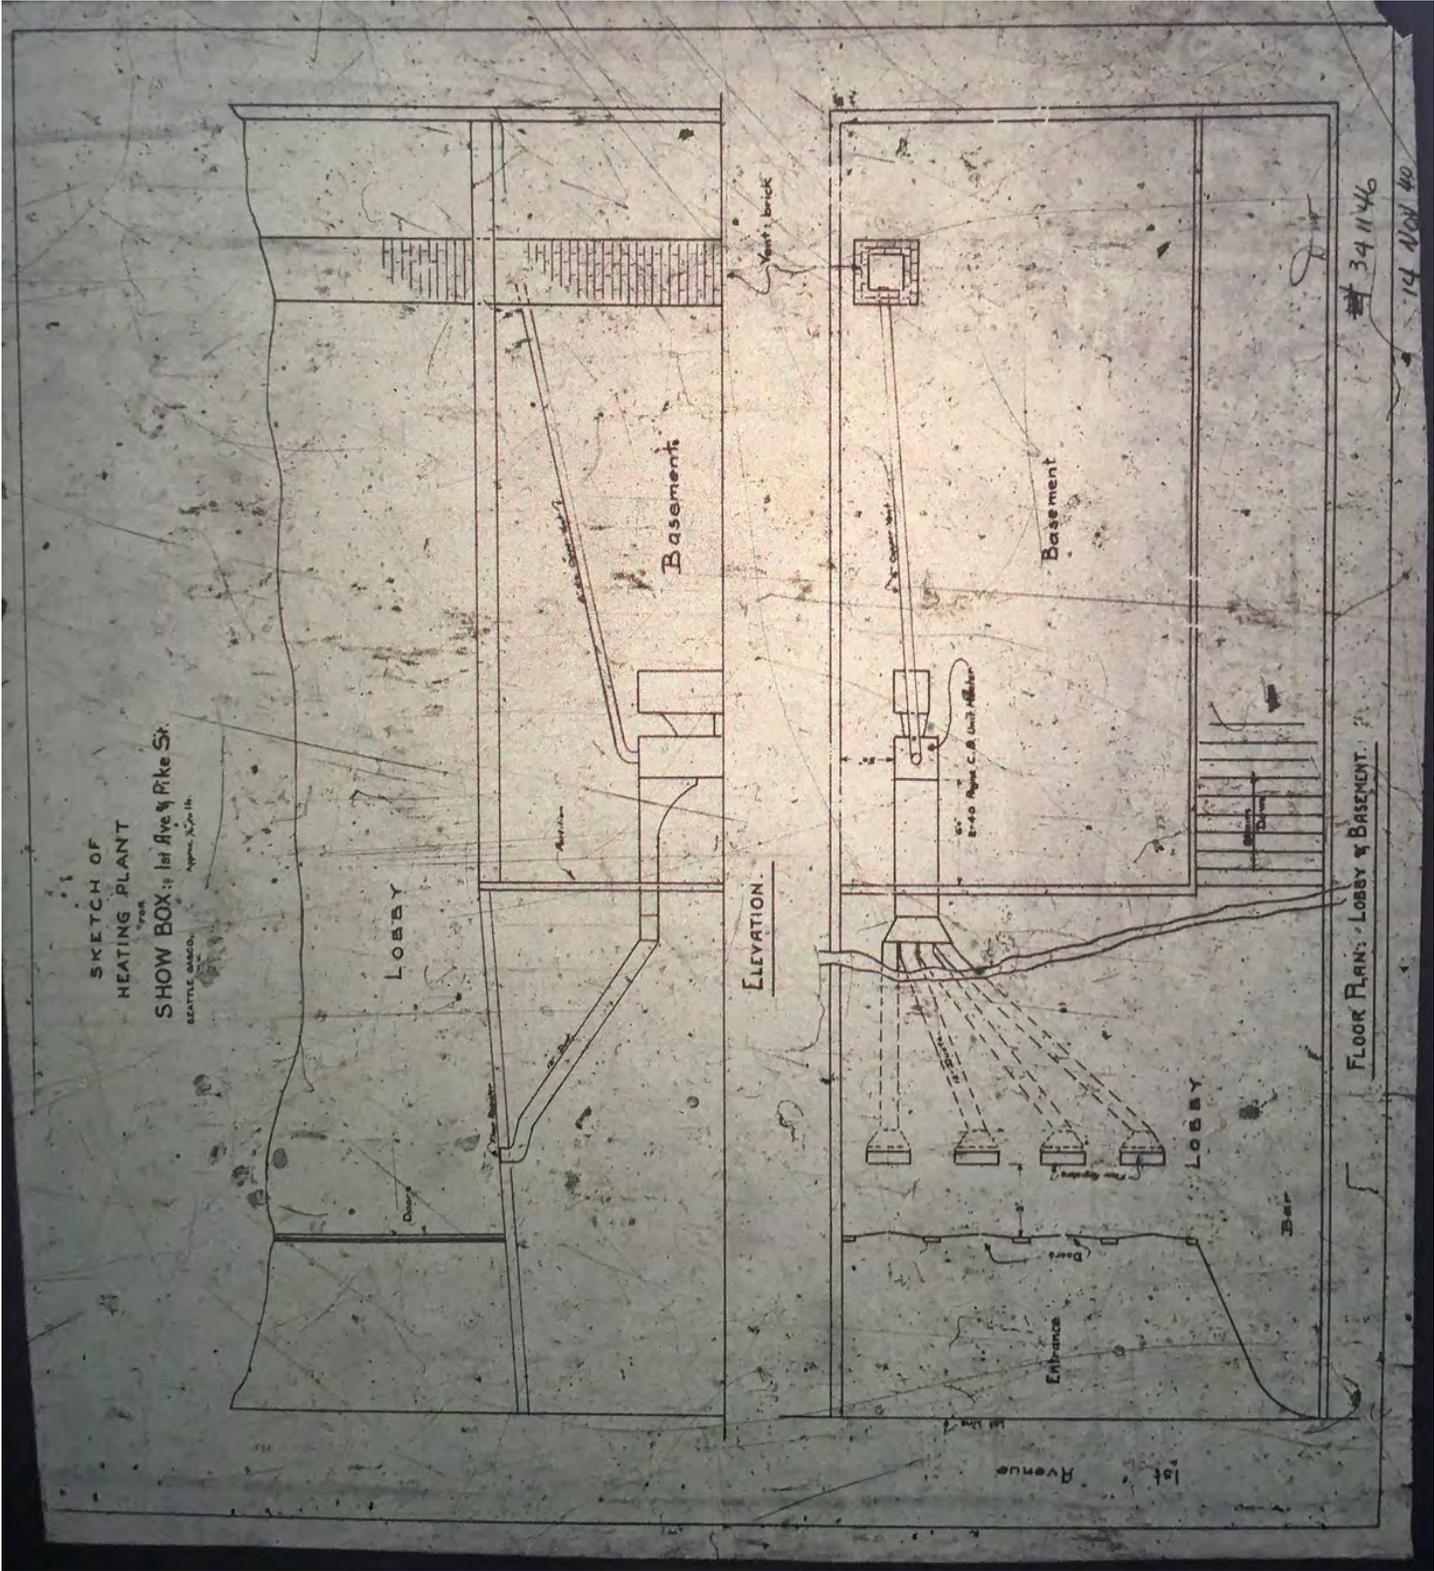
Figure 74. 1940 (November 14) drawing showing the mechanical system and heating provisions for the Showbox passageway. Courtesy Seattle Department of Construction and Inspections microfilm library.

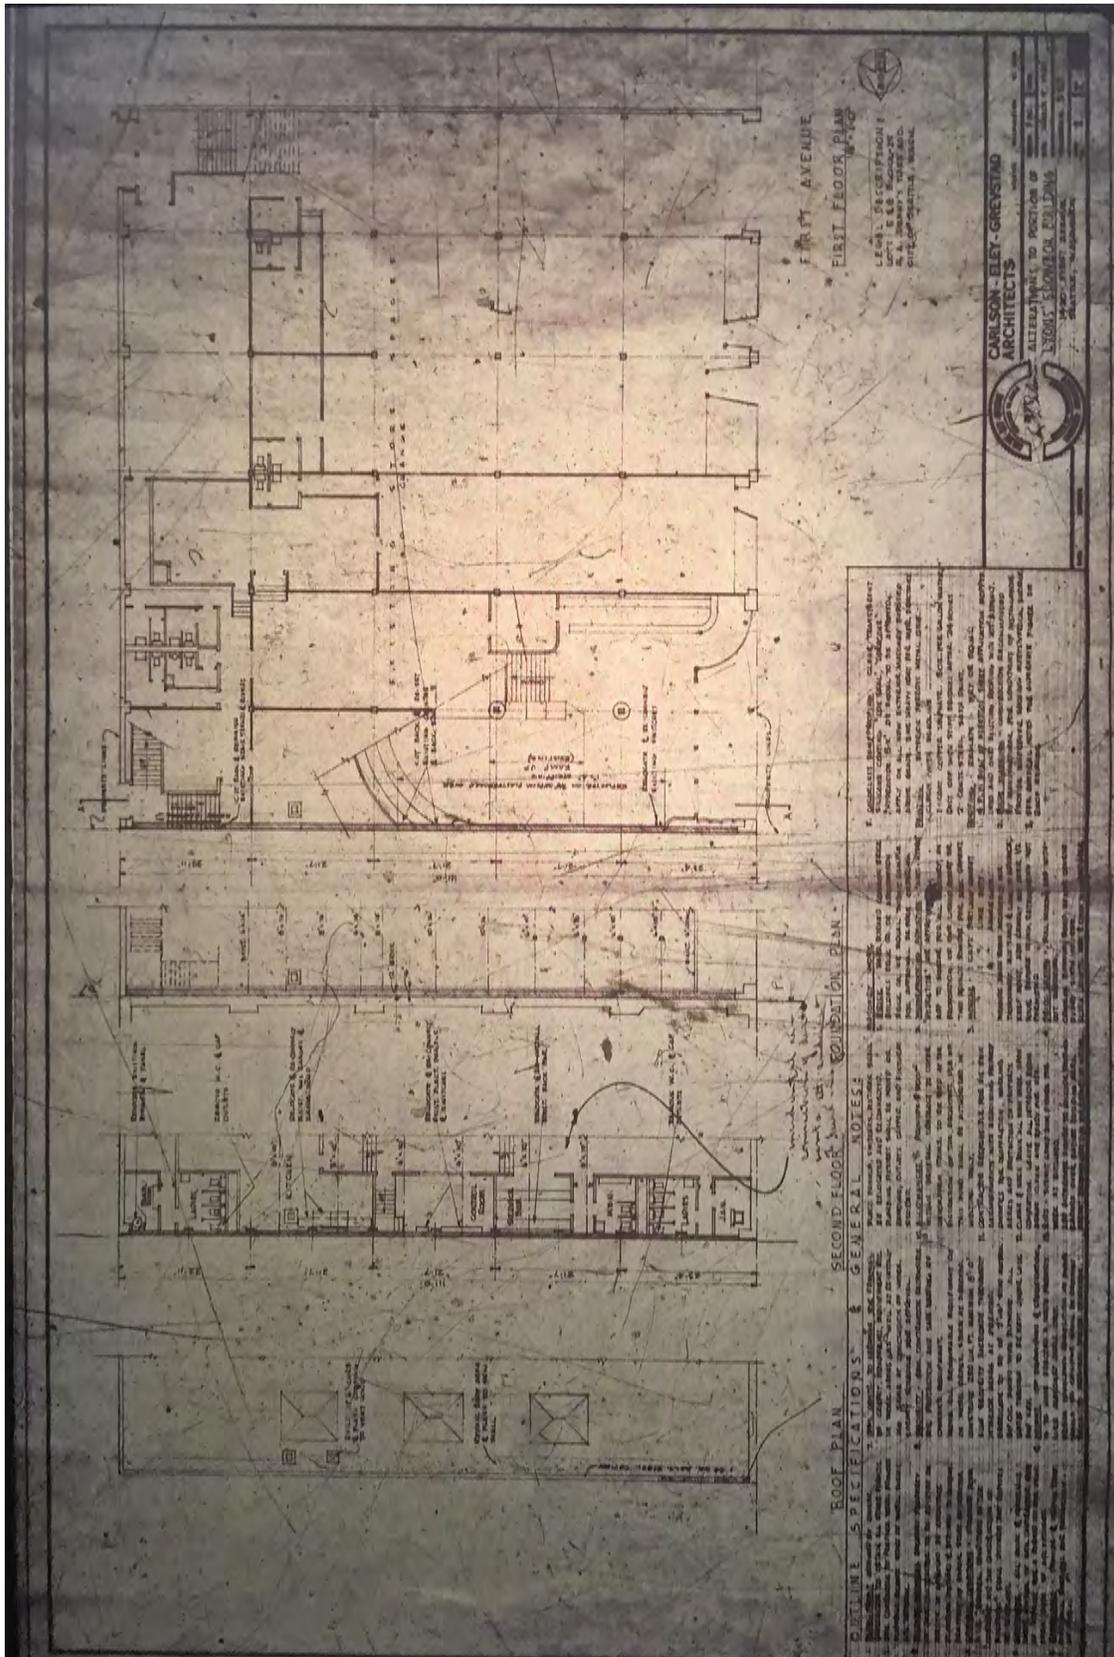
Figure 75. 1959 plans prepared by architects Carlson Eley Greystad as part of the north wall rebuilt following the demolition of the Regent Hotel in 1958.

- 1959: Architects Carlson, Eley, Grevstad designed the construction of a new north wall for the building. The building had originally used the south wall of the former building to the north. When that building was demolished, its south wall was left standing, but in an unusable condition. This required the construction of the existing concrete masonry wall. Existing beams were fire cut into the new wall. Pilasters were constructed running the full height of the wall to pick up a beam along the outer edge of roof deck. At one time there were three hipped roof skylights along the north wall provided lighting for service bar, control room, and the kitchen, which were located along the north wall at the second floor. **See Figures 75.**
