SHOWBOX

1426 First Avenue
SEPTEMBER 10, 2018

The City of Seattle
Landmarks Preservation Board

Street and Number: 1426 First Avenue

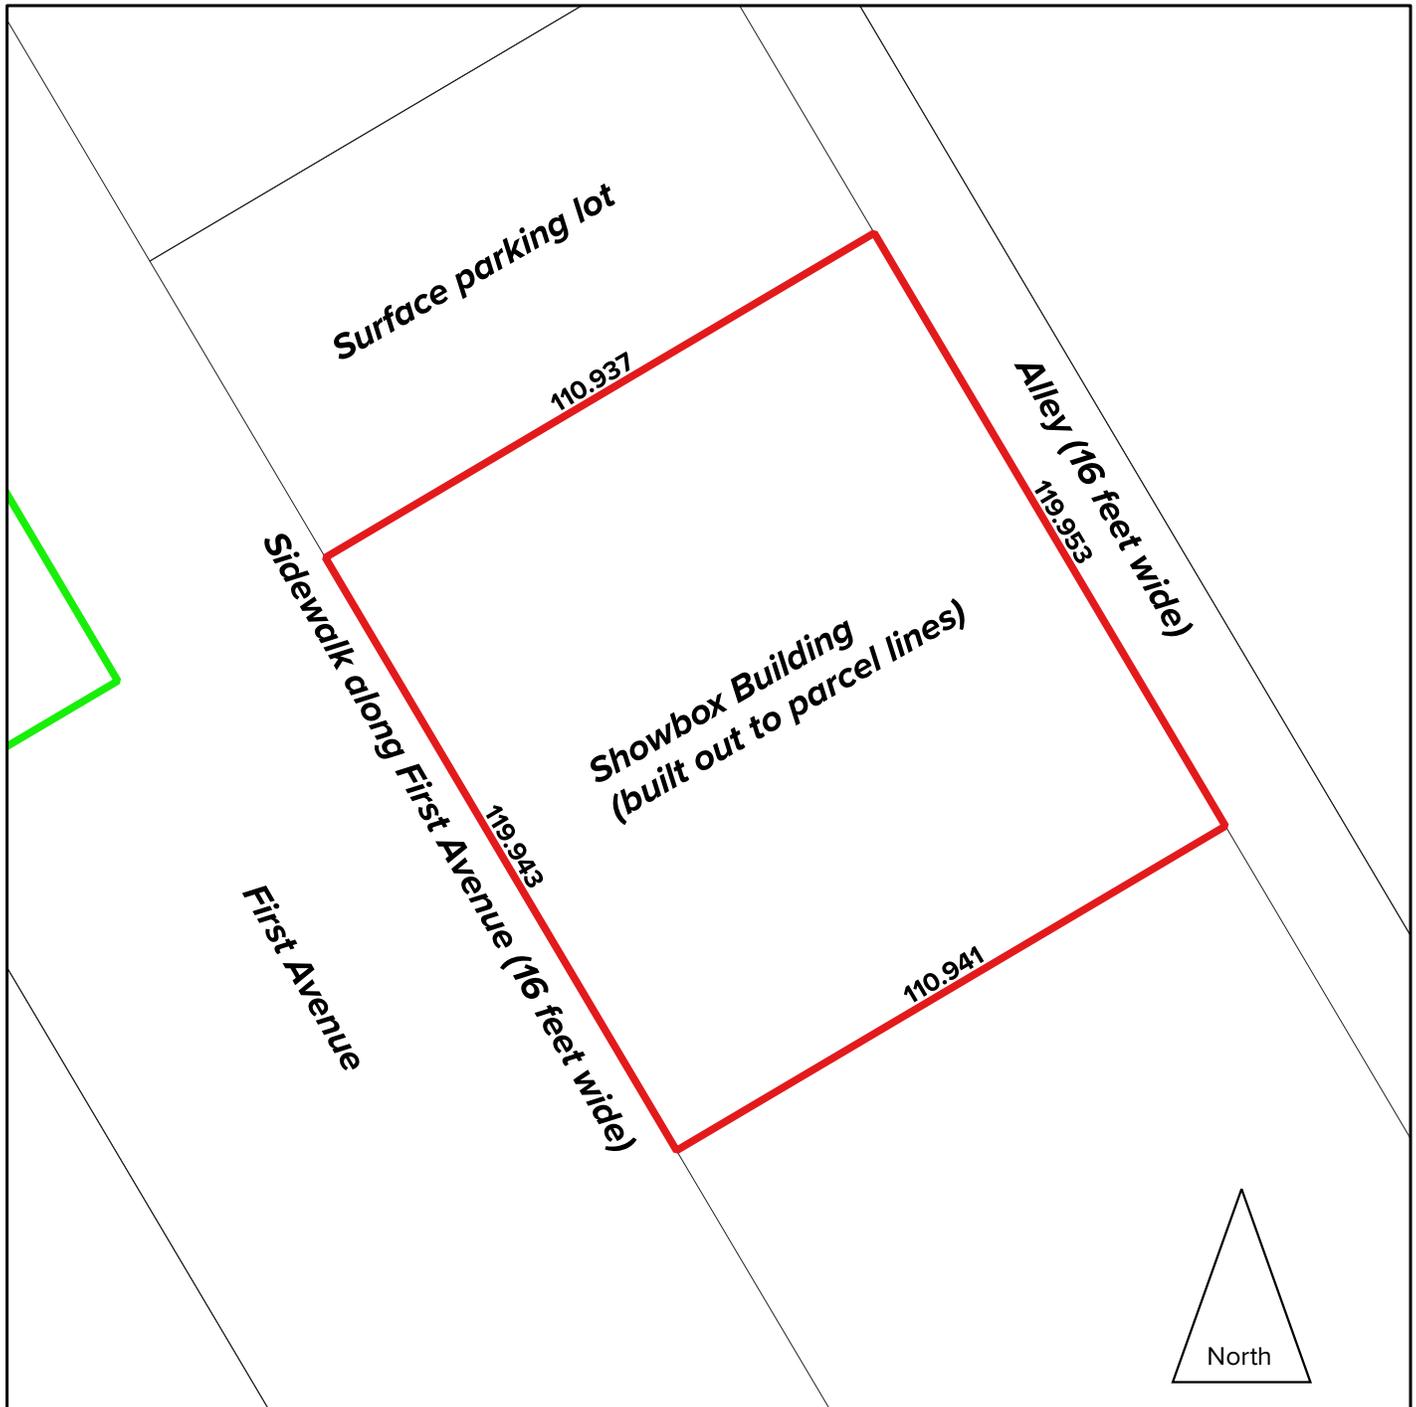
Figure 2. Site plan. The footprint of the Showbox is outlined in red. The building is built out to the parcel lines.

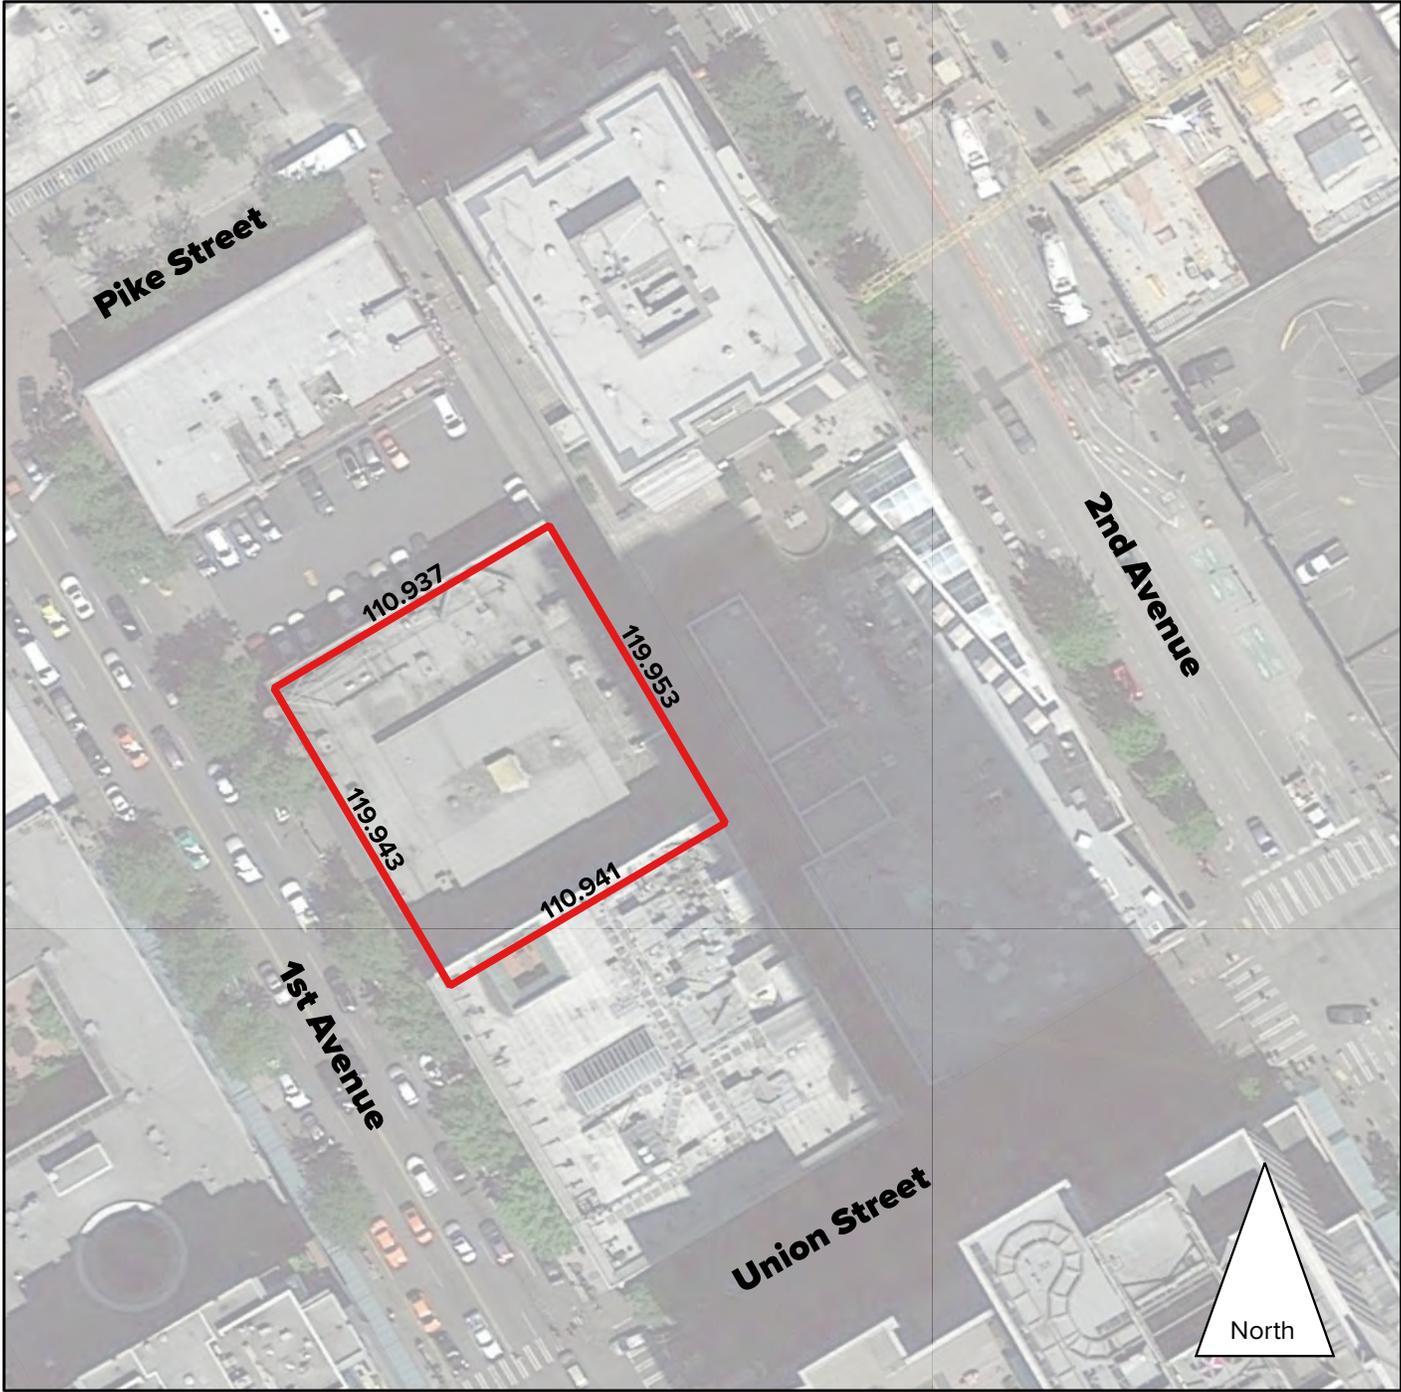
Figure 3. Nominated property map. Note that although the red line appears to be offset slightly, this is due to the angle of the satellite imagery. The red line actually follows the footprint of the building and the parcel boundary.

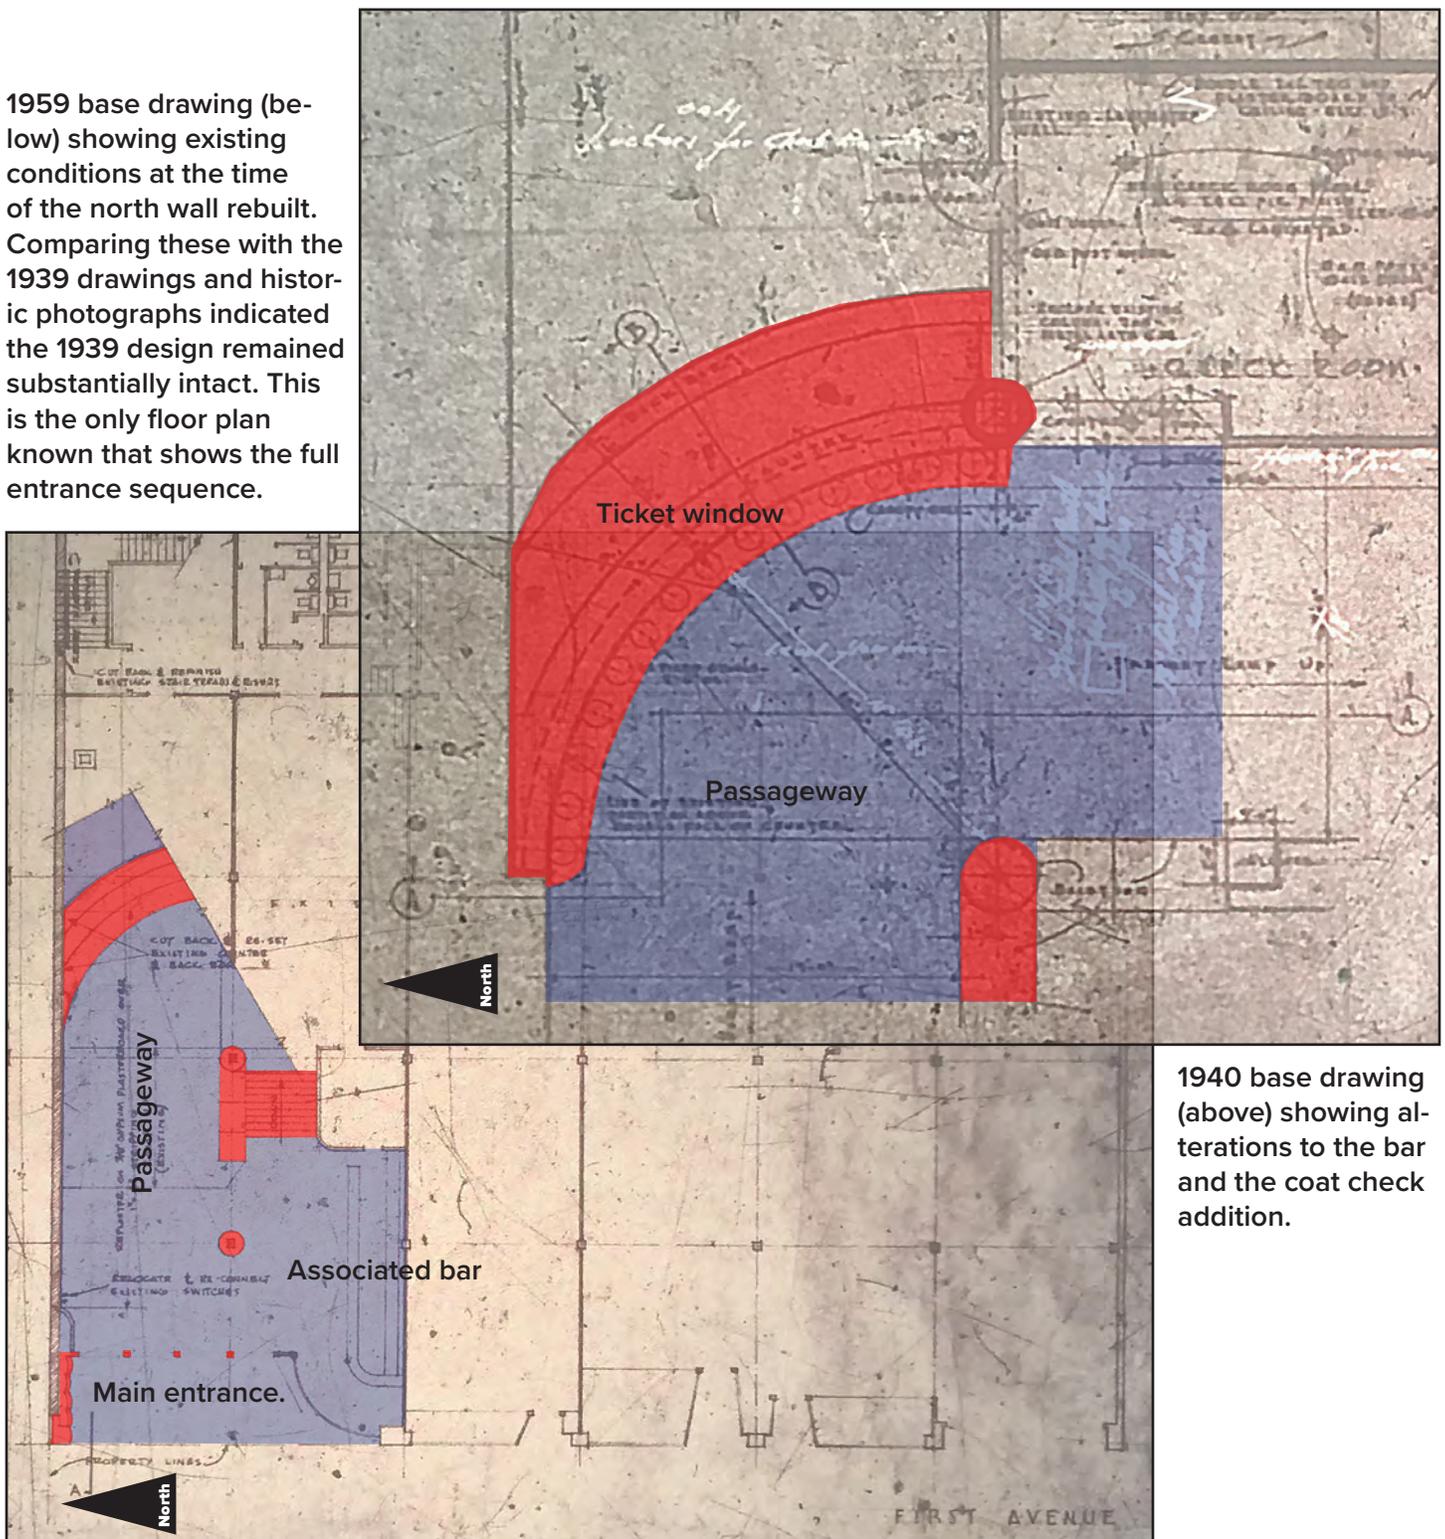
1959 base drawing (below) showing existing conditions at the time of the north wall rebuilt. Comparing these with the 1939 drawings and historic photographs indicated the 1939 design remained substantially intact. This is the only floor plan known that shows the full entrance sequence.

1940 base drawing (above) showing alterations to the bar and the coat check addition.

Figure 5. First floor entrance and passageway analysis plan. The 1959 north wall rebuilt and the 1940 alterations plans are the base drawings with overlaid color coding to show what remains today from the original design. The core volume, exterior engaged columns, door mullions (reeded surrounds, transom), large columns, stairs down to the 1424 lower level, stepped cheek wall, ticket counter (former bar), and the original ramp structure of the passageway all remain. Inspection in the crawl space and lower level confirmed the ramping remains intact below added stairs. Refer to the character defining features and spaces section in the description for a full list of the features.

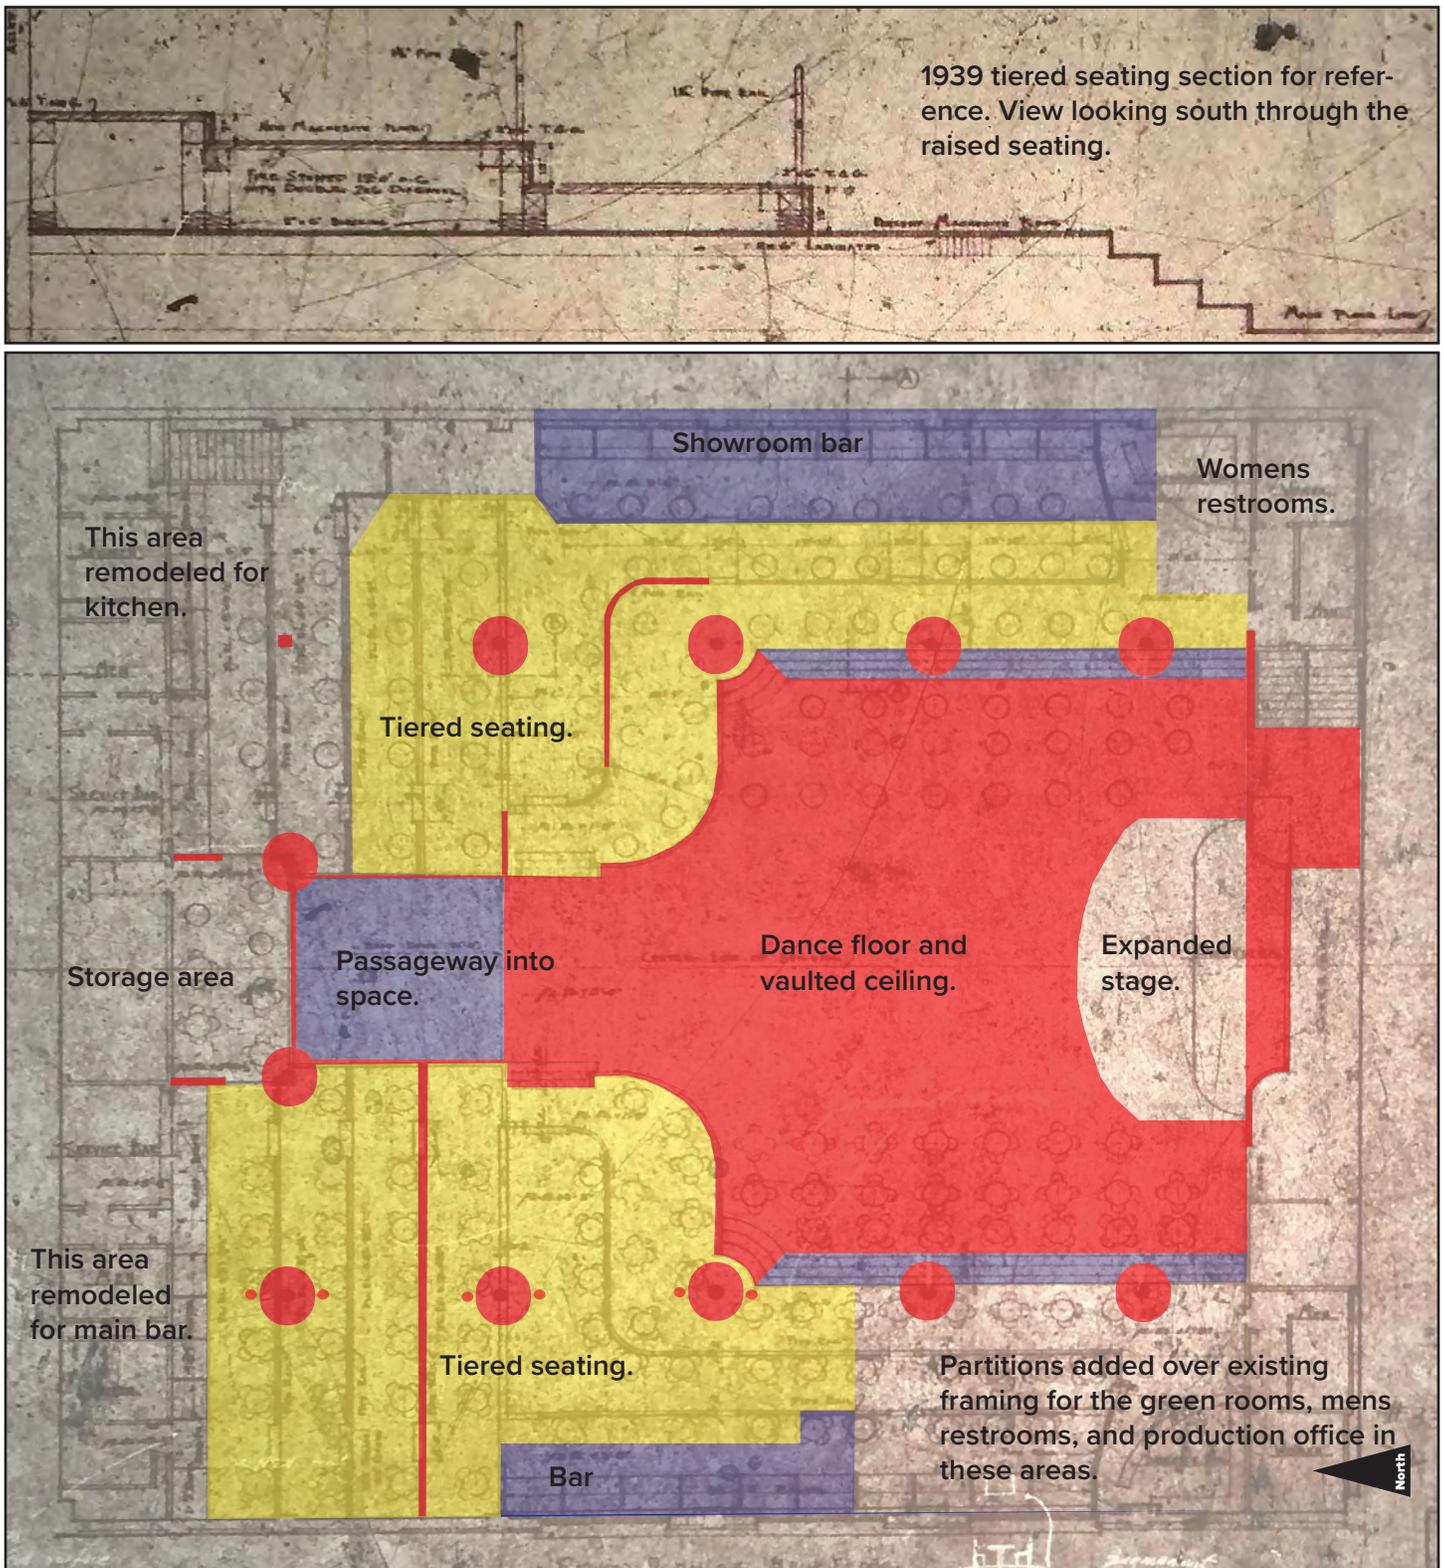
Figure 6. Second floor analysis plan. The 1939 remodel plan is the base drawing with overlaid color coding to show what remains today from the original design. The core volume, dance floor, raised seating, columns, proscenium, and fly loft all remain. Refer to the character defining features and spaces section in the description for a full list of the features.

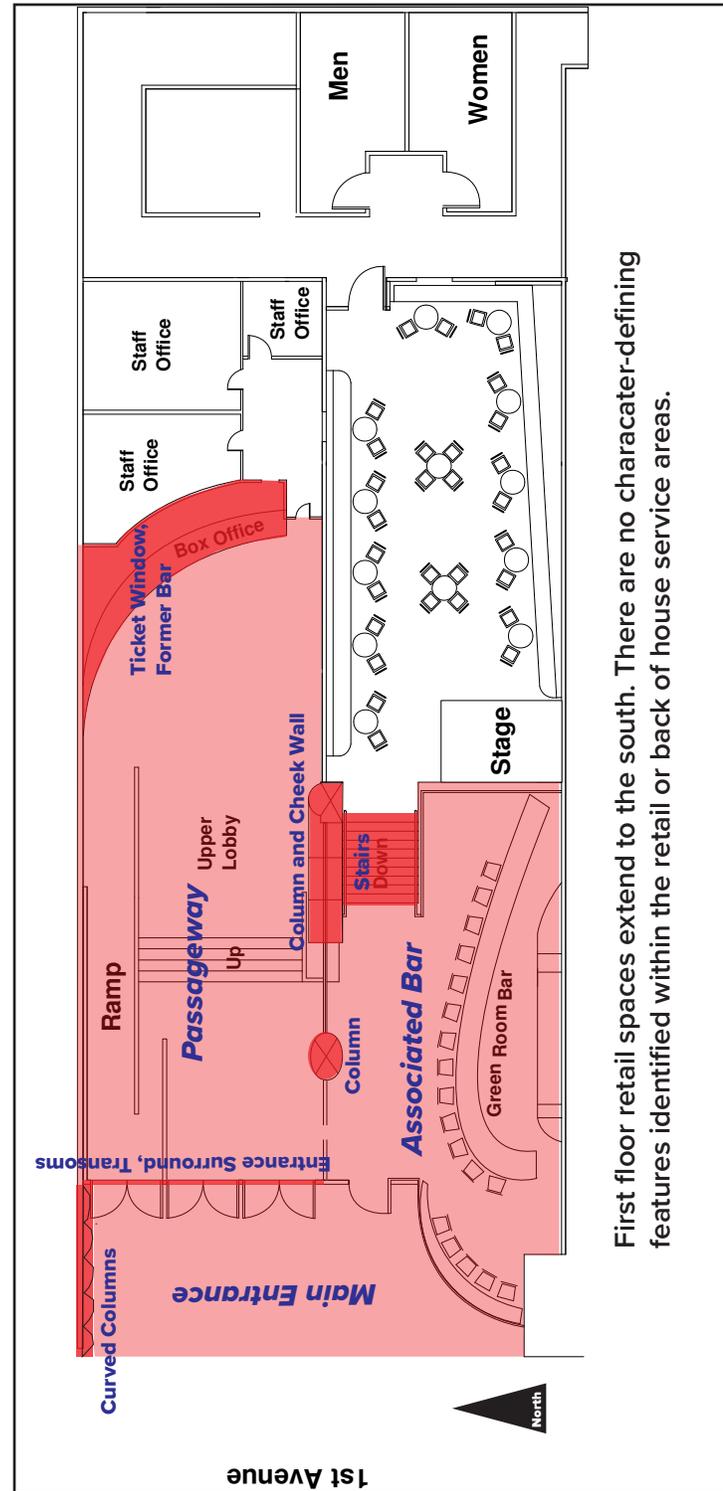
Figure 7. First floor character defining features and spaces plan. This plan identifies by color coding the character defining features and spaces. Refer to the character defining features and spaces section in the description for a full list of the features.

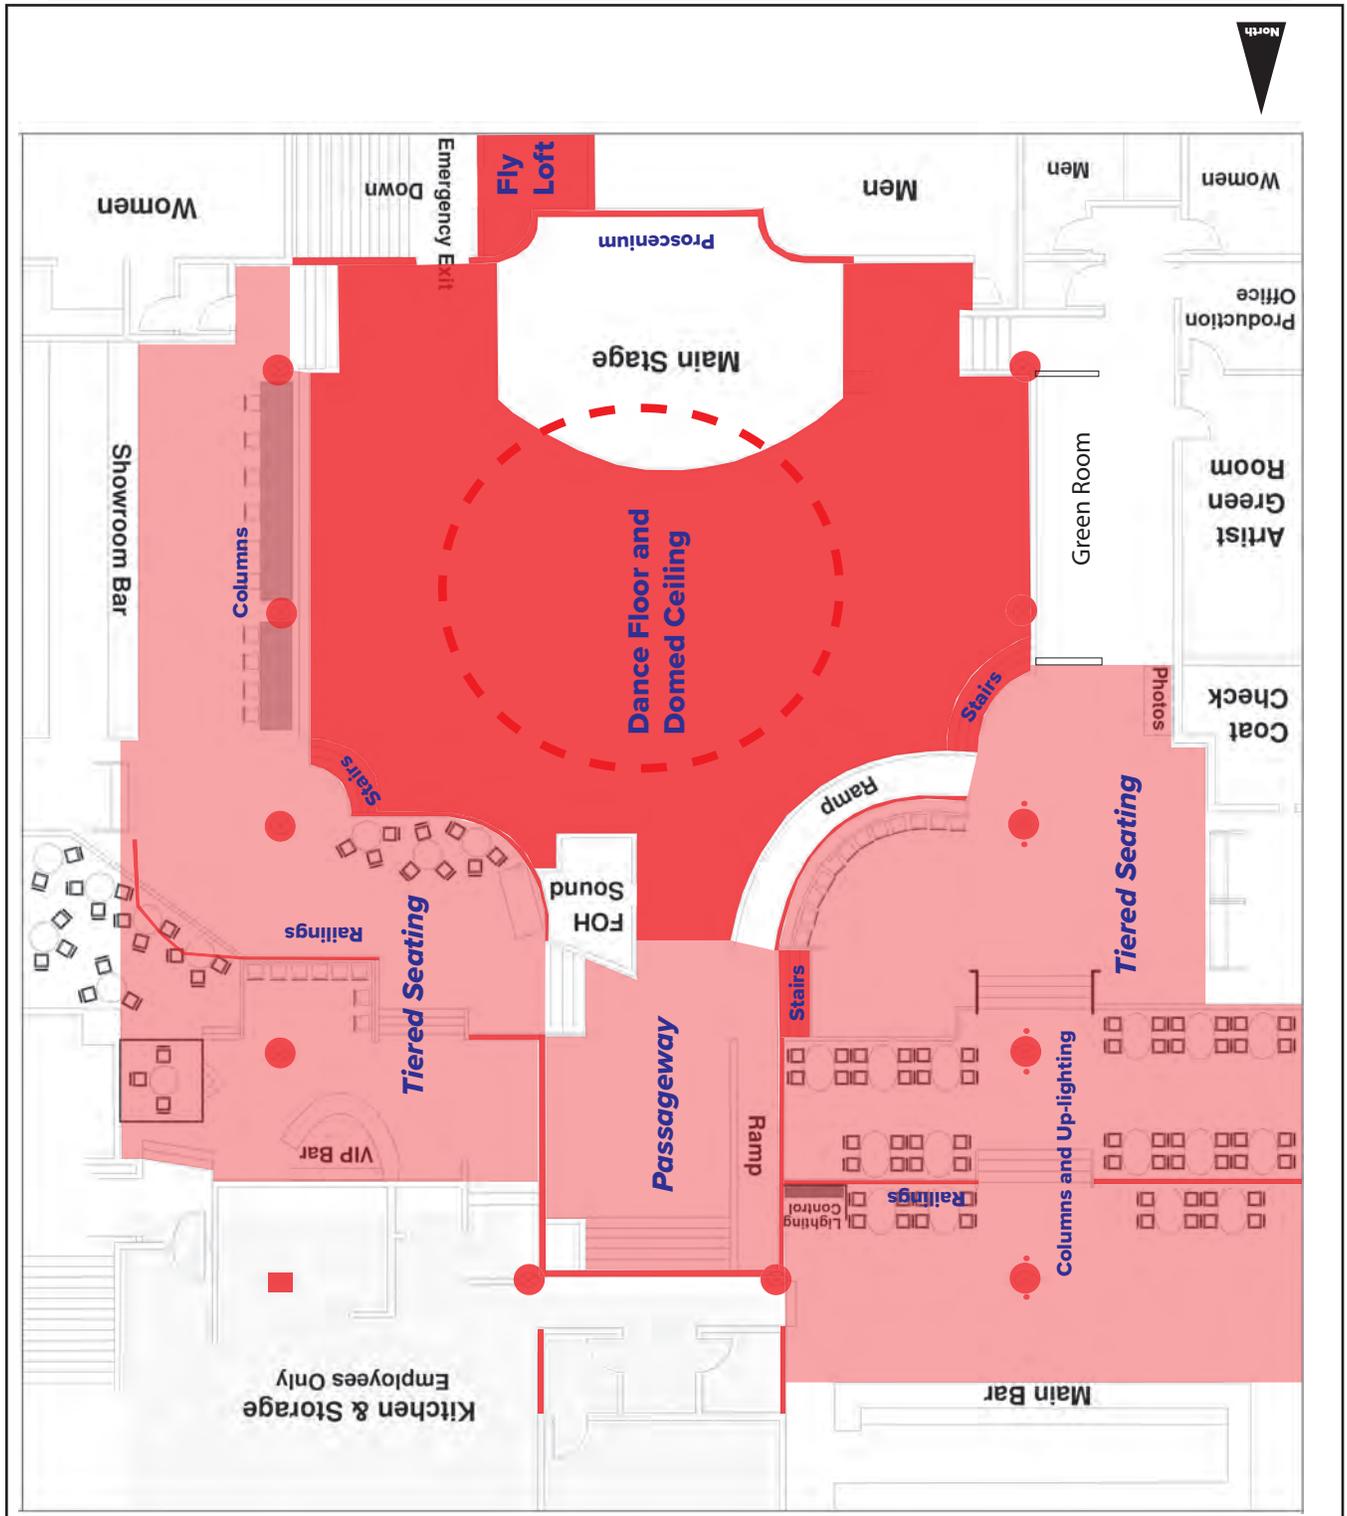
Figure 8. Second floor character defining features and spaces plan. This plan identifies by color coding the character defining features and spaces. Refer to the character defining features and spaces section in the description for a full list of the features.

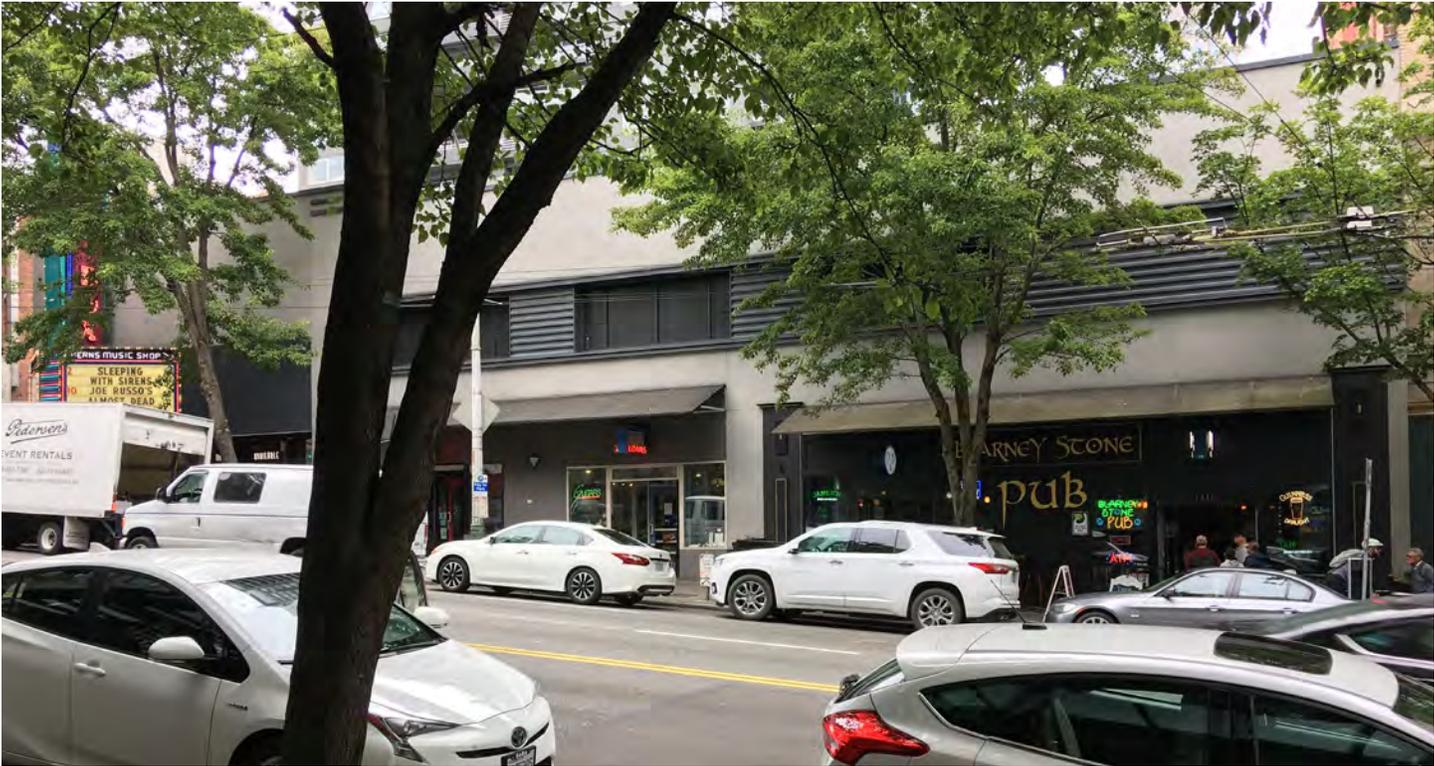
Figure 11. Front, west facade along 1st Avenue.

A masonry foundation supports the building structure with footings below the wood posts. There are no known basement areaways extending below the sidewalk along First Avenue. The building's east and west walls consist of unreinforced, load bearing common bond brick walls with headers every sixth course. These walls are three to four wythes thick for an approximate wall thickness of 12- to 16-inches. Brick piers step out on the interior face of the wall to carry beams supporting the floor framing. The southern third of the east wall at the second story level consists of stacked hollow clay tile, with a brick parapet above. Multiple steel louvers at through-wall openings along the first story level support building mechanical functions. **See Figures 11, 18-20.**

Windows occur on the front west and rear east facades. West facade windows consist of three window openings set in a horizontal band characteristic of the Streamline Moderne style. Each opening consists of two fixed sash flanked by narrow sash having a larger fixed upper and smaller operable lower sash. Window frames are anodized aluminum. The window band is framed by a projecting modernistic border emphasizing the horizontal character of the facade, with painted corrugated metal panels between the windows and at the south end. The border consists of raised outer edges with a central recessed channel. **See Figures 11, 13, 59-60.**

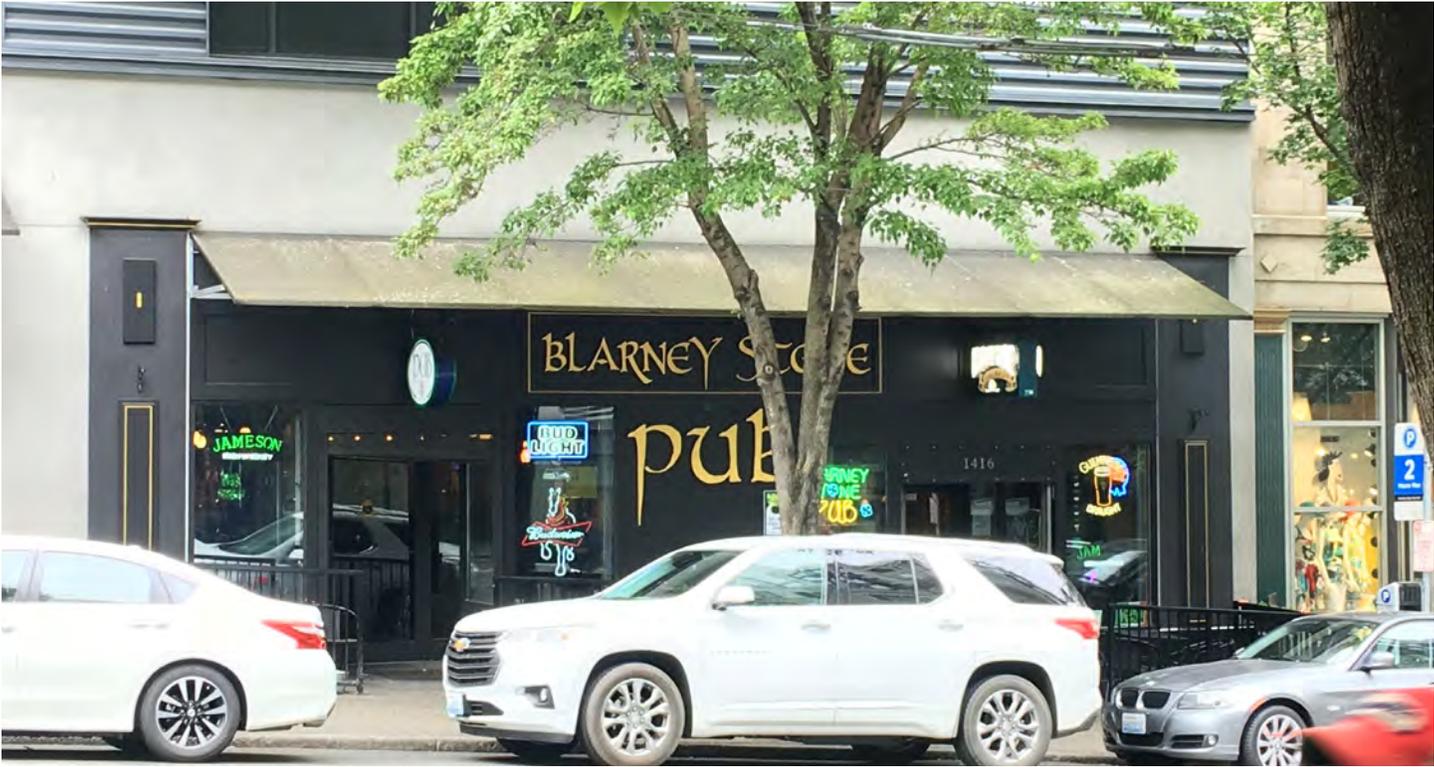
Figure 12. The 1416 and 1418 1st Avenue storefronts on the west facade.

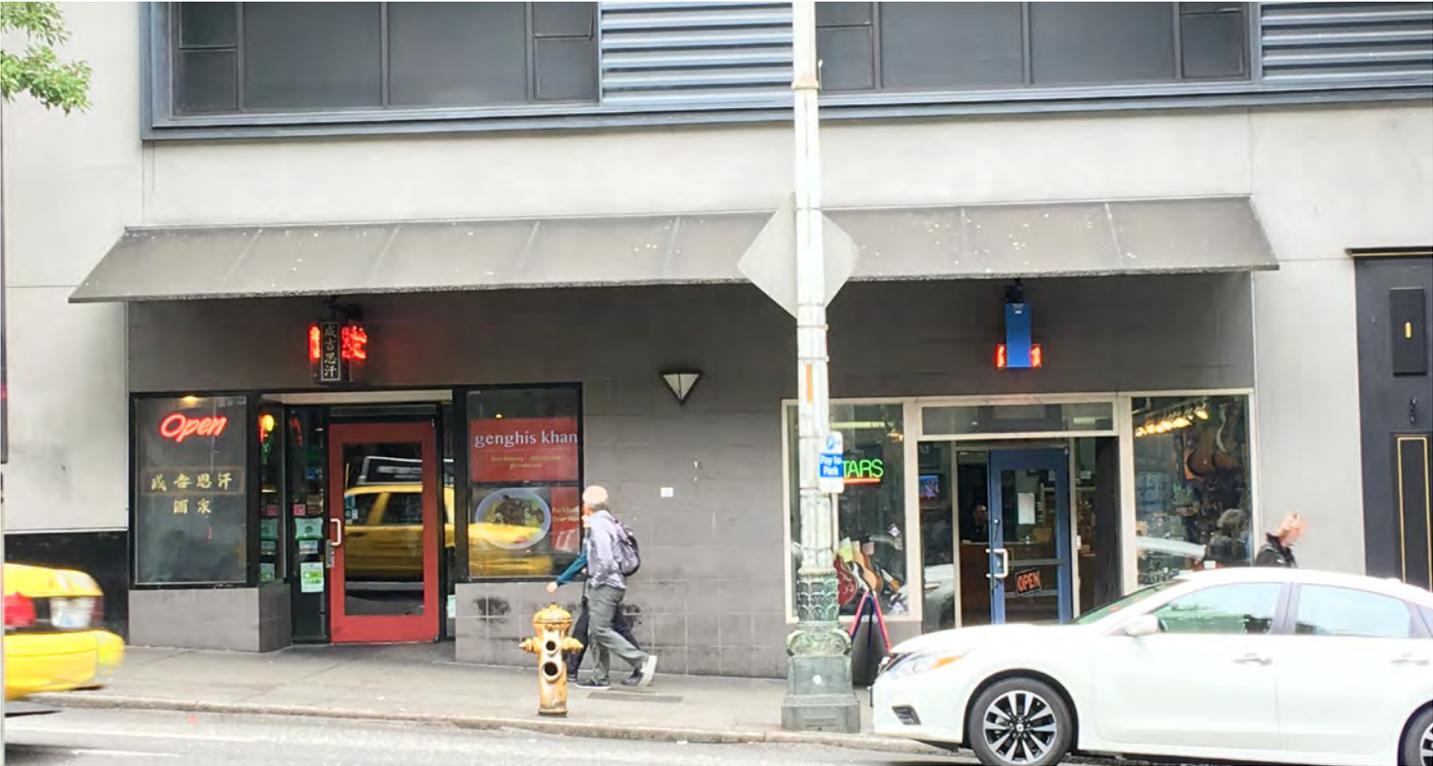
Figure 13. The 1420 and 1422 1st Avenue storefronts on the west facade.

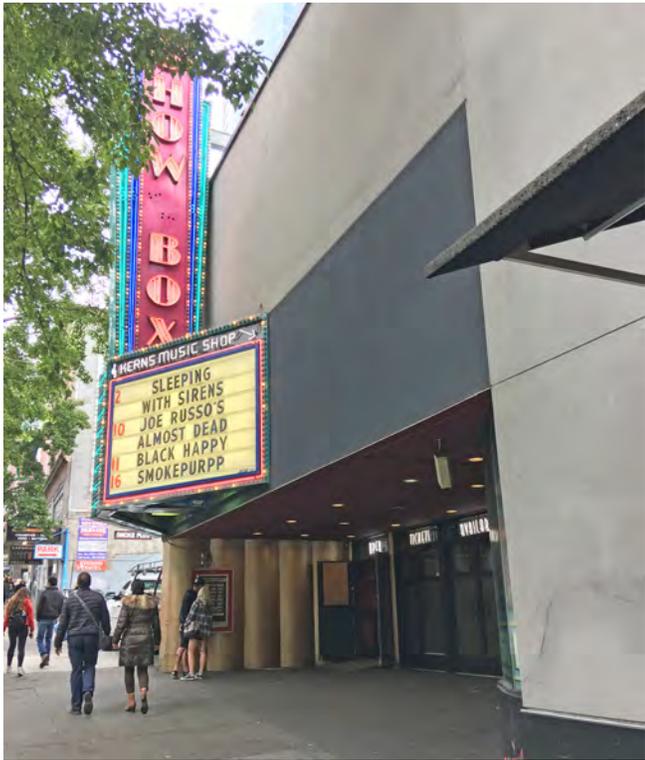
Figure 15. Front marquee along 1st Avenue, looking north.

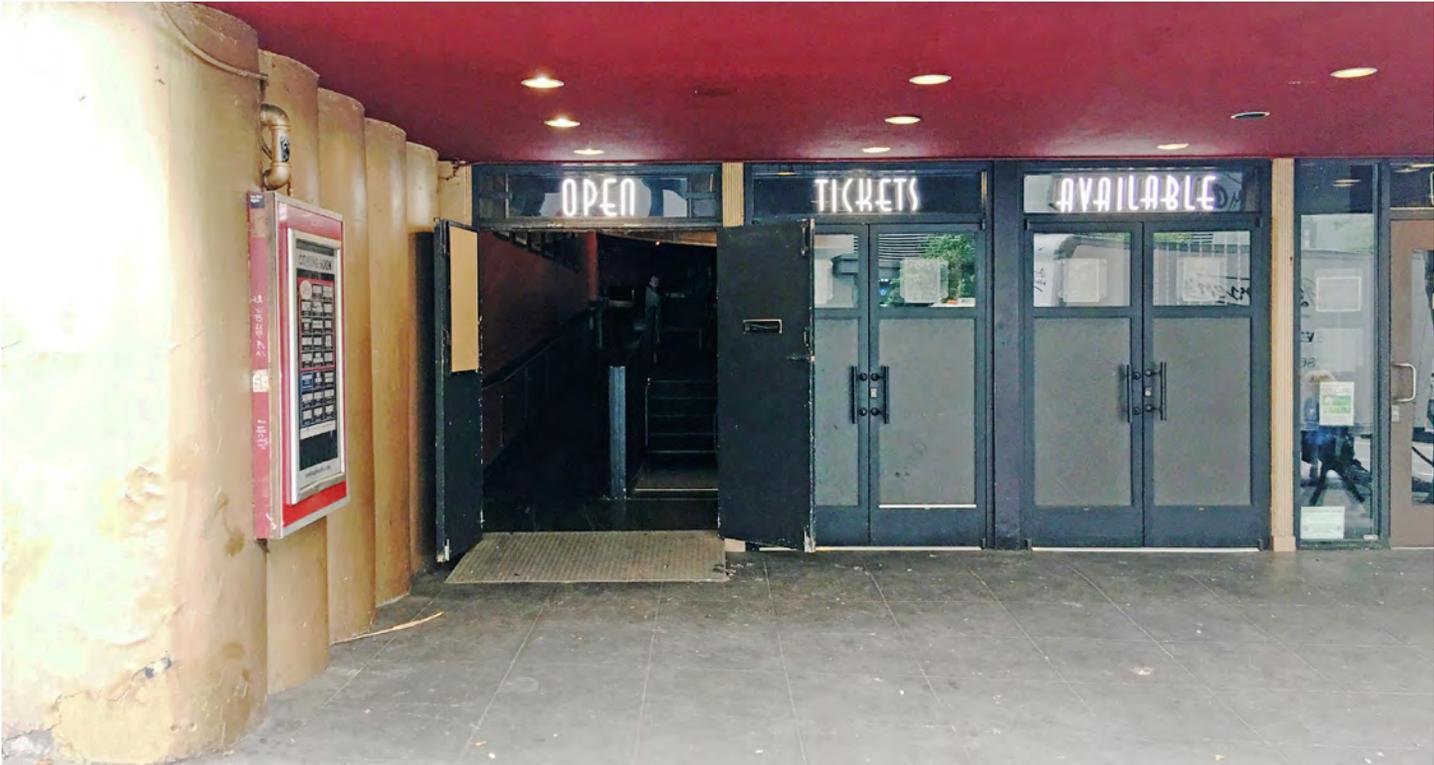
Figure 16. Showbox entrance with the original columns and entrance configuration stemming from the 1939 remodel that created the Showbox.

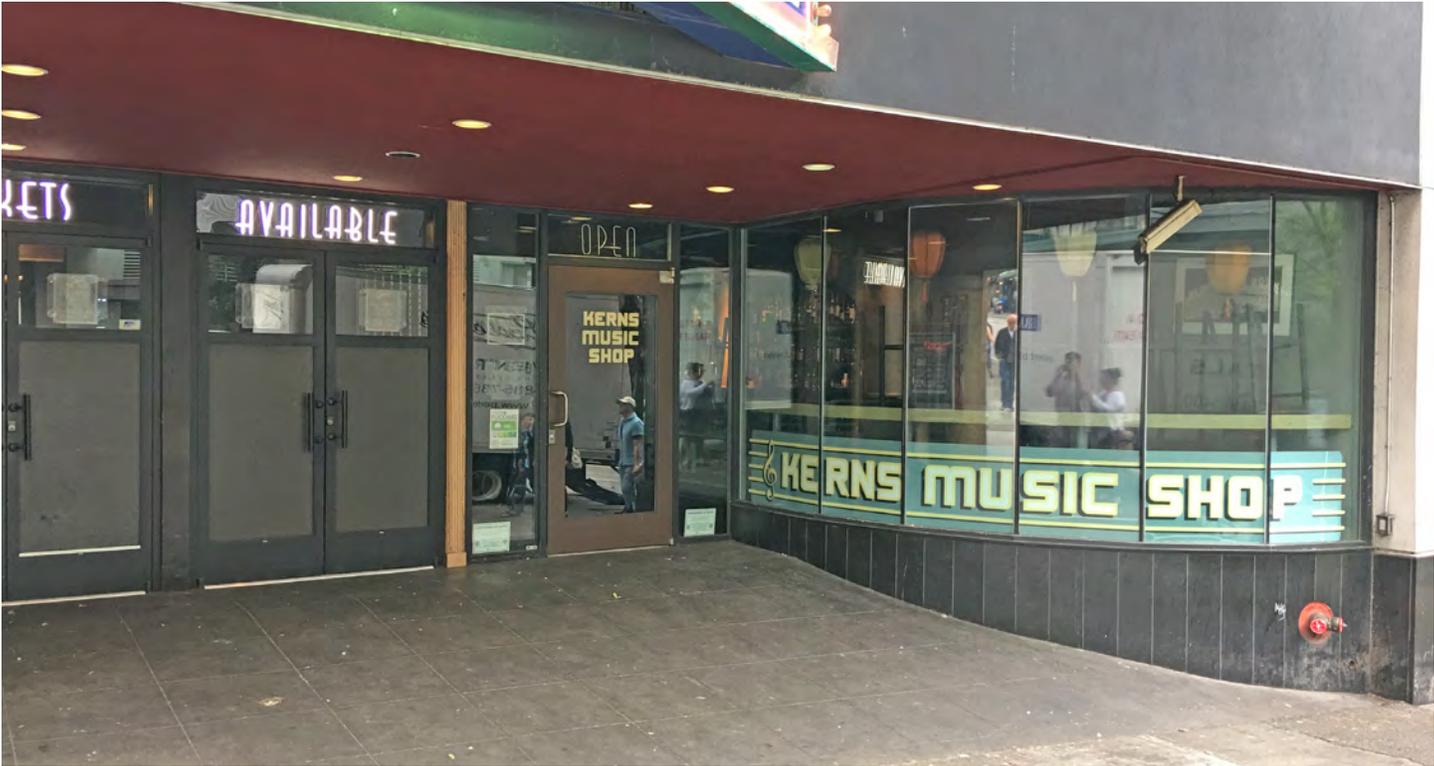
Figure 17. Curved storefront and bar entrance that function as part of the Showbox entrance.

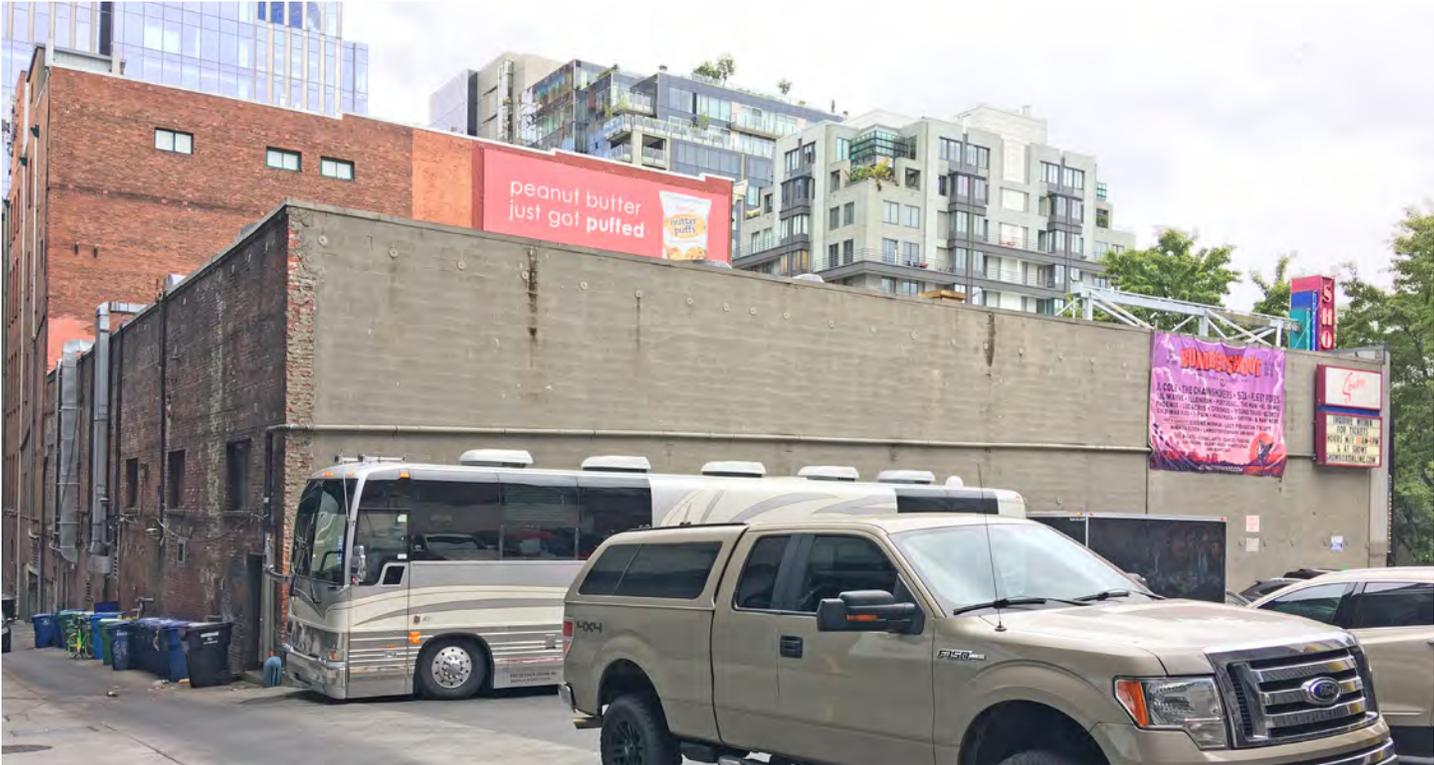
Figure 18. Northeast corner, looking southwest along the alley. The reconstructed north wall is visible.

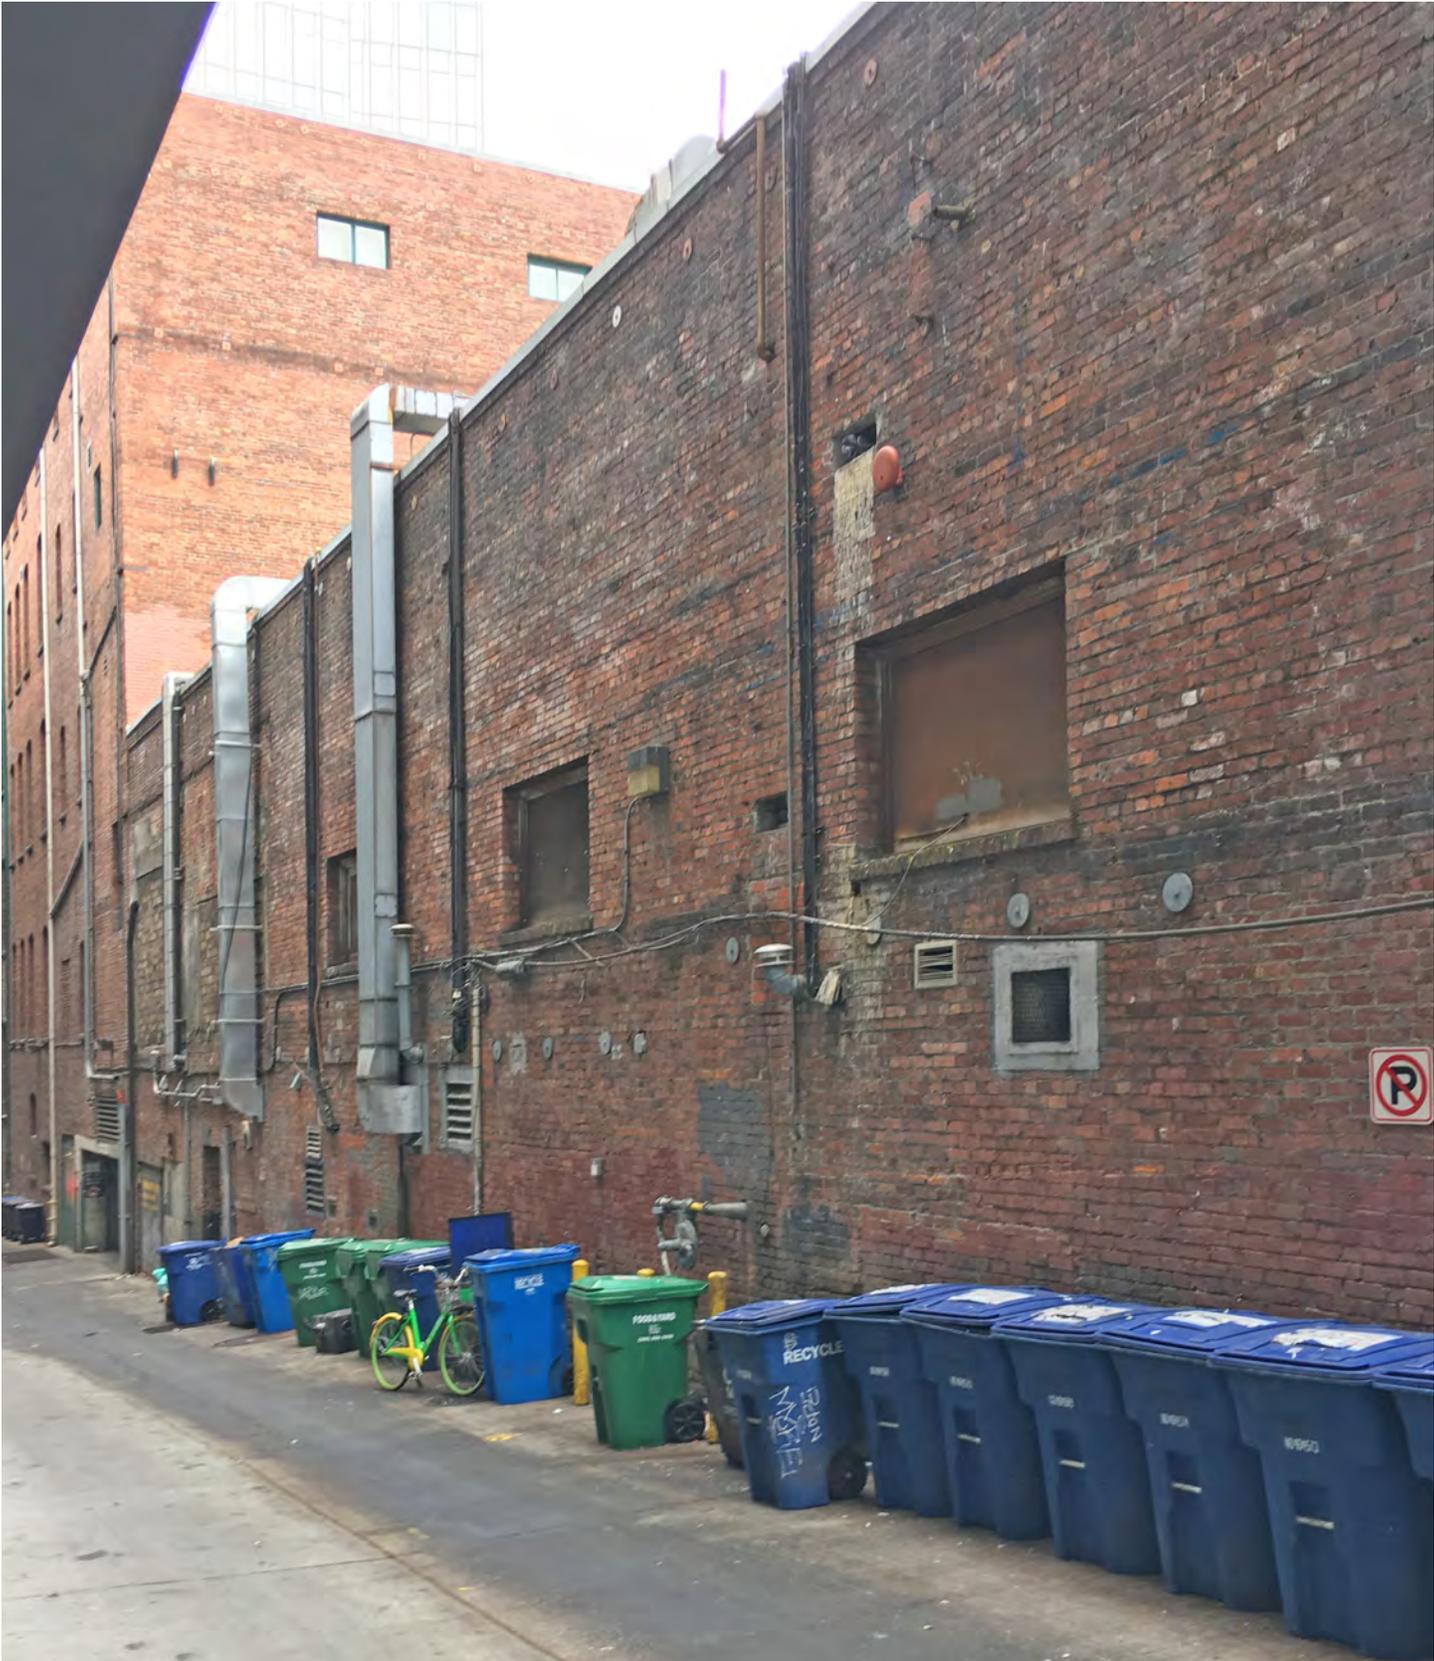
Figure 19. East alley facade looking south. The load bearing brick construction stems from the building's 1916 construction.
