SHOWBOX

1426 First Avenue
SEPTEMBER 10, 2018

The City of Seattle
Landmarks Preservation Board

Street and Number: 1426 First Avenue

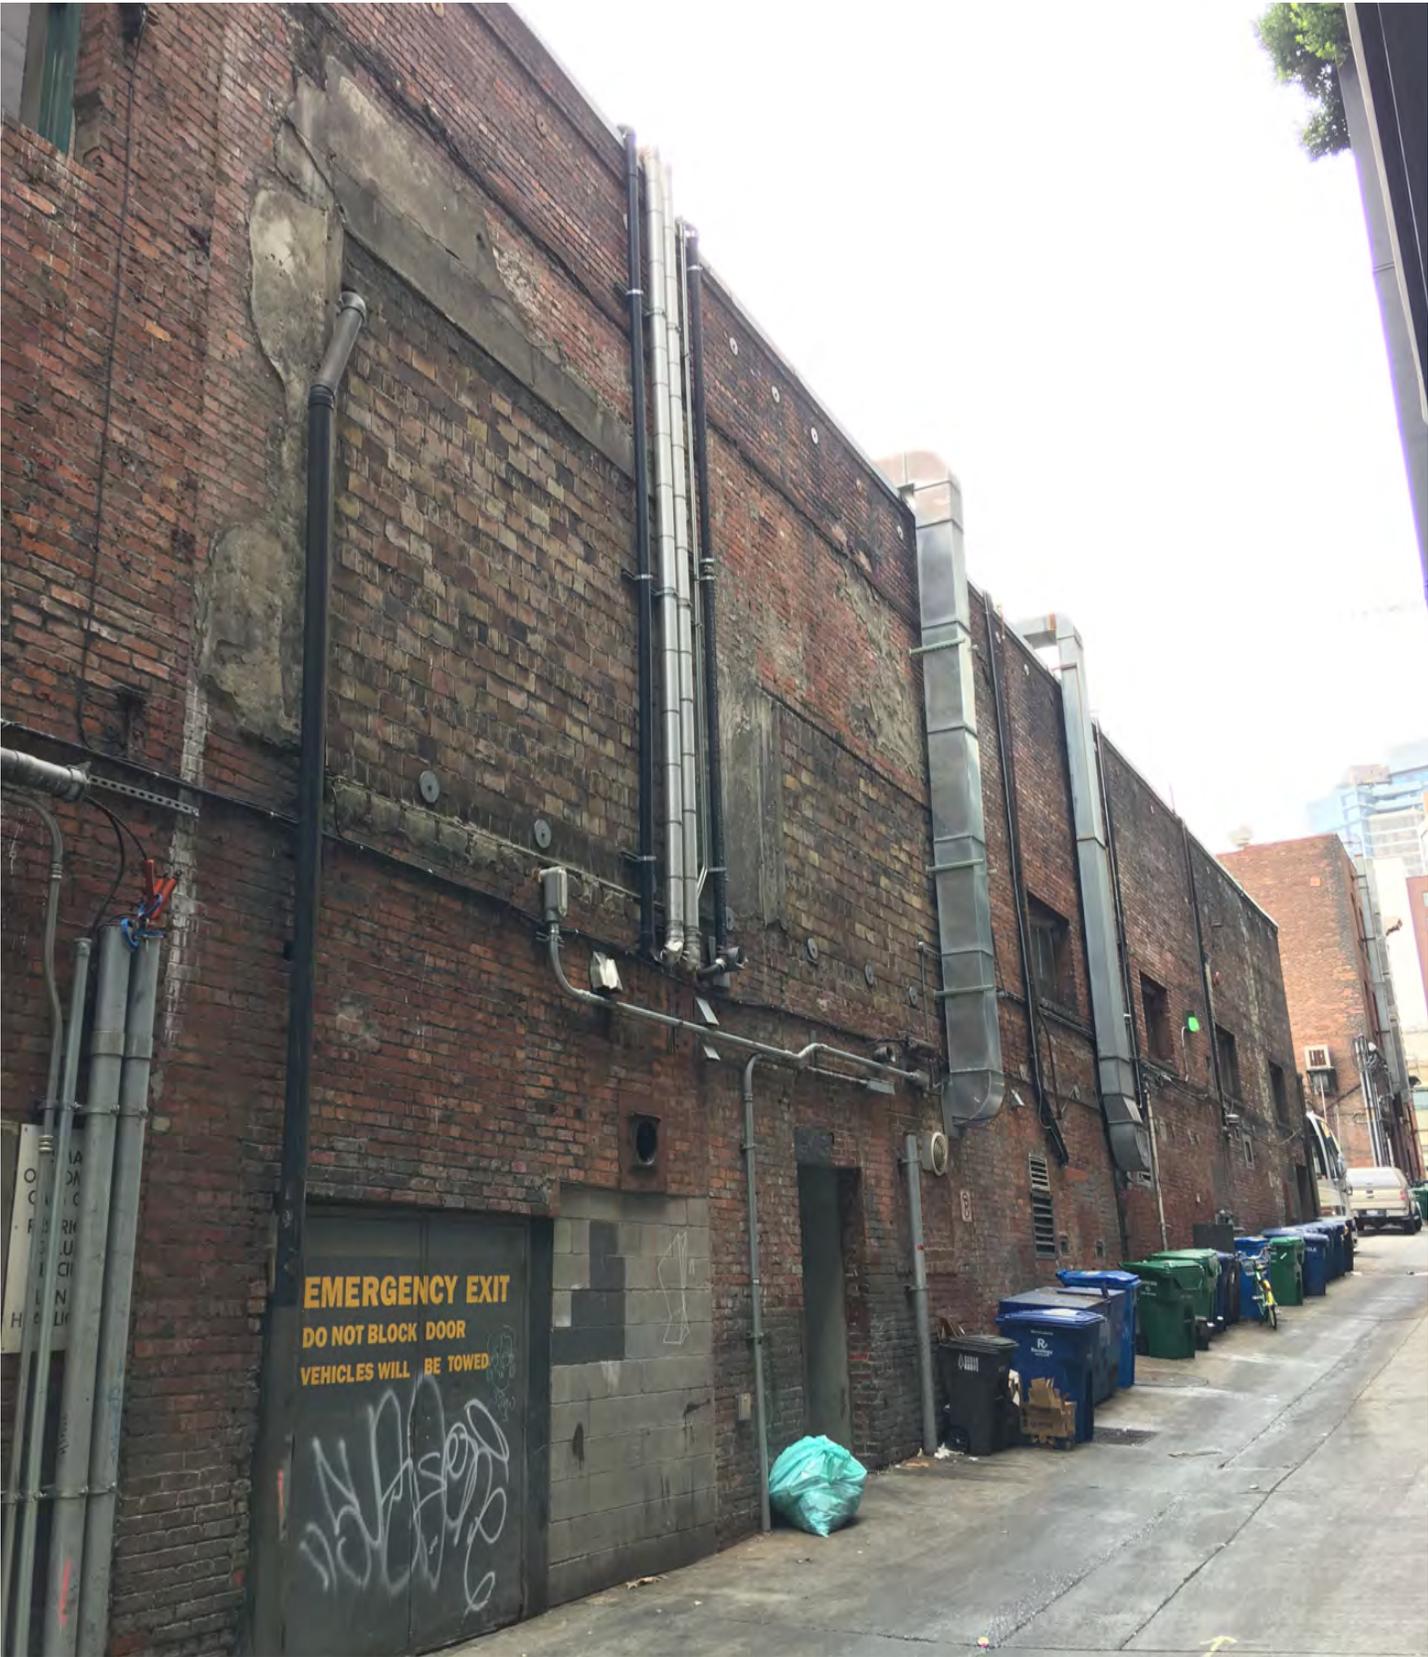
Figure 20. East alley facade, looking north.

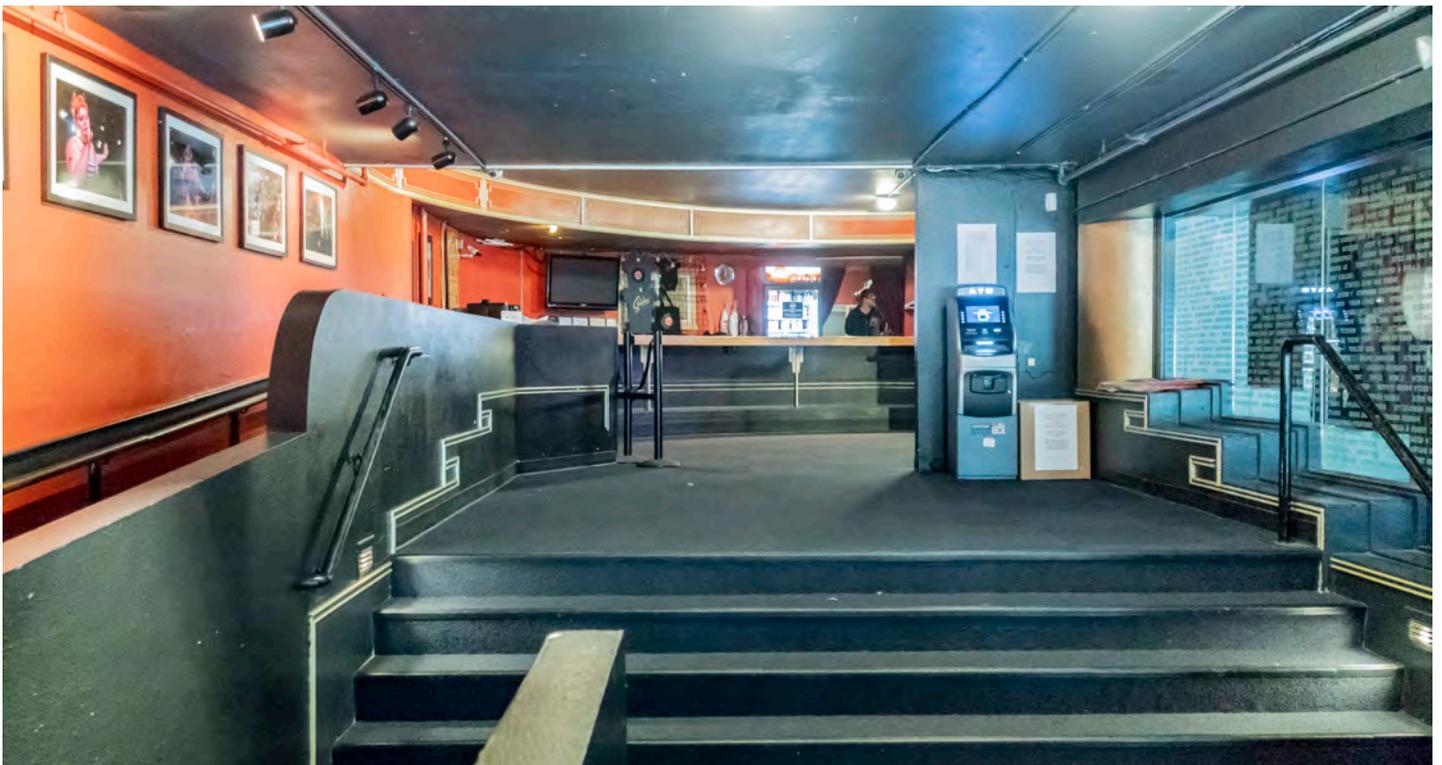
Figure 24. Showbox, entrance passageway showing the stairs, original south cheek wall and column, intermediate landing, and the original ticket window (originally a bar).

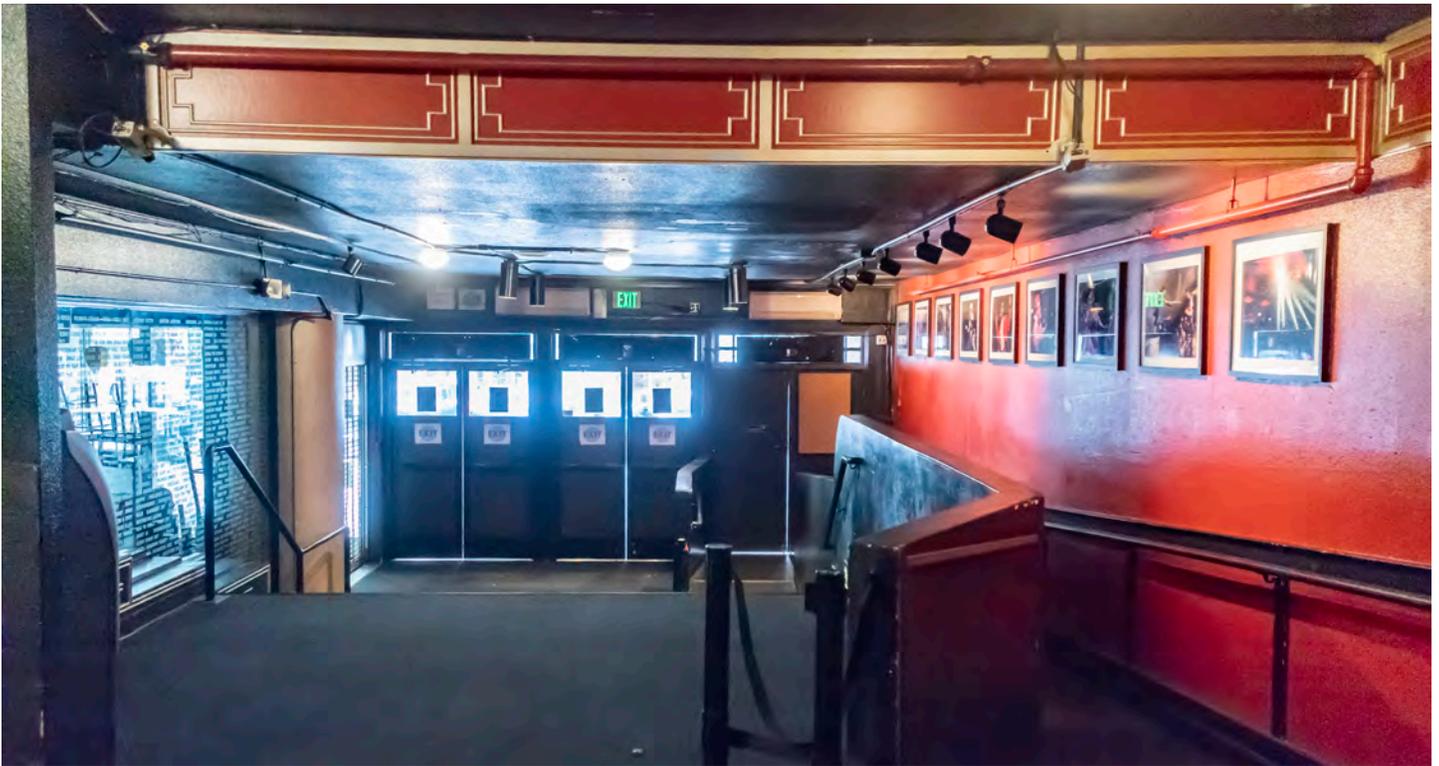
Figure 25. Showbox, looking west along the passageway at the three doorways providing access. The soffit above marks the line of the second floor framing. The volume of this passageway, door surrounds, and the large column at left are original to the 1939 remodel creating the Showbox.

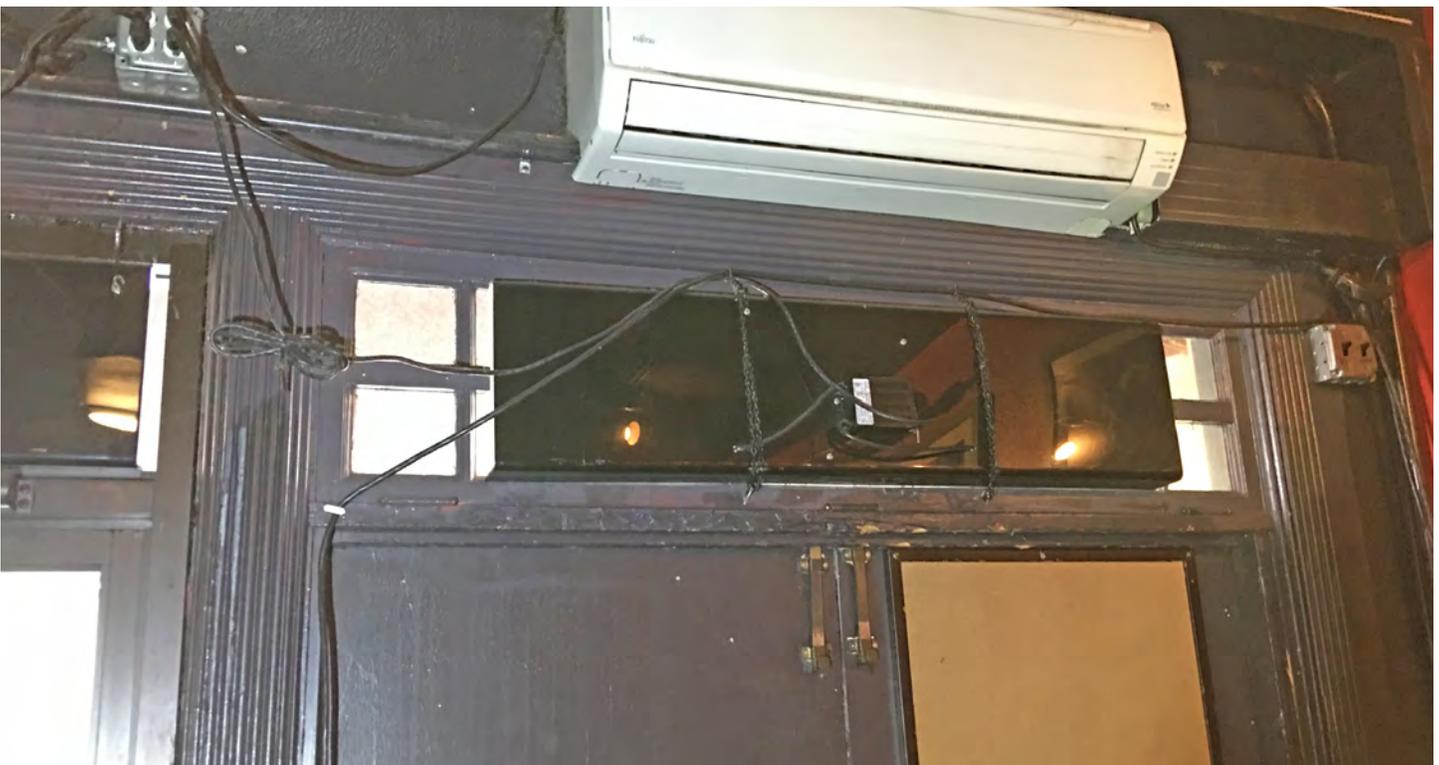
Figure 26. Showbox, detail view of the interior face of the doors showing the reeded detailing original to the 1939 remodel that is replicated on the exterior side of the doorways as well. The wood sash transom is also visible.

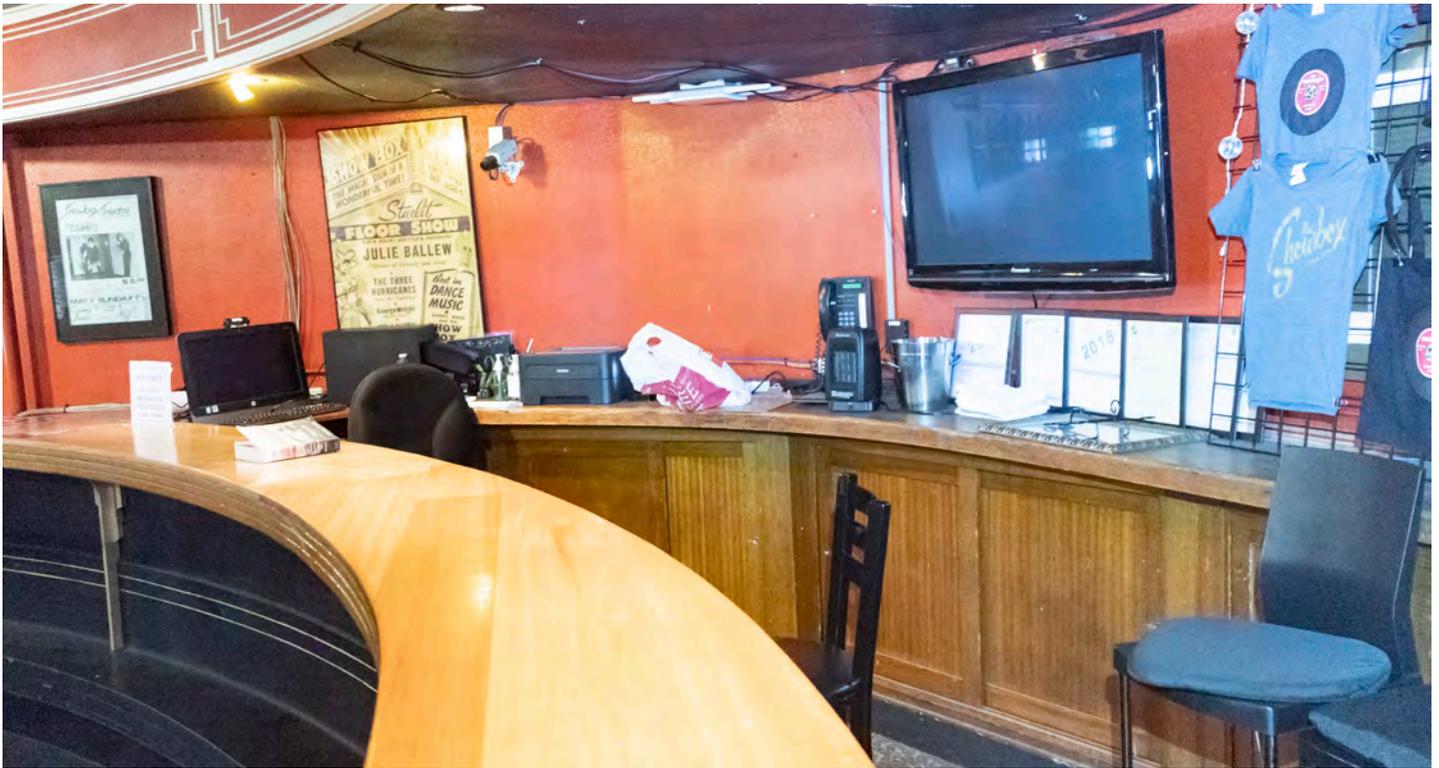
Figure 27. Showbox, looking north at the ticket window. The counter and back cabinets and overall opening are original to the 1939 remodel and 1940 modifications creating the Showbox. This space originally functioned as a bar for guests on their way to the performance volume.

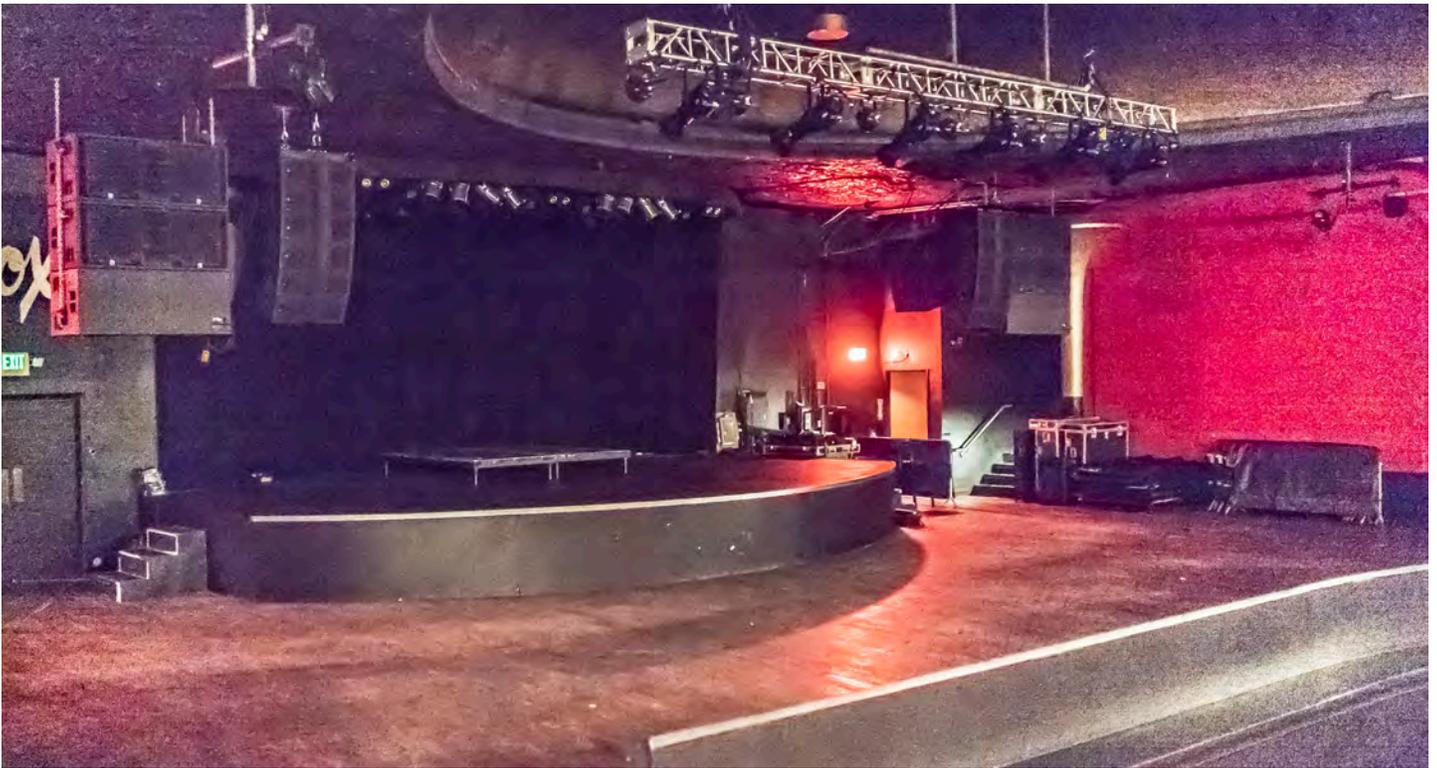
Figure 29. Showbox, looking south at the stage. The proscenium consisting of large rounded corners leading back to a flat back wall are original to the 1939 remodel and remain behind the curtains.

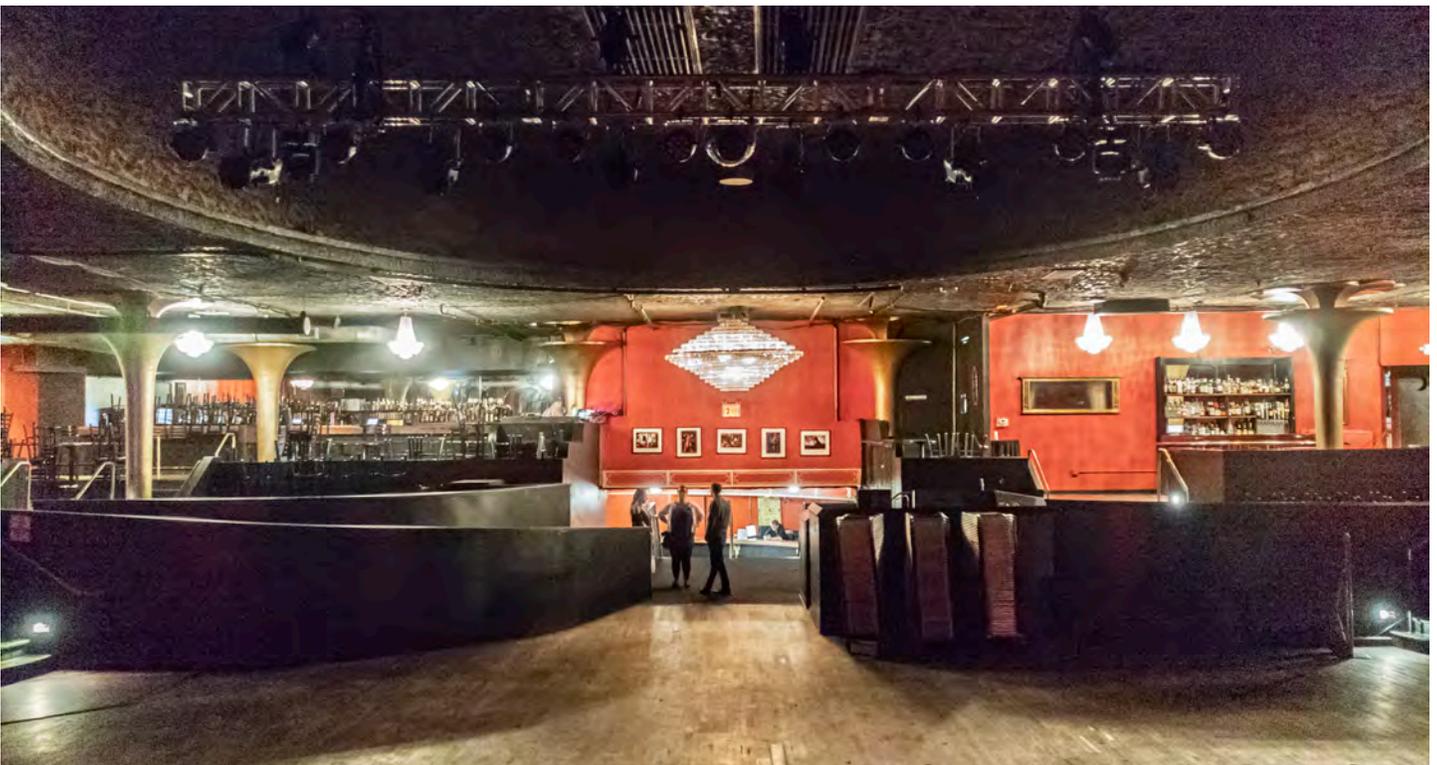
Figure 30. Showbox, looking north from the stage at the passageway entrance to the space. The vaulted ceiling is original to the 1939 remodel.

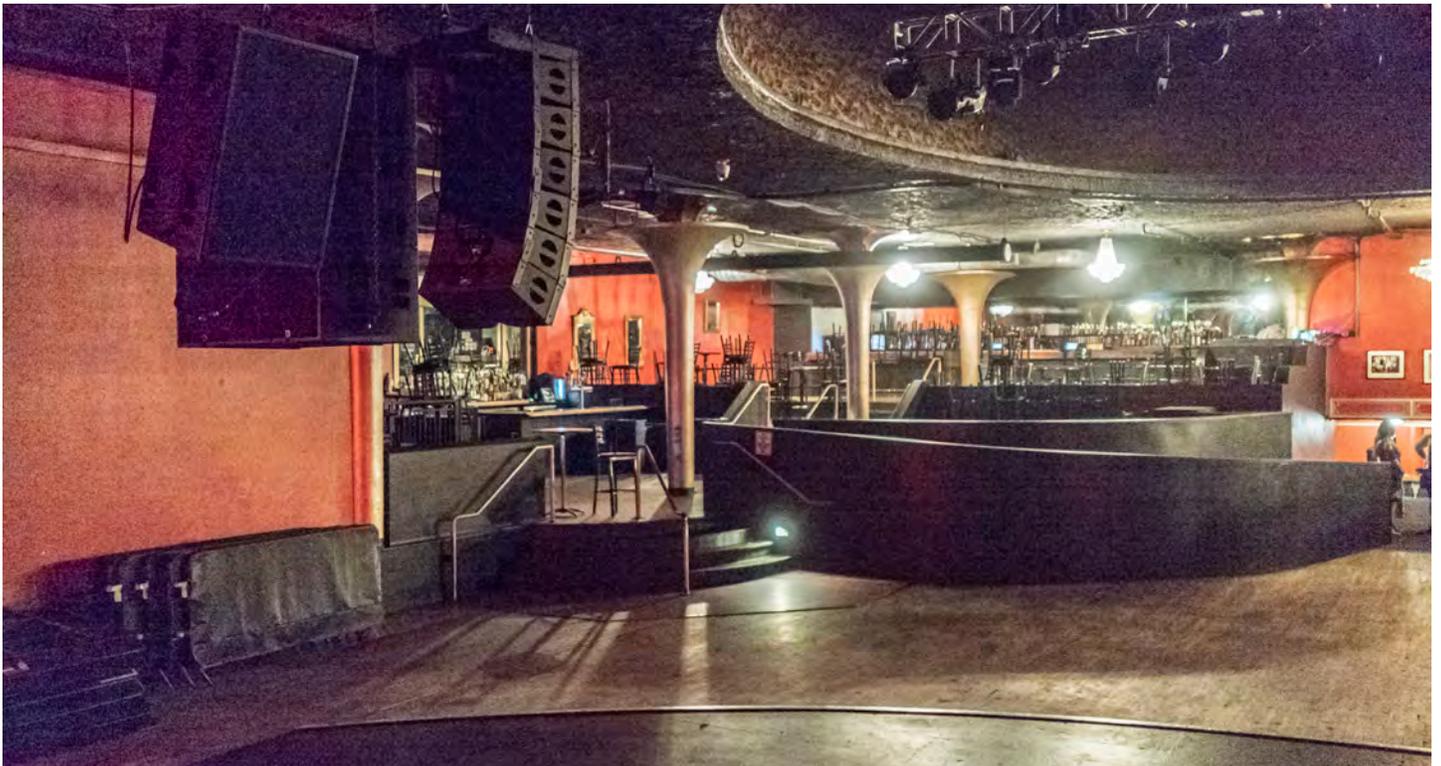
Figure 31. Showbox, looking west from the stage. The columns and parts of the tiered seating are original to the 1939 remodel.

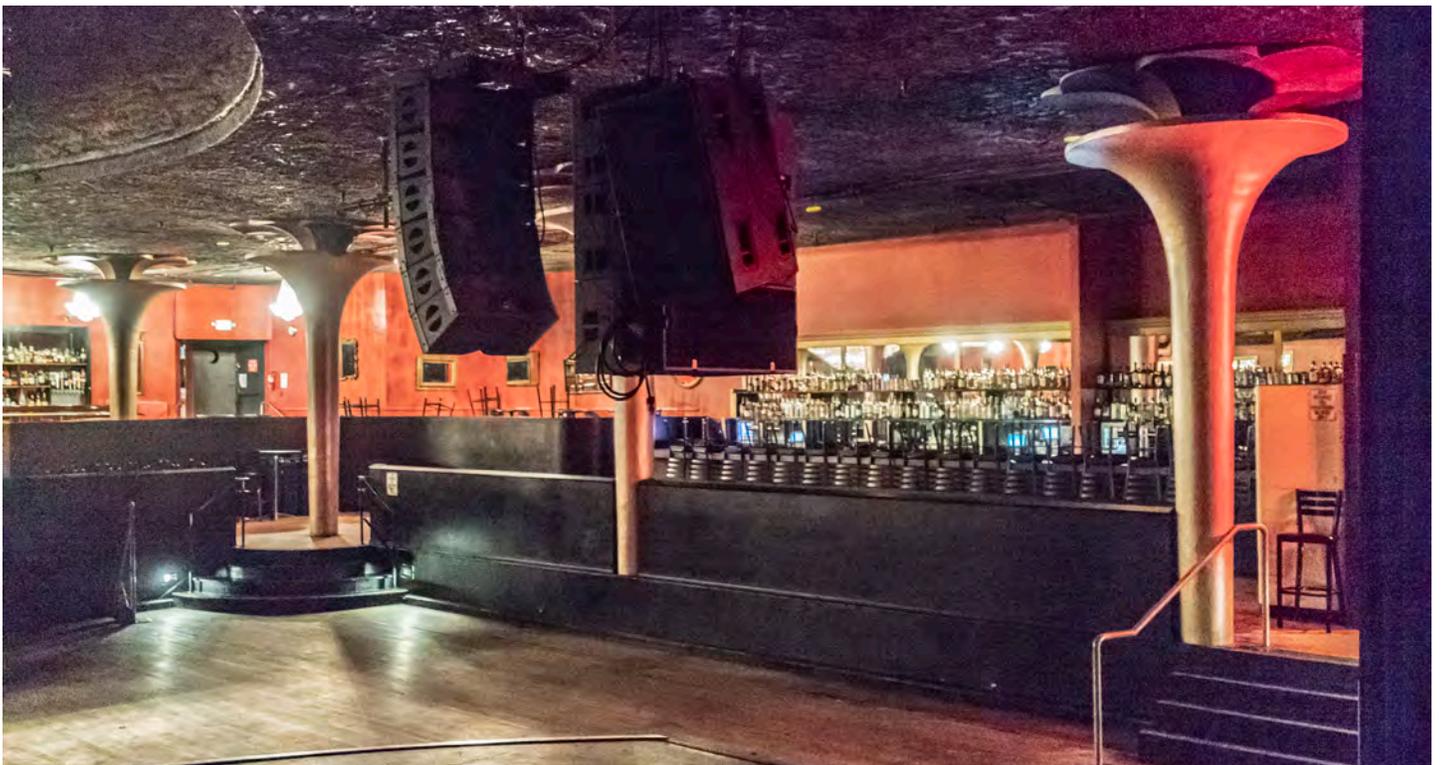
Figure 32. Showbox, looking east from the stage. The columns and parts of the tiered seating are original to the 1939 remodel.

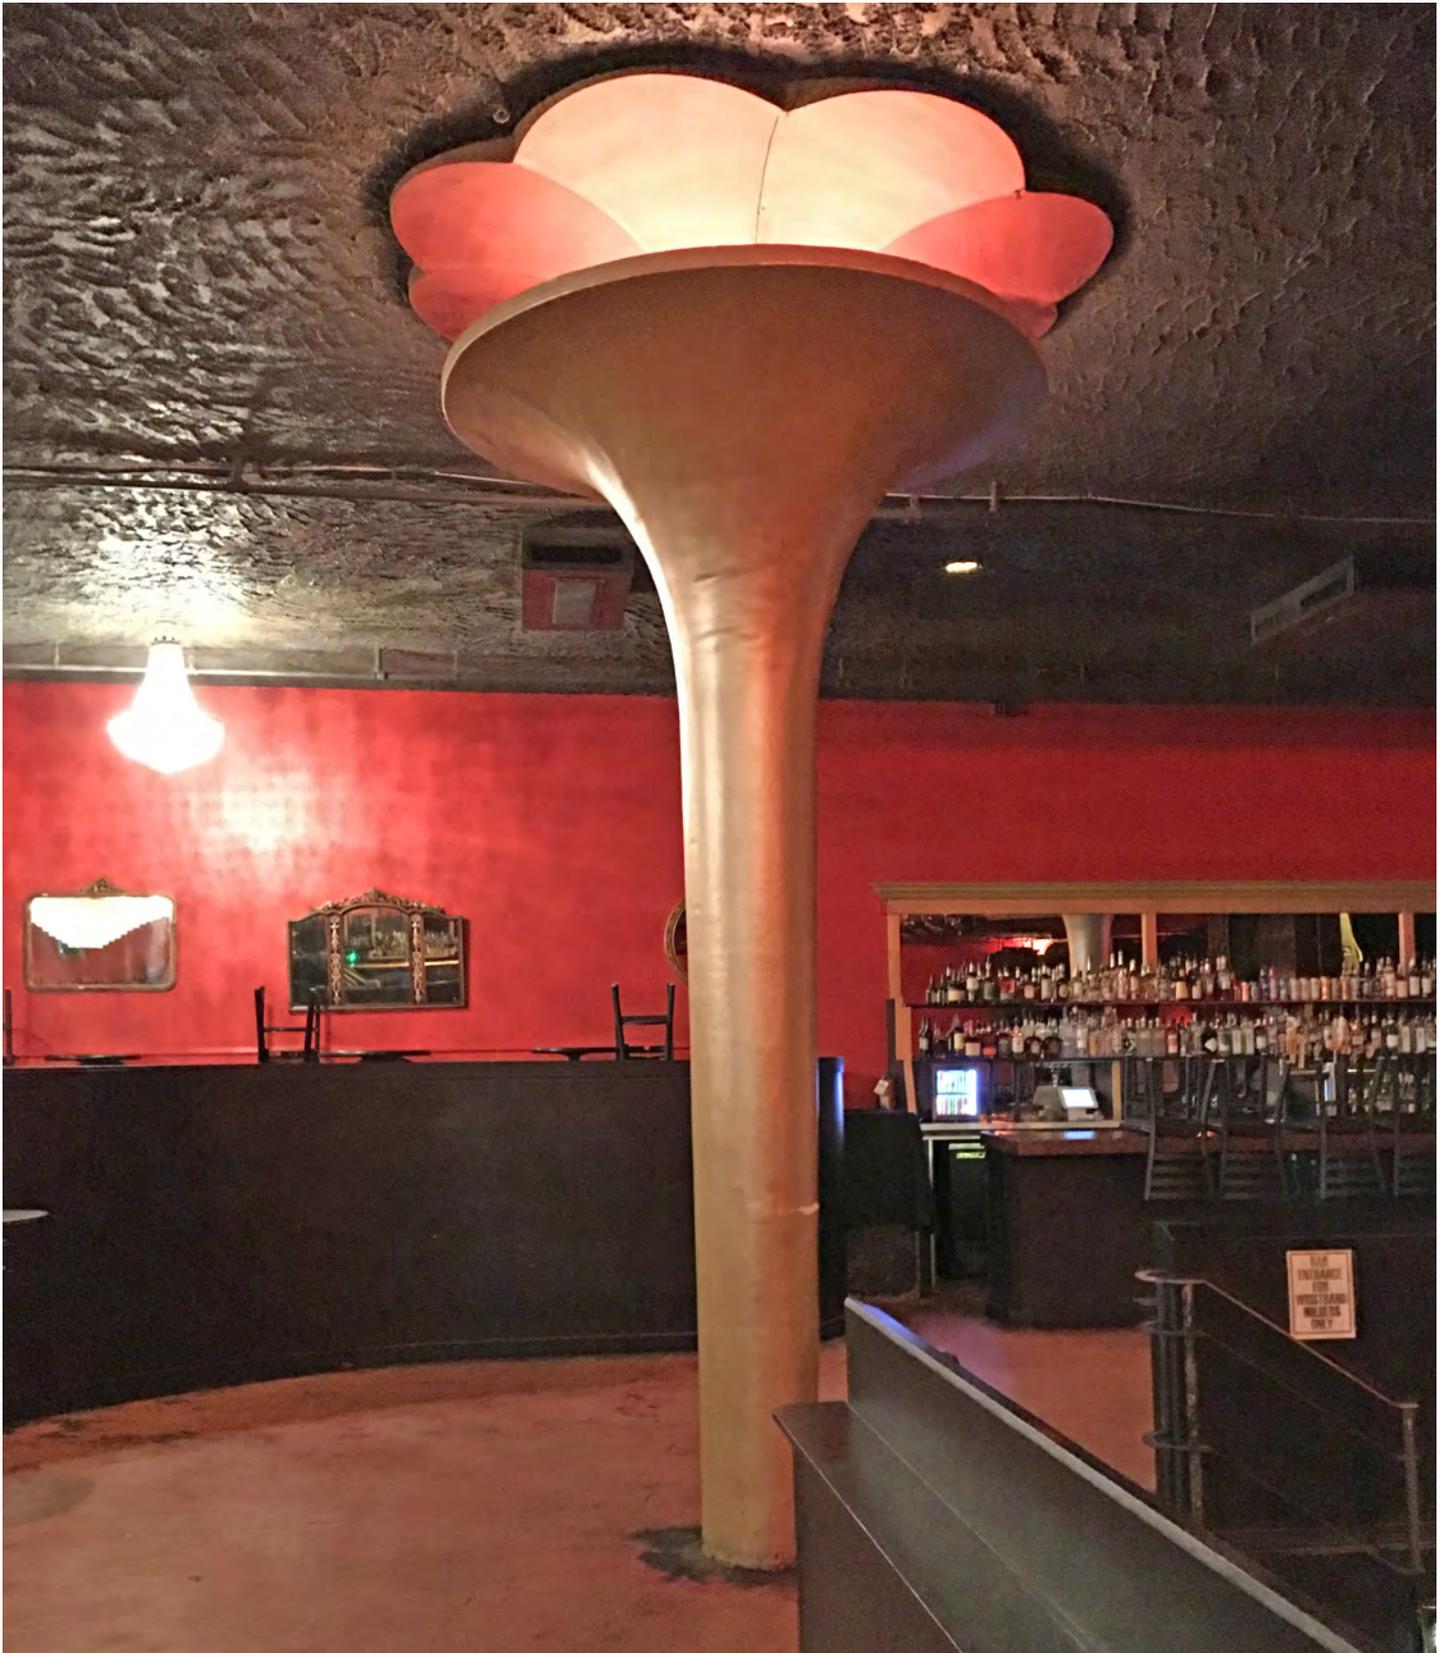
Figure 37. Showbox, detail of column original to the 1939 remodel. The core is a wood post with an outer plaster and wood form.

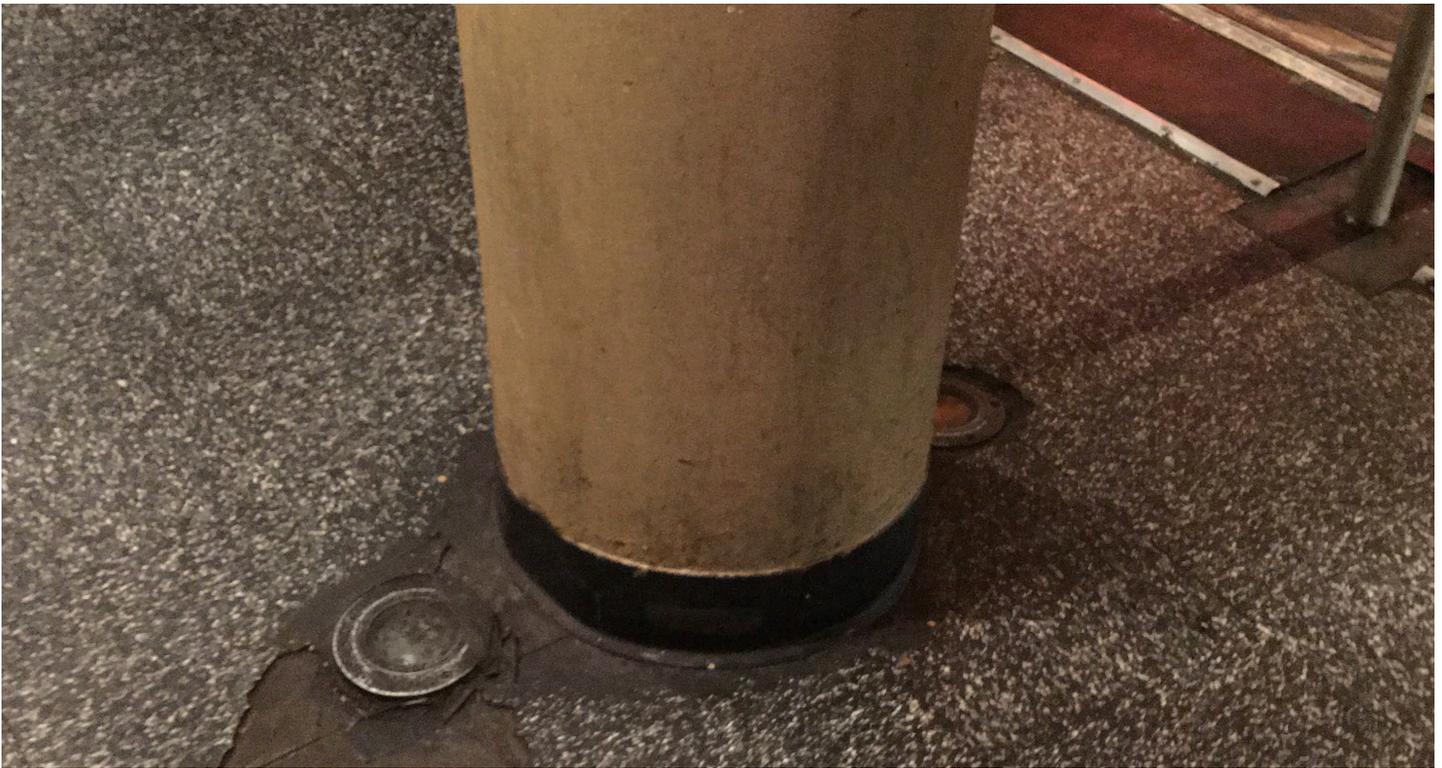
Figure 38. Showbox, detail of the floor lights original to the 1939 remodel that provided a light wash up the column.

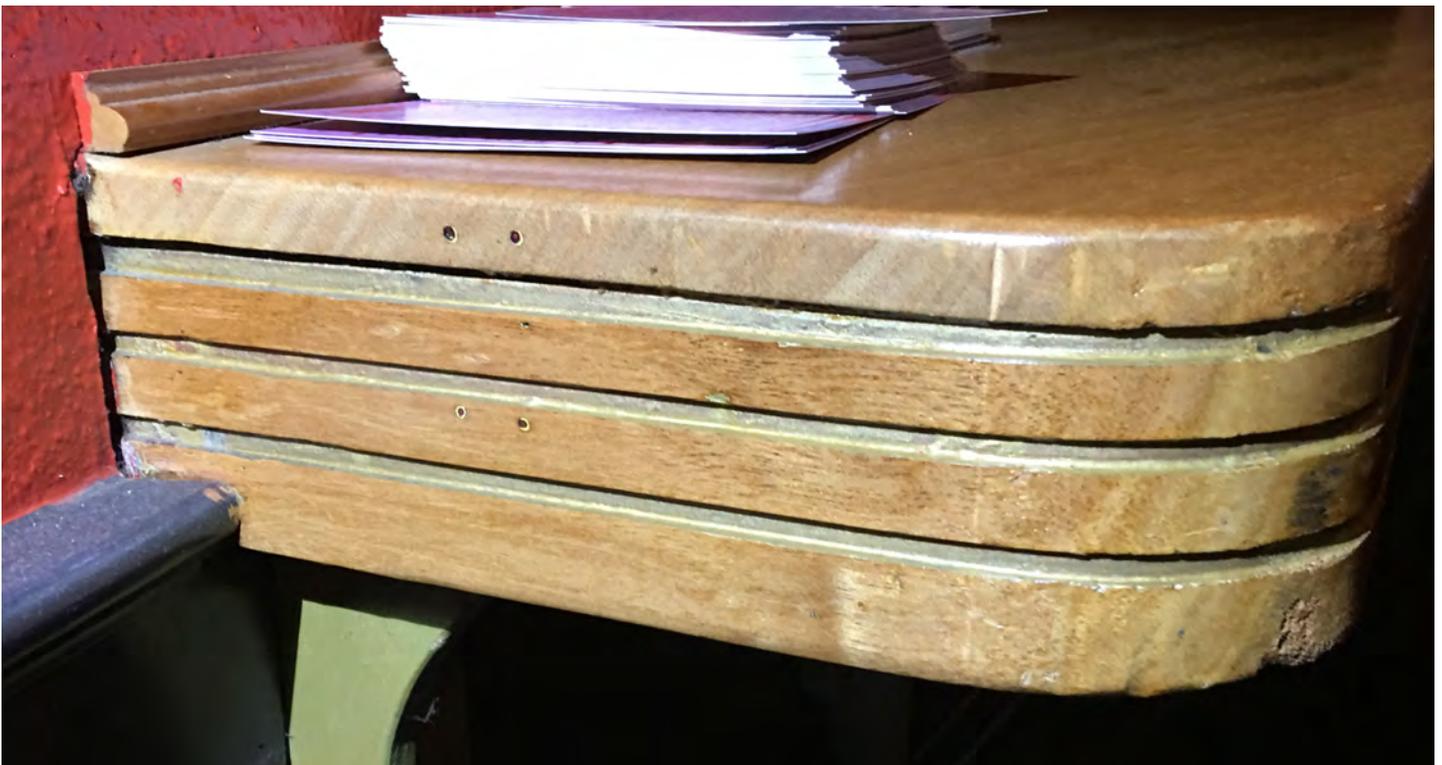
Figure 39. Showbox, detail of the ticket counter that is original to the 1939 remodel.

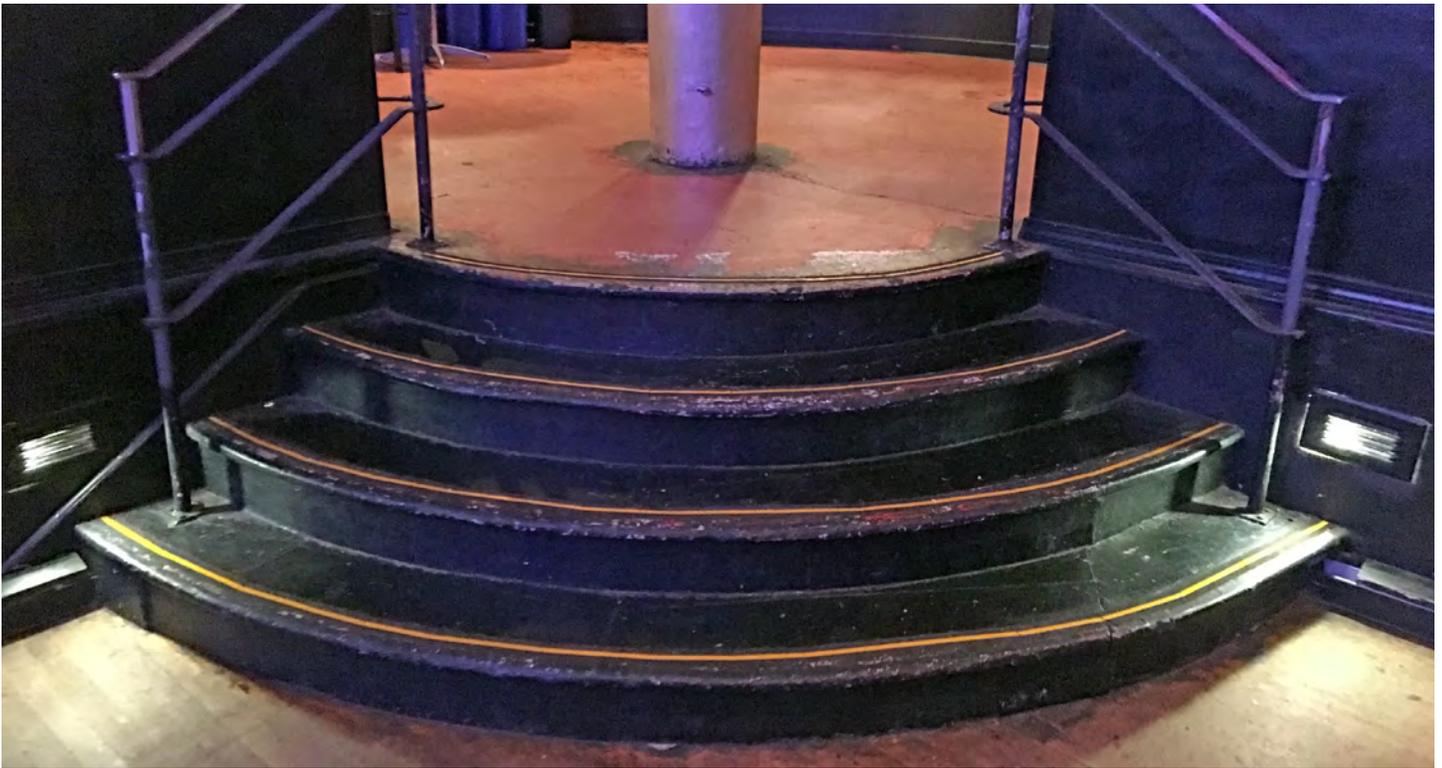
Figure 40. Showbox, detail of curved stairs and metal railings up from the dance floor to the terraced seating that are original to the 1939 remodel.

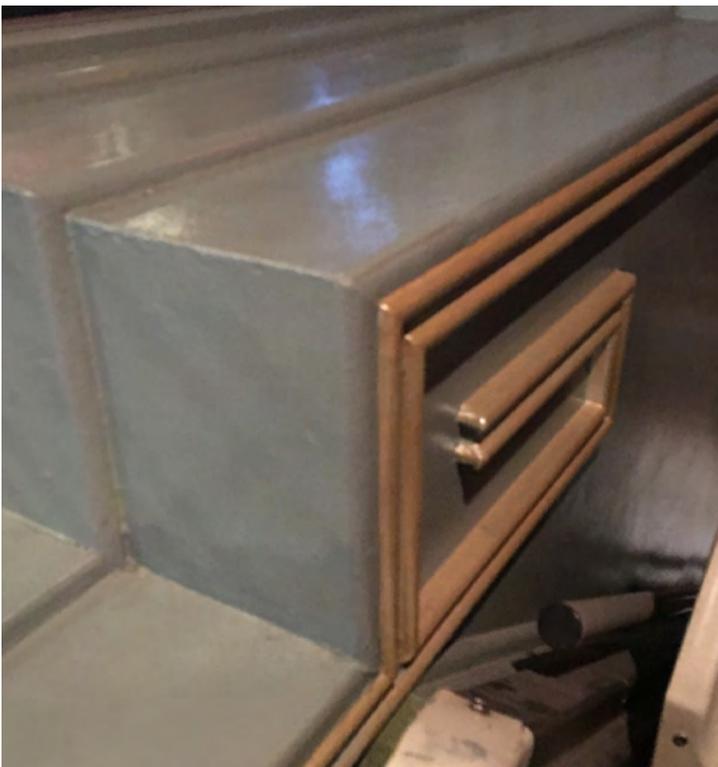
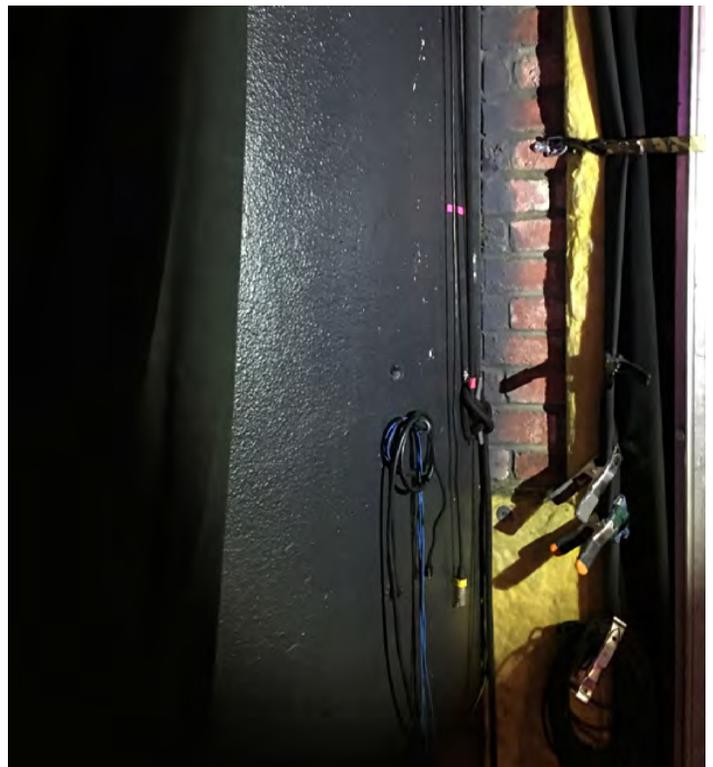
Figure 41. Showbox, detail (above left) of the stepped cheek walls and detailing that are original to the 1939 remodel. Detail (above right) of the curved proscenium edges that are original to the 1939 remodel.

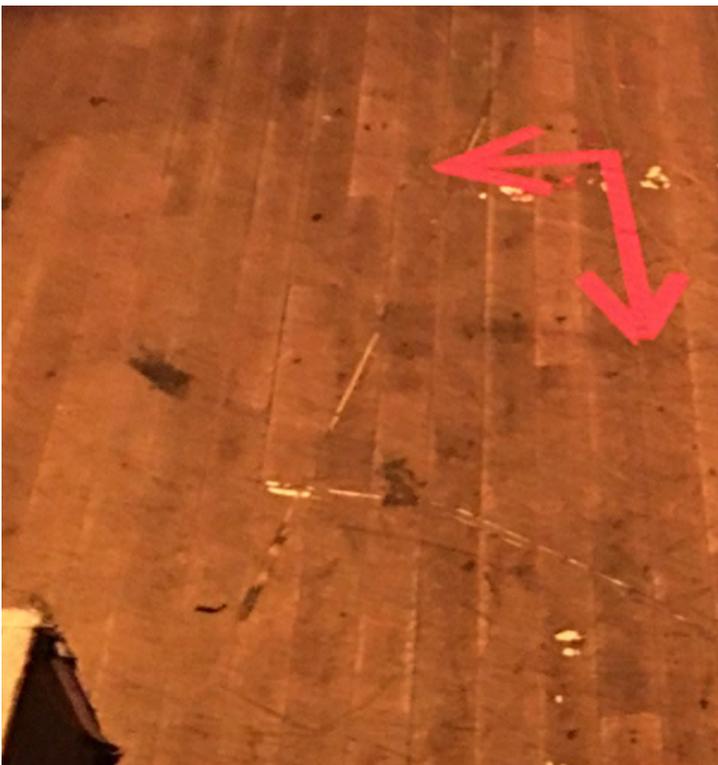
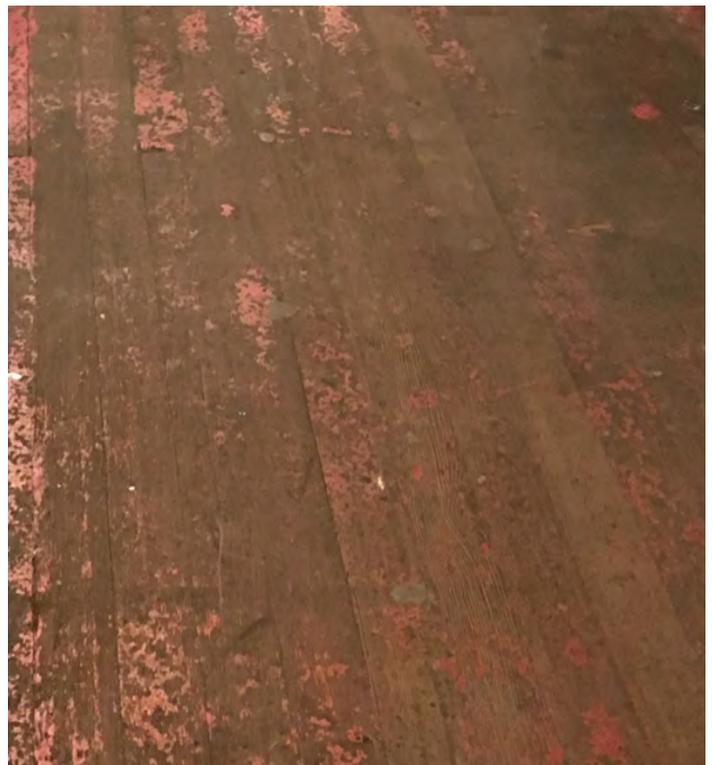
Figure 43. Showbox, detail (above left) of the maple dance floor original to the 1939 remodel. Detail (above right) of the Douglas fir flooring at sections of the raised seating area and behind the stage and at the ticket counter that are original to the 1939 remodel.

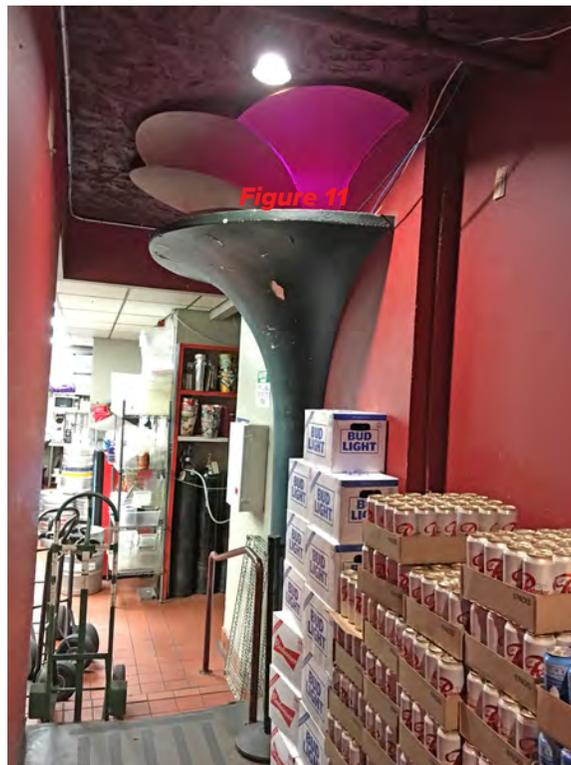
Figure 45. Showbox, detail of the walkway above the passageway from the west seating area into the kitchen. Note how later partitions were abutted up to the column elements leaving them intact.

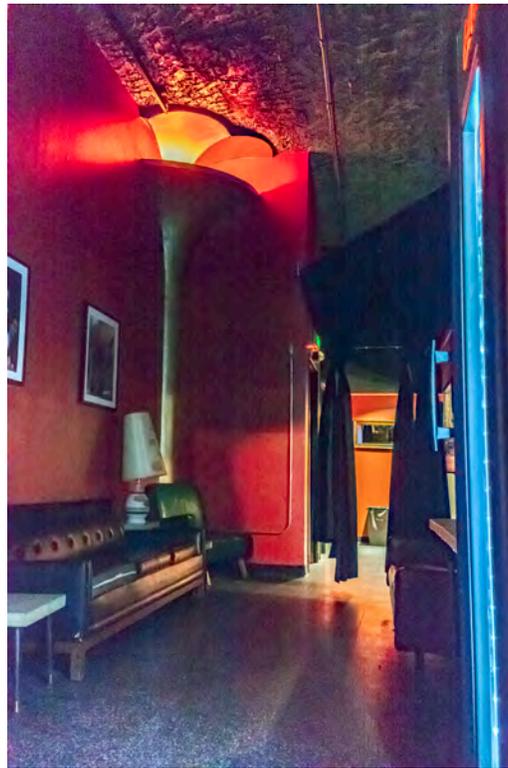
Figure 46. Showbox, outer green room looking south. Note how later partitions were abutted up to the column elements leaving them intact.

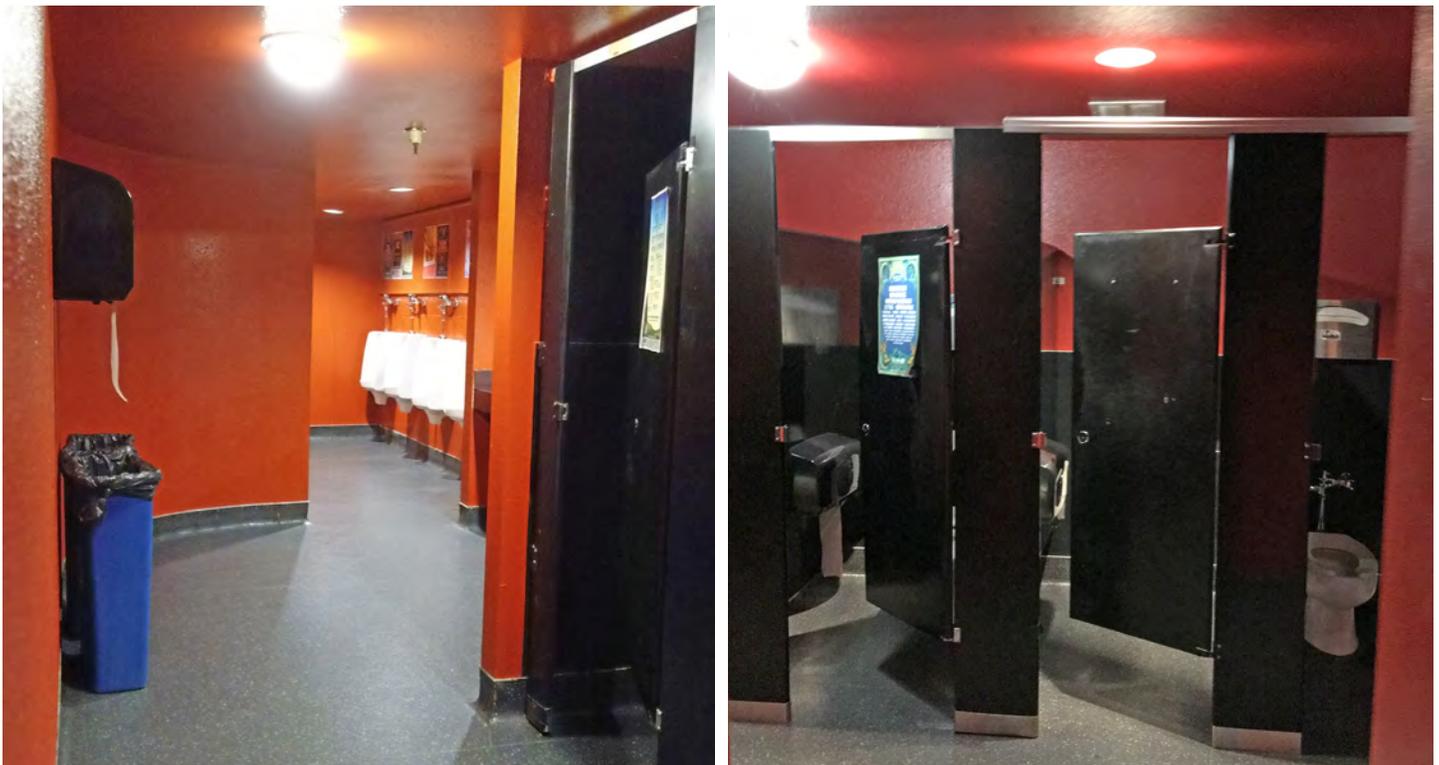
Figure 49. Showbox, men's restroom (above left) looking east. Note the curved wall which is the inner side of the proscenium curve at the stage. Detail (above right) of the women's restroom on the east side of the floor.

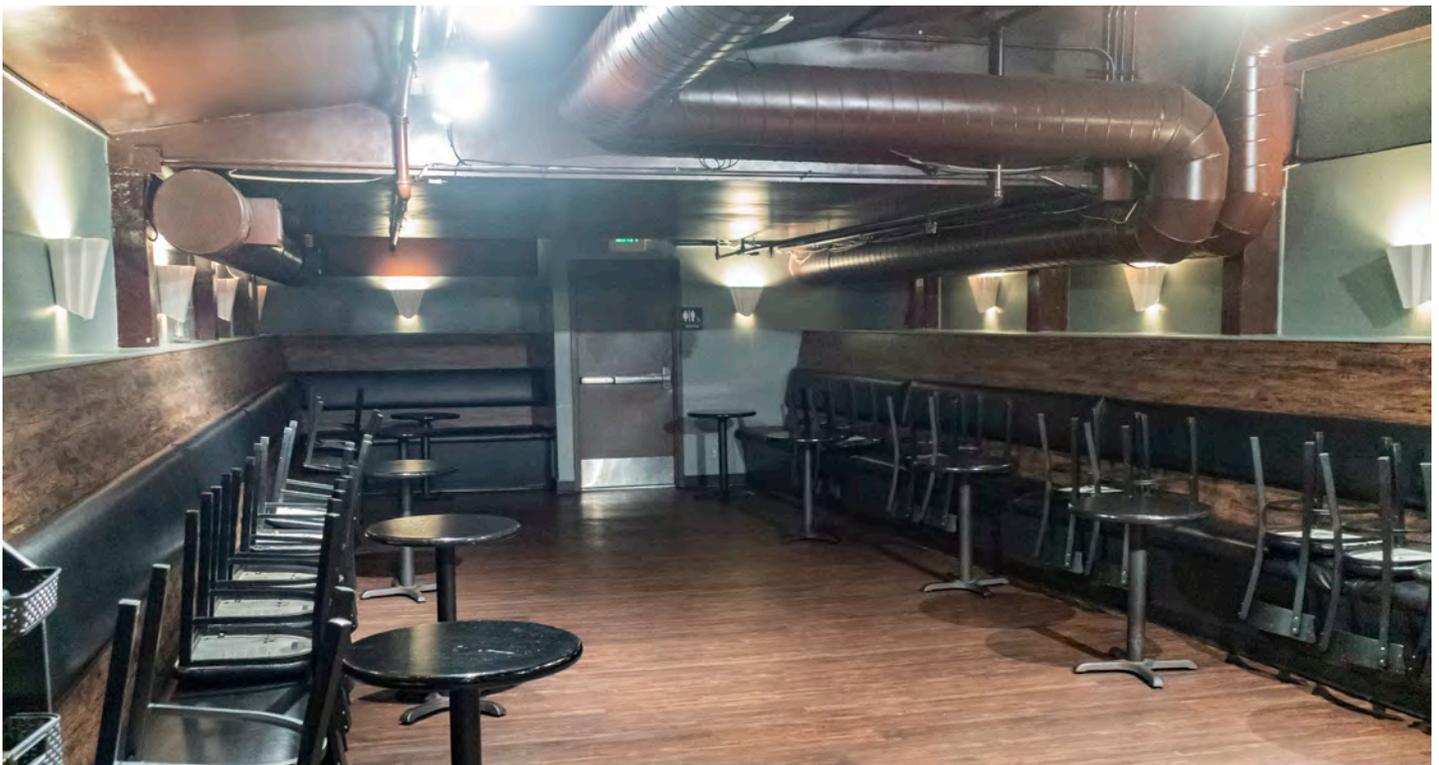
Figure 55. Showbox, looking east through the lower level. Note the sloped ceiling which is original to the 1939 remodel and is the underside of the original ramp up to the performance hall from the ticket counter.
