SHOWBOX

1426 First Avenue
SEPTEMBER 10, 2018

The City of Seattle
Landmarks Preservation Board

Street and Number: 1426 First Avenue

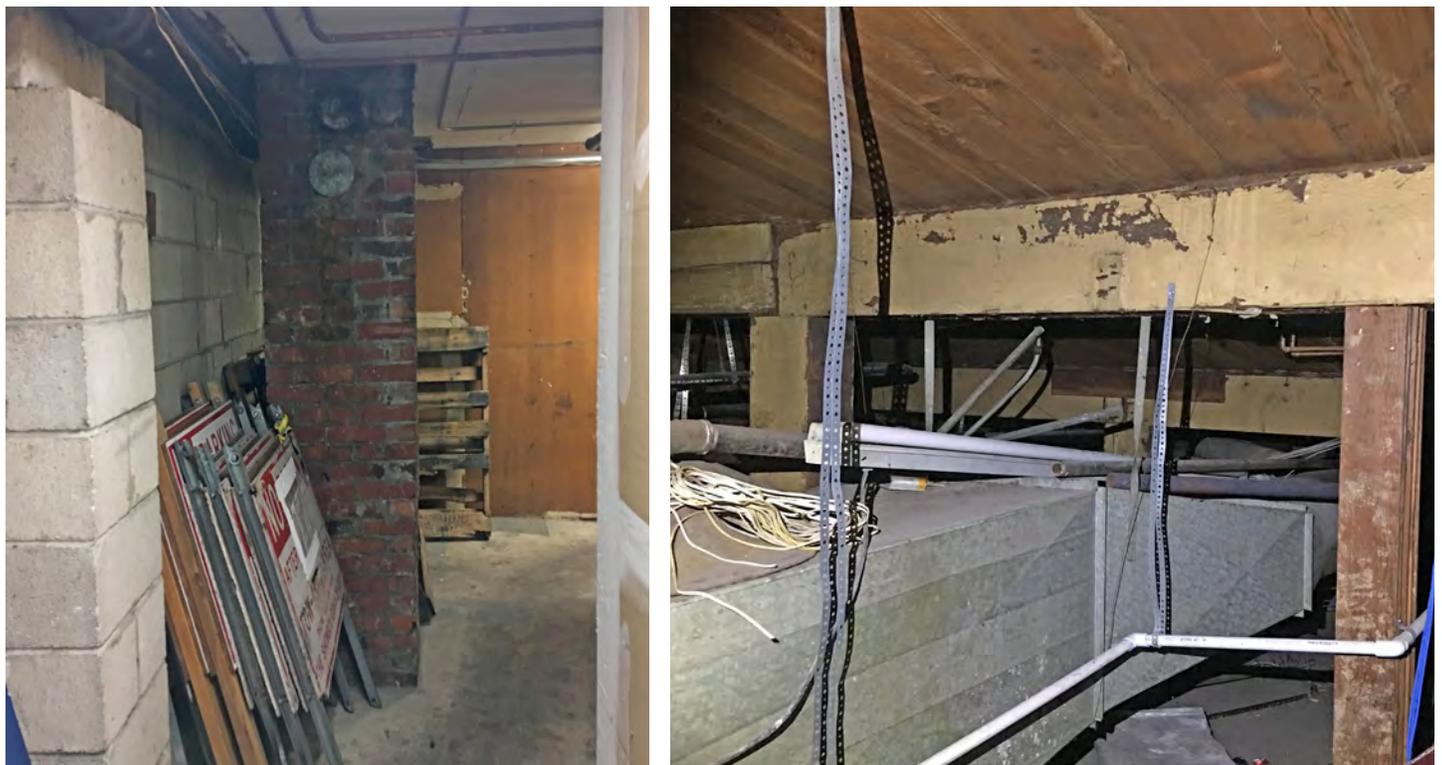
Figure 57. Service area, looking east along the rebuilt north facade. The brick chimney is original to the 1916 construction of the building (above left). A view looking west (above right) below the Showbox passageway showing the framing and ramp that are original to the 1939 remodel.

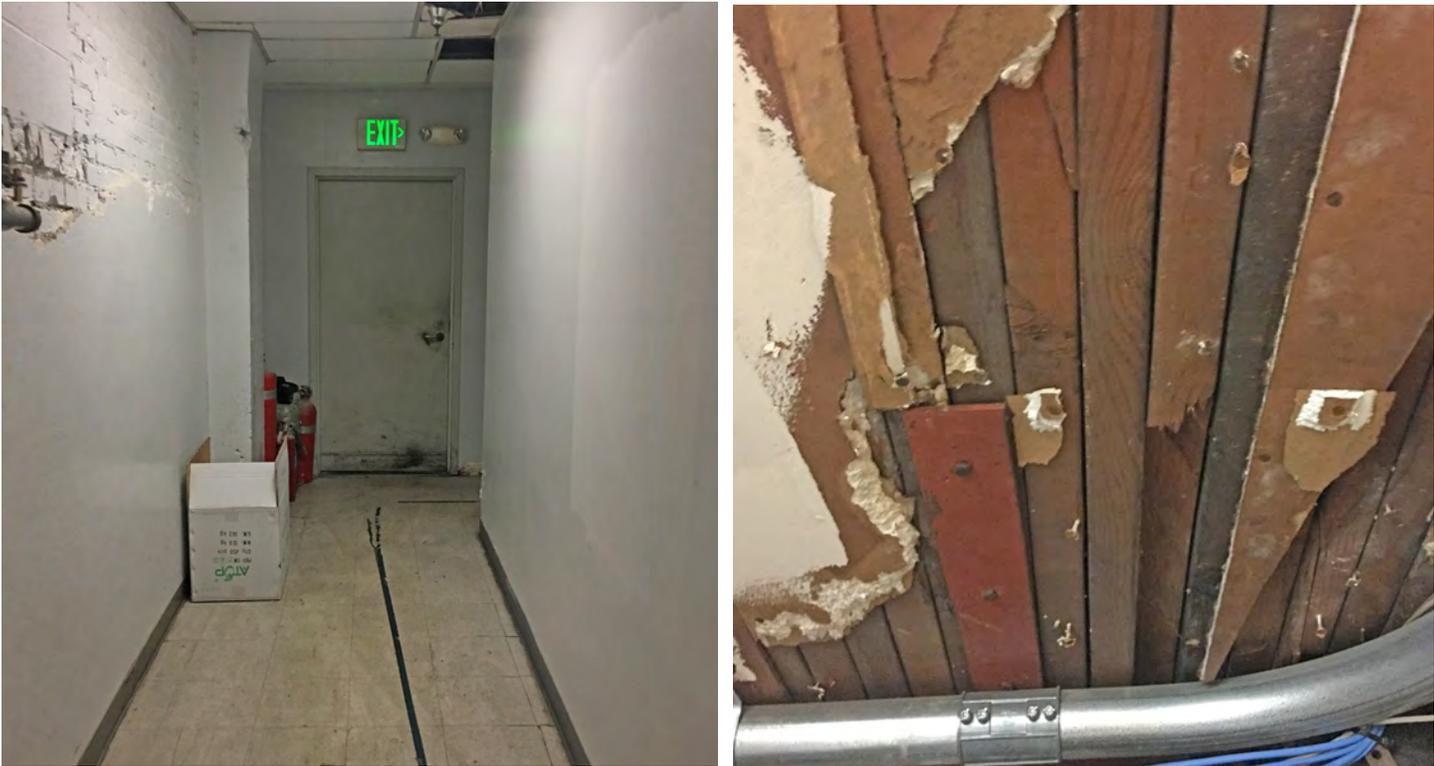
Figure 58. Service area, looking east and showing typical wall finishes (above left). The wall along the left side is the outer brick masonry wall. Note the brick pier that steps out to support the massive east to west beams carrying the second floor. A detail (above right) of the crib construction (2x boards on edge) comprising the floor structure for the second floor.

Interior framing consists of ten- by ten-inch posts set on 22-foot centers that support the floor framing. These wood posts occur at each floor. The posts have chamfered corners and carry massive timber beams (approximately 14- by 14-inches in section) that run east to west. Steel strap ties anchor the beam ends to the outer walls. The first floor consists of a concrete slab with some wood floor sections along First Avenue. The second floor and roof deck consist of nominally two-inch-thick boards set on edge and butted one next to the other. This construction method provides a high load capacity for the flooring system. Steel brackets anchor the posts to the beams. Through-wall steel ties connect the second floor and roof framing to the exterior walls. **See Figure 58, upper right image.**

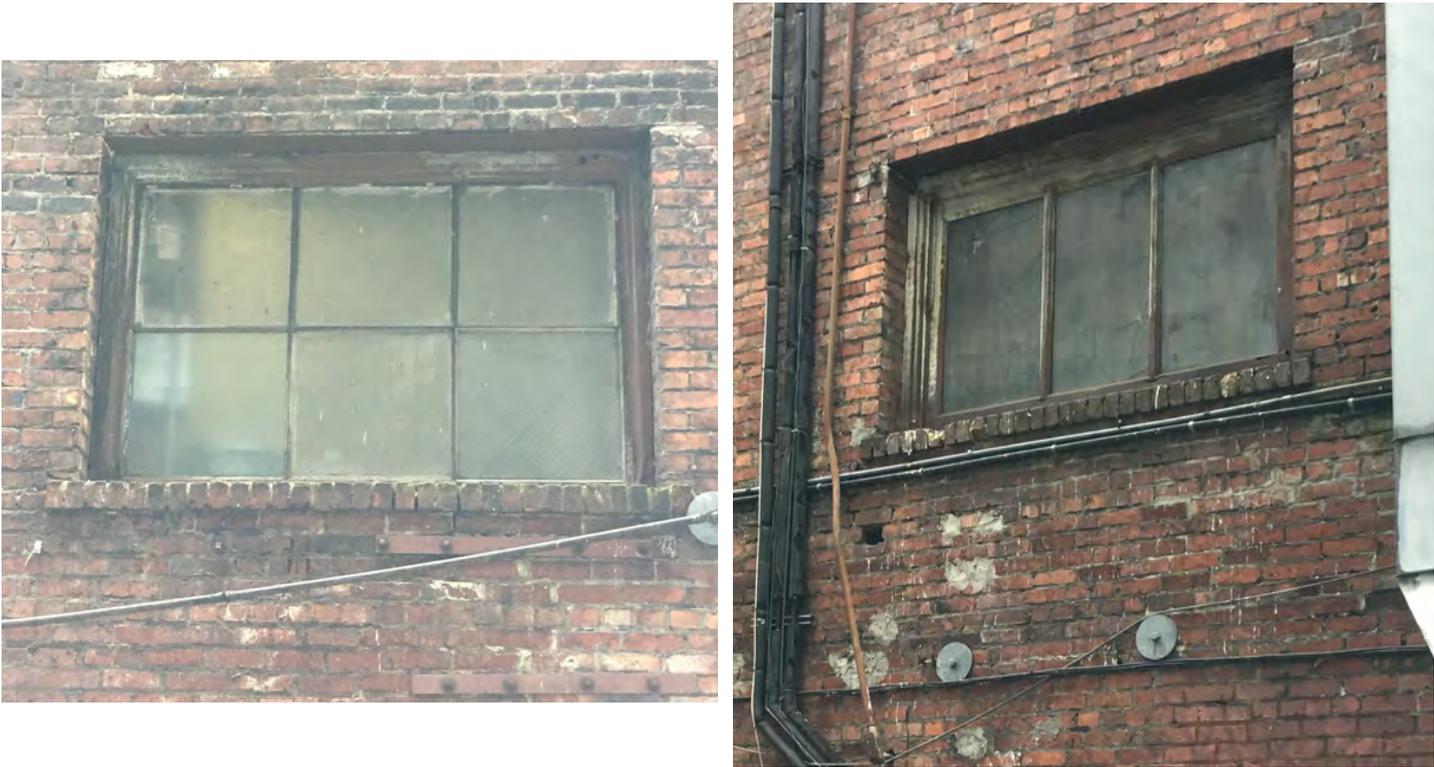
Figure 59. Alley facade, detail of the 6-lite (above left) and 3-lite (above right) sash along this facade.

Windows occur on the front west and rear east facades. West facade windows consist of three window openings set in a horizontal band characteristic of the Streamline Moderne style. Each opening consists of two fixed sash flanked by narrow sash having a larger fixed upper and smaller operable lower sash. Window frames are anodized aluminum. The window band is framed by a projecting modernistic border emphasizing the horizontal character of the facade, with painted corrugated metal panels between the windows and at the south end. The border consists of raised outer edges with a central recessed channel. **See Figures 11, 13, 59-60.**

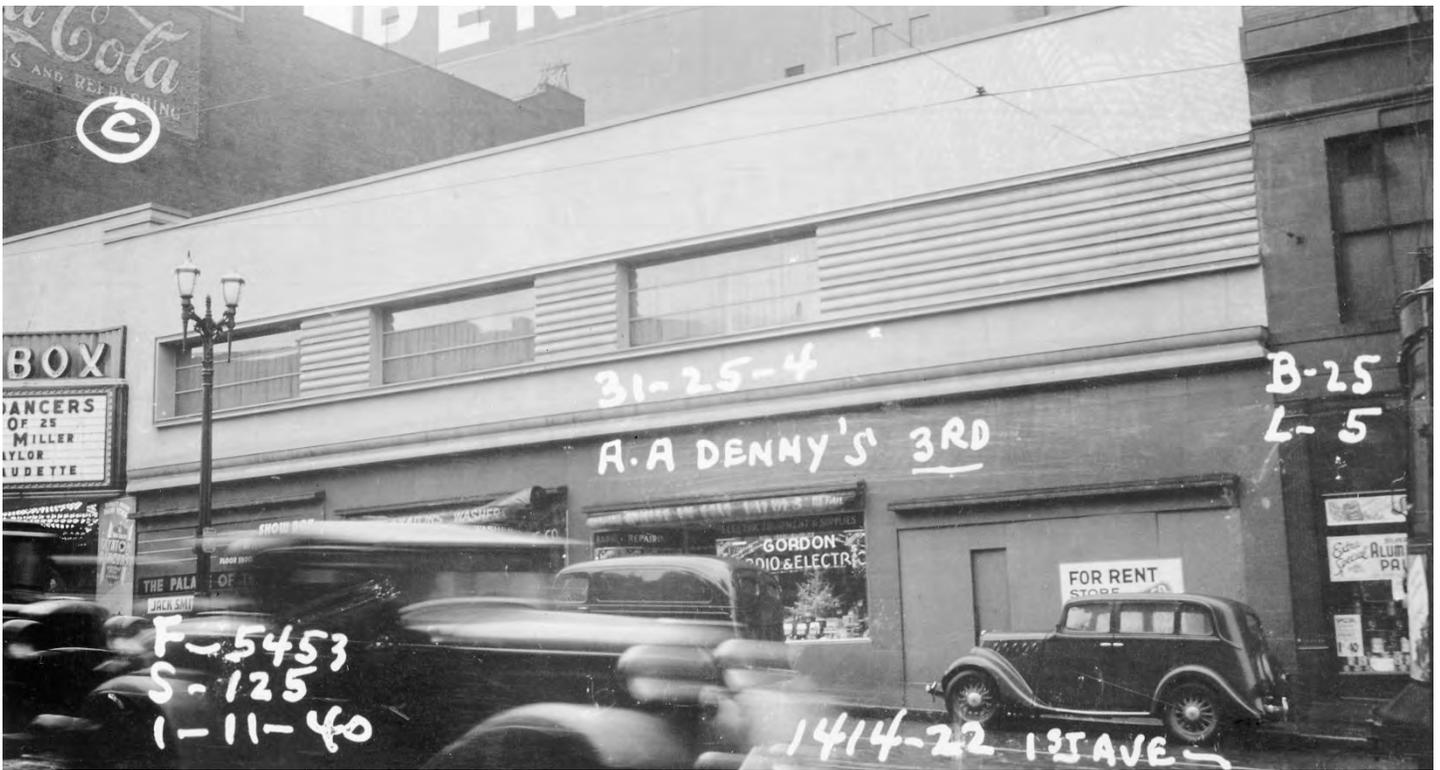
Figure 60. Ca. 1938 photograph showing the north portion of the west facade of the building when it was the Central Market, prior to the 1939 renovation that created the Showbox. This photograph also shows the Regent Hotel prior to its demolition and creation of the surface parking lot. Source: Puget Sound Regional Archives.

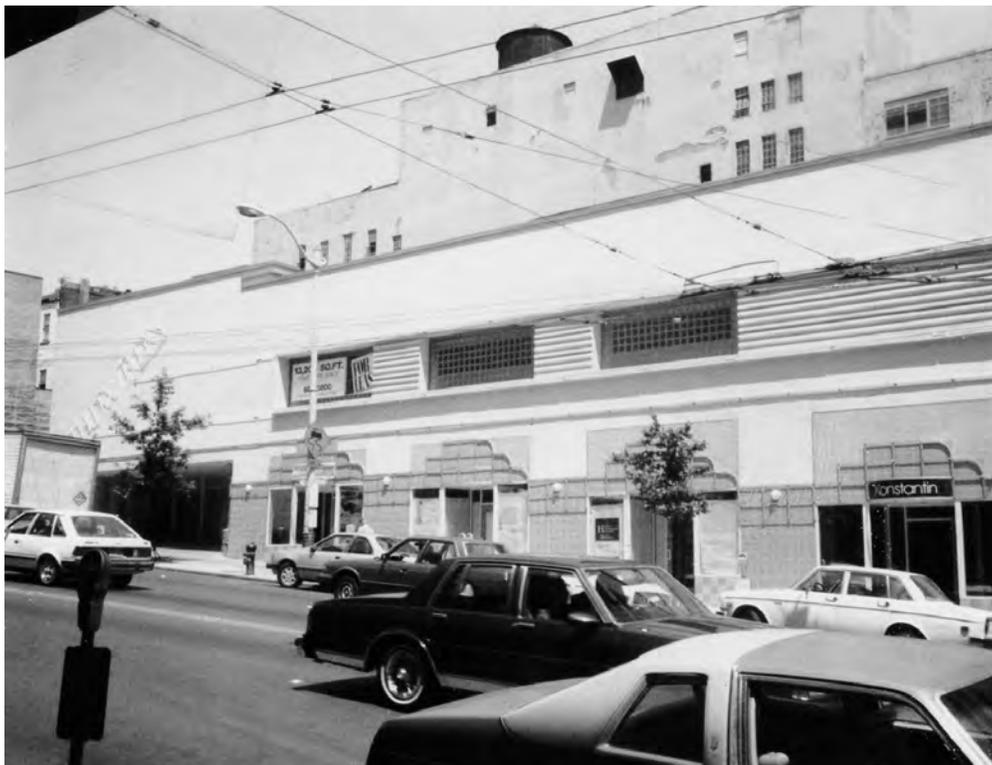
Figure 67. 1981 view looking southeast along 1st Avenue. Source: University of Washington Special Collections, Hamilton 2918, SEA4942.

- By 1981 the main marquee over the front entrance had been removed. **See Figures 66-67.**
- 1986: this work by EHA Architects and Ratti Fossatti Associates, P.S. consisted of seismic upgrades and alterations to the west facade. The roof framing was upgraded and through wall ties were added connecting the outer masonry walls to the floor framing. Shear walls were added along the west facade between the storefronts. As part of this work the front facade was re-stuccoed and the storefronts rebuilt to their current configuration with a centered recessed entrance flanked by display windows. The wider piers between the storefronts cover the new shear walls. New tiles were installed around the storefronts with an aluminum grid overlaid on these tiles above the storefronts for decorative effect. The windows were replaced with glass block. **See Figures 68.**

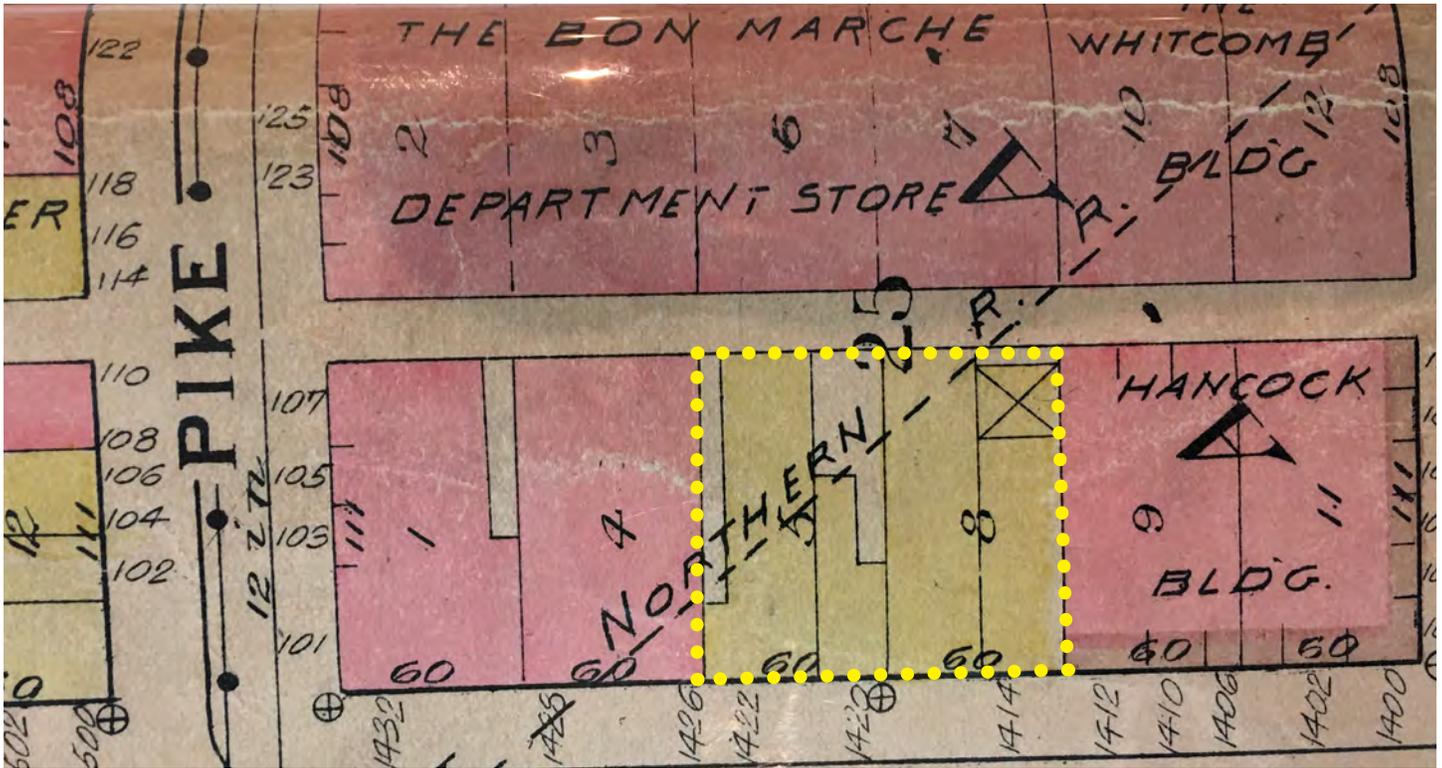
Figure 69. 1908 Baist's Real Estate Atlas Map. Courtesy of Seattle Public Library, Seattle Room. This map shows the buildings at the site (outlined in yellow dots) prior to construction of the Central Market Building in 1916, which would become the Showbox. Note the Great Northern Railroad tunnel passing below the building site.

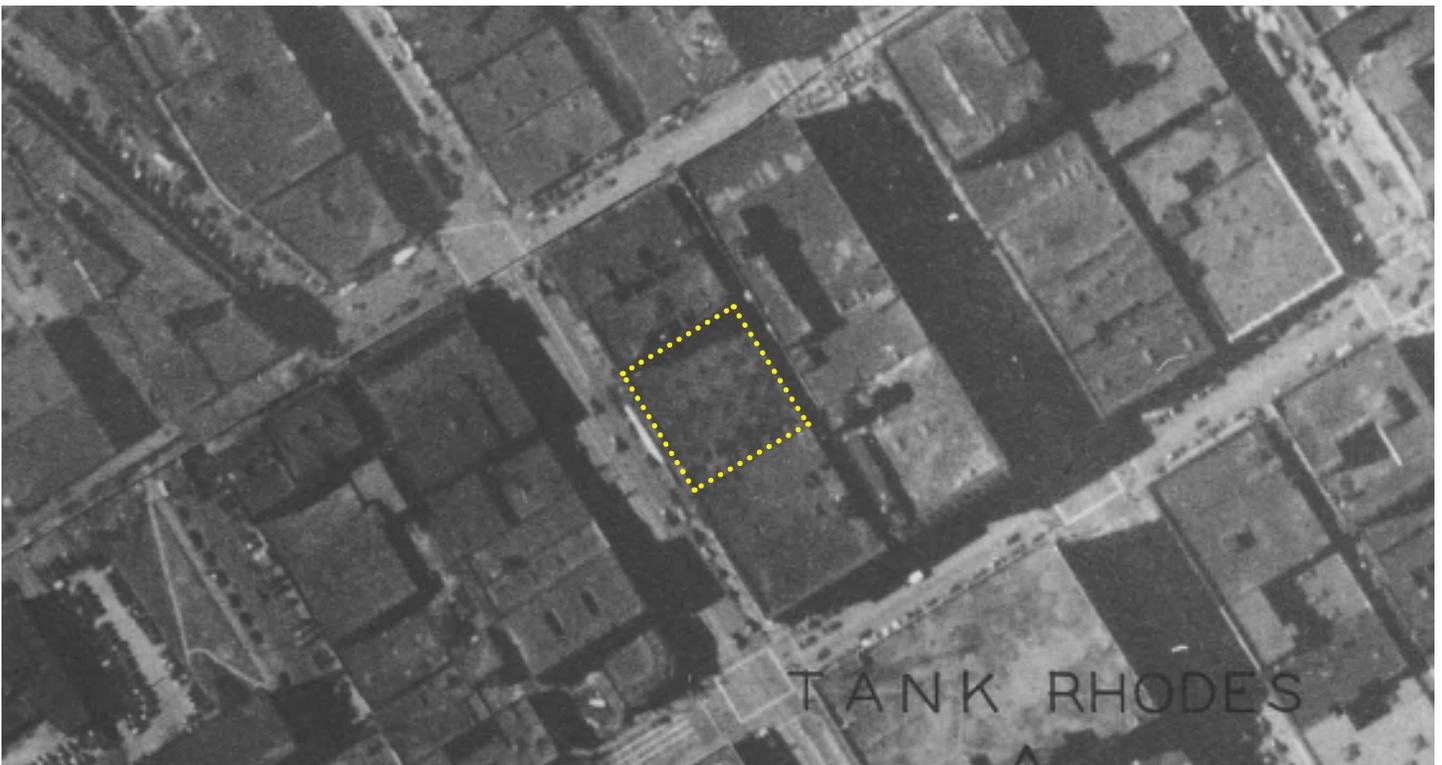
Figure 74. 1937 King County aerial showing the building (outlined in yellow dots) prior to the 1939 remodel. Note the elevated central truss roof portion for the vaulted ceiling at the second floor was part of the 1939 remodel.

A flat roof with composition roofing clads the building. A central low-pitched gable roof portion projects up from the main roof over the second-floor trusses and the domed ceiling. Parapets extend along the west, north, and east sides of the roof with a thin ledge (coping) along the front facade to visually accent the parapet edge and provide a horizontal emphasis to the facade. This ledge is repeated at a step in the parapet height. Sheet metal flashing caps the parapet. A steel armature mounted to the roof framing and supporting the front marquee occupies the northwest corner of the roof behind the parapet. Rooftop mechanical equipment is located around the roof perimeter behind the parapet. Sheet metal ducting and steel enclosed conduit (related to restaurant and performance venue functions) extend up to this equipment along the outer face of the east facade to avoid disrupting the interior performance volume. Metal downspouts extend down from the roof along the east facade, discharging at the alley. An internal brick chimney is in the northeast corner of the building. **See Figures 3, 74.**

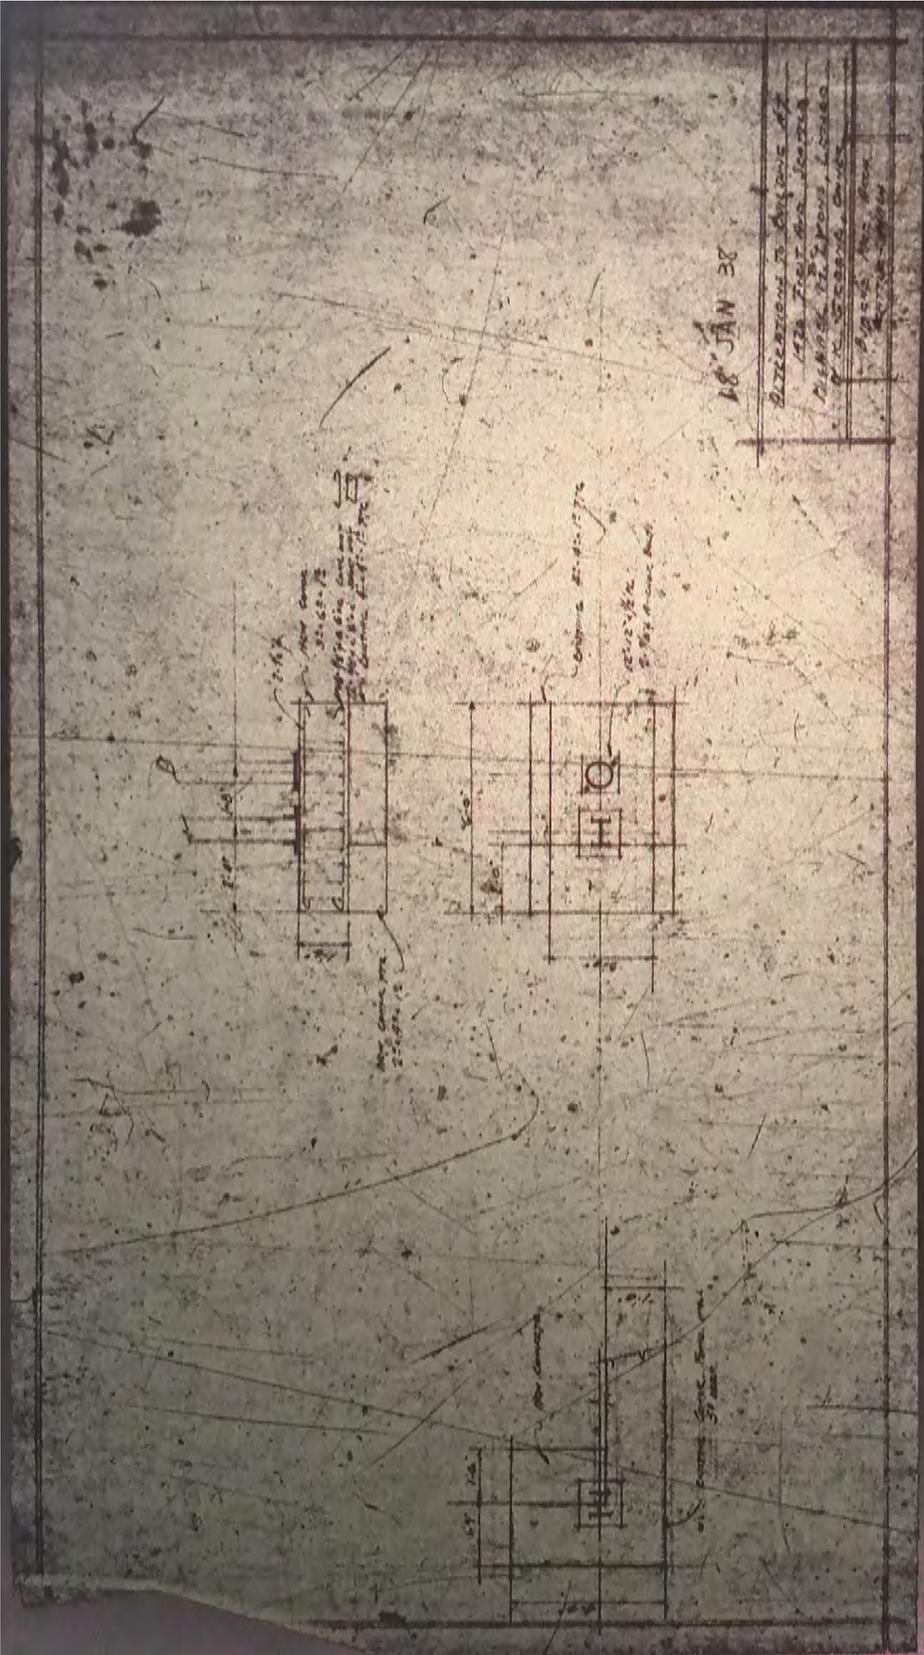
Figure 75. 1938 (January 18) drawing showing foundation upgrades for Michael Lyons (leasing space) and K. Greene (owner) by architect Bjarne Moe. Courtesy Seattle Department of Construction and Inspections microfilm library.

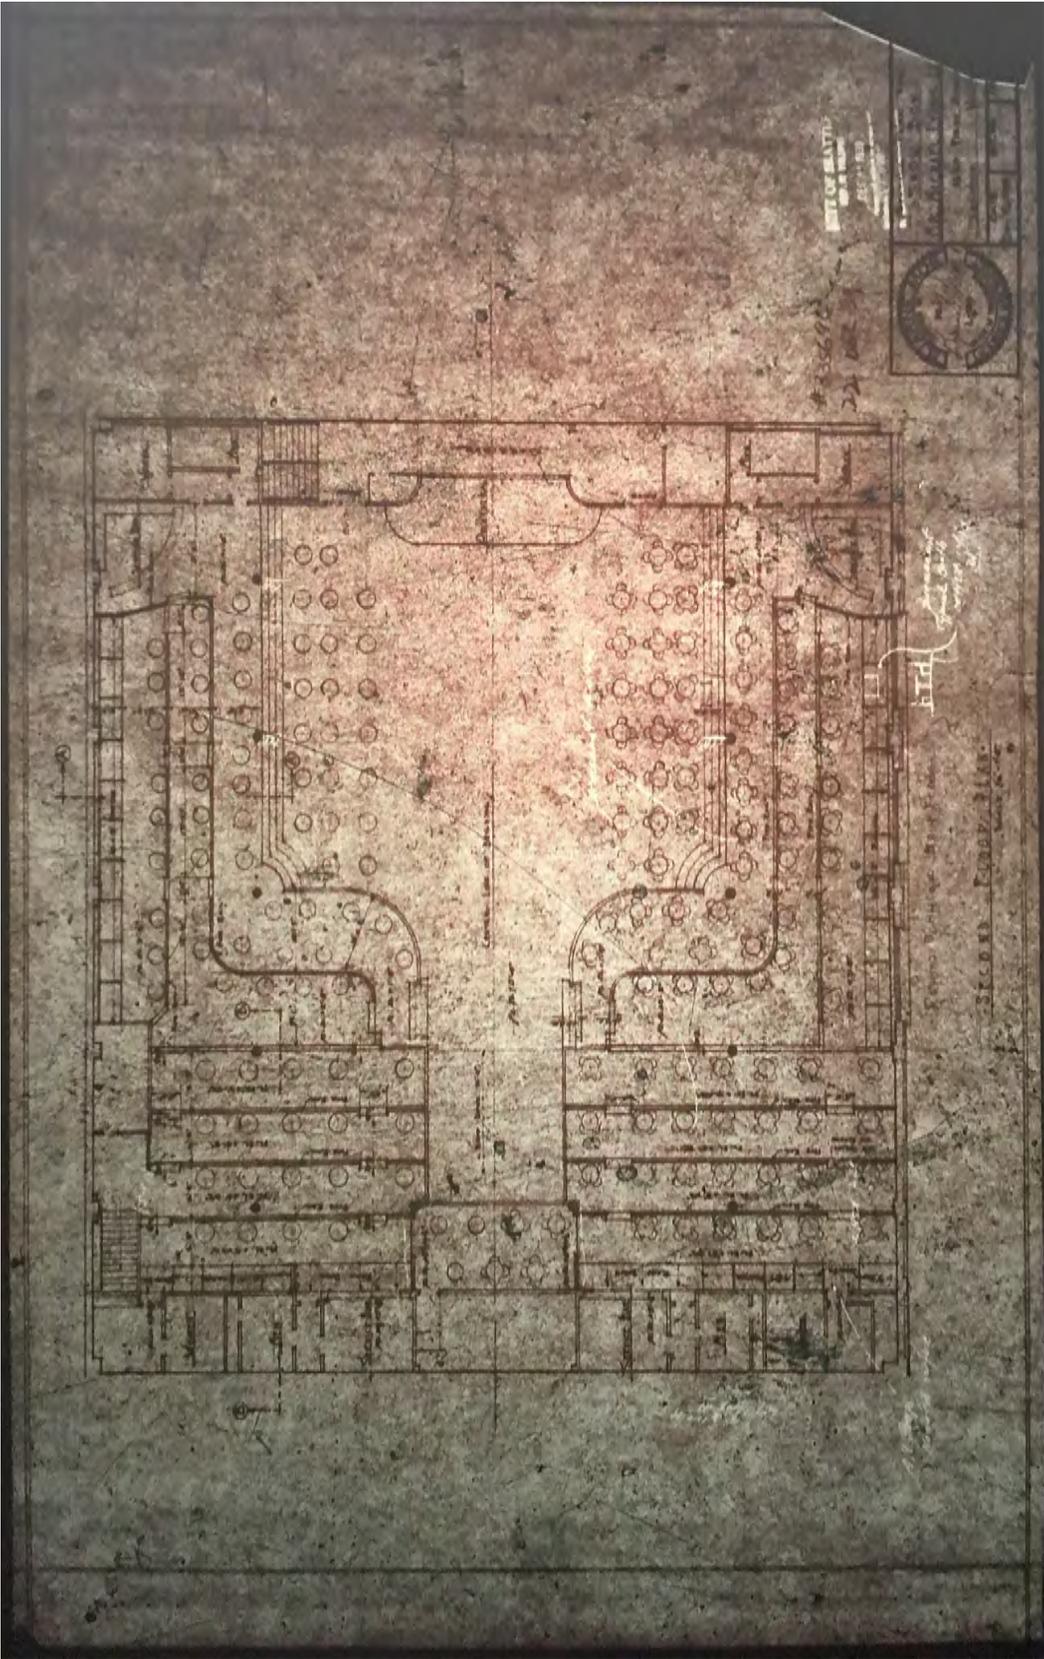
Figure 76. 1939 (December 15) drawing showing the second floor plan for the Showbox remodel for Michael Lyons prepared by architect Bjarne Moe. Courtesy Seattle Department of Construction and Inspections microfilm library.

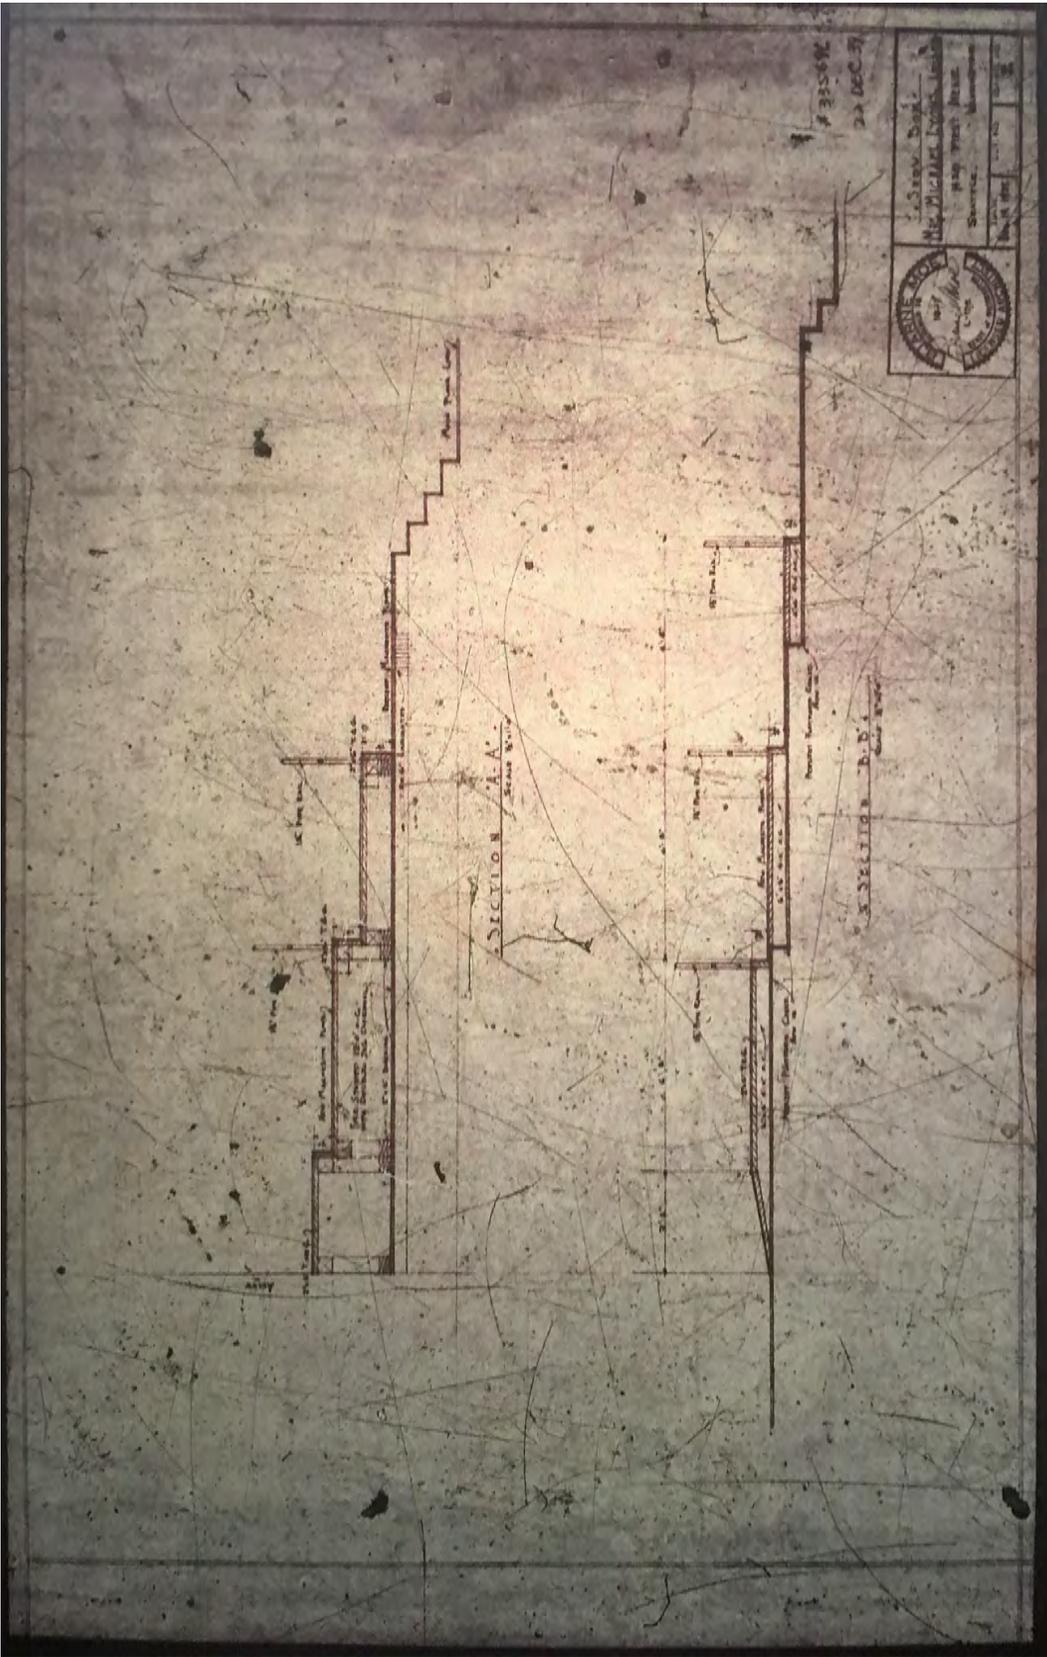
Figure 77. 1939 (December 19) drawing showing the second floor tiered seating design for the Showbox remodel for Michael Lyons prepared by architect Bjarne Moe. Courtesy Seattle Department of Construction and Inspections microfilm library.

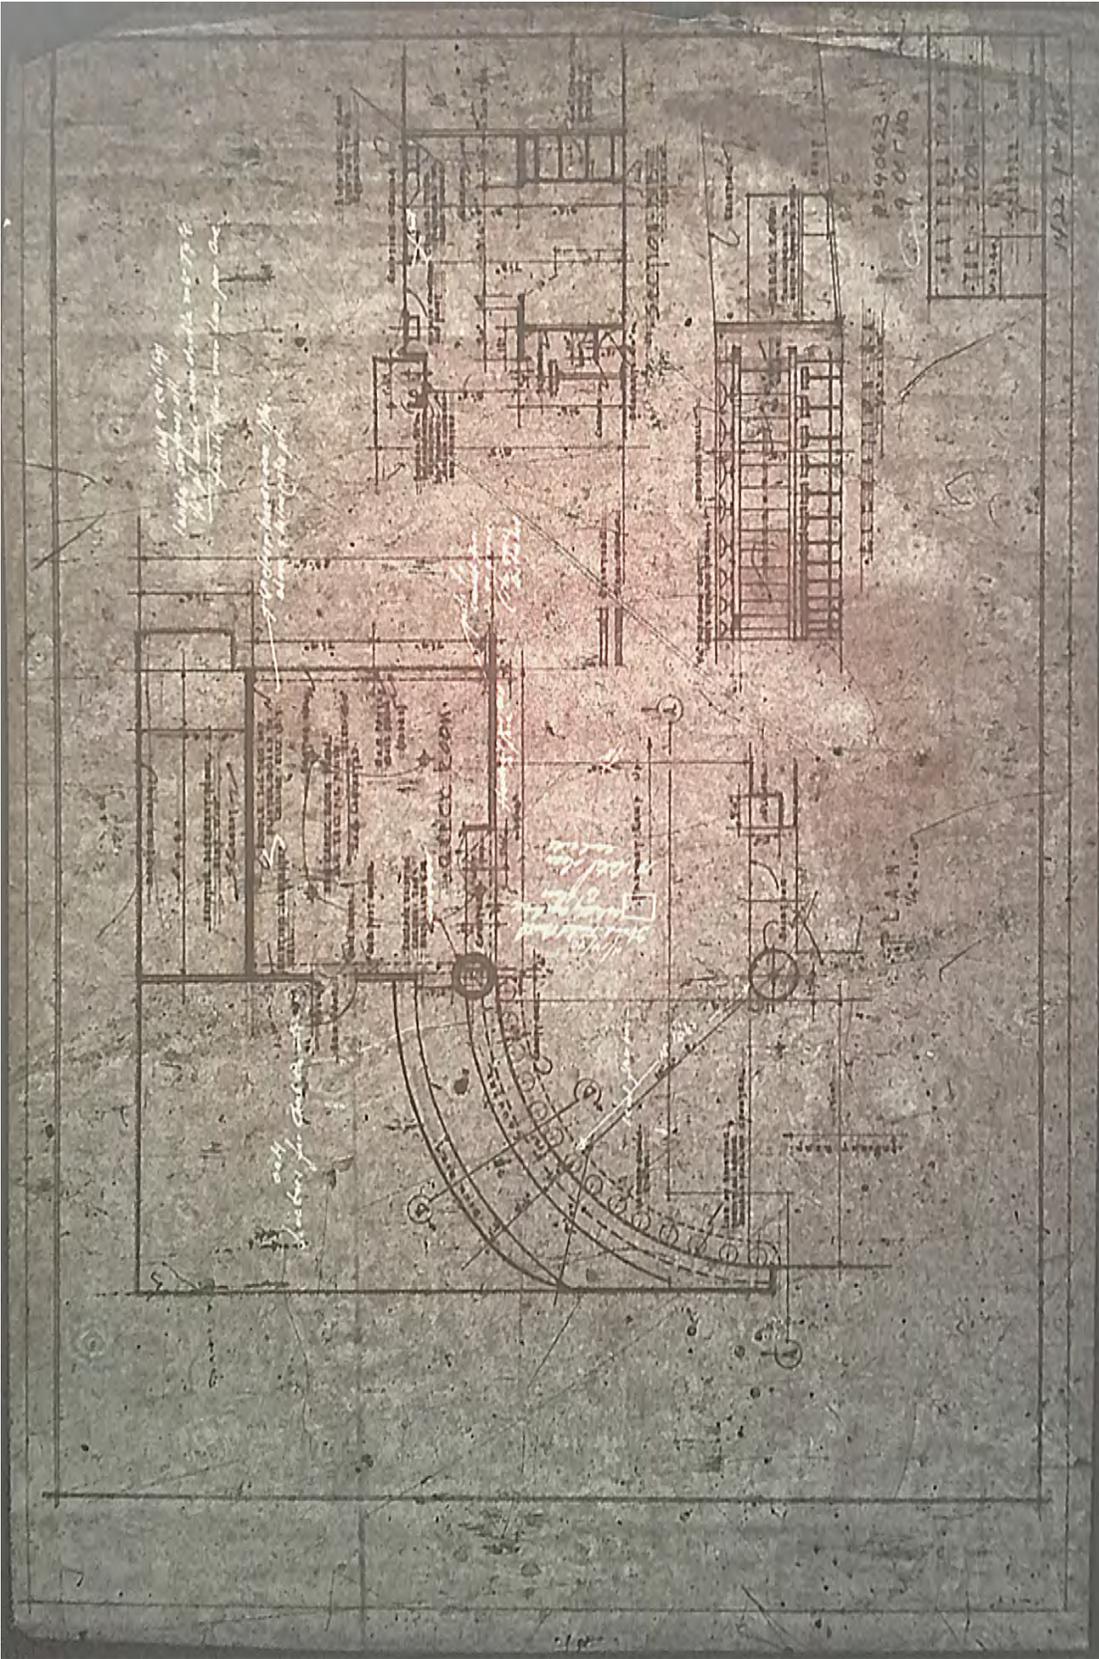
Figure 78. 1940 (October 3) drawing showing alterations to the passageway for the Showbox adding a coat check room and work at the bar for Michael Lyons. Courtesy Seattle Department of Construction and Inspections microfilm library.

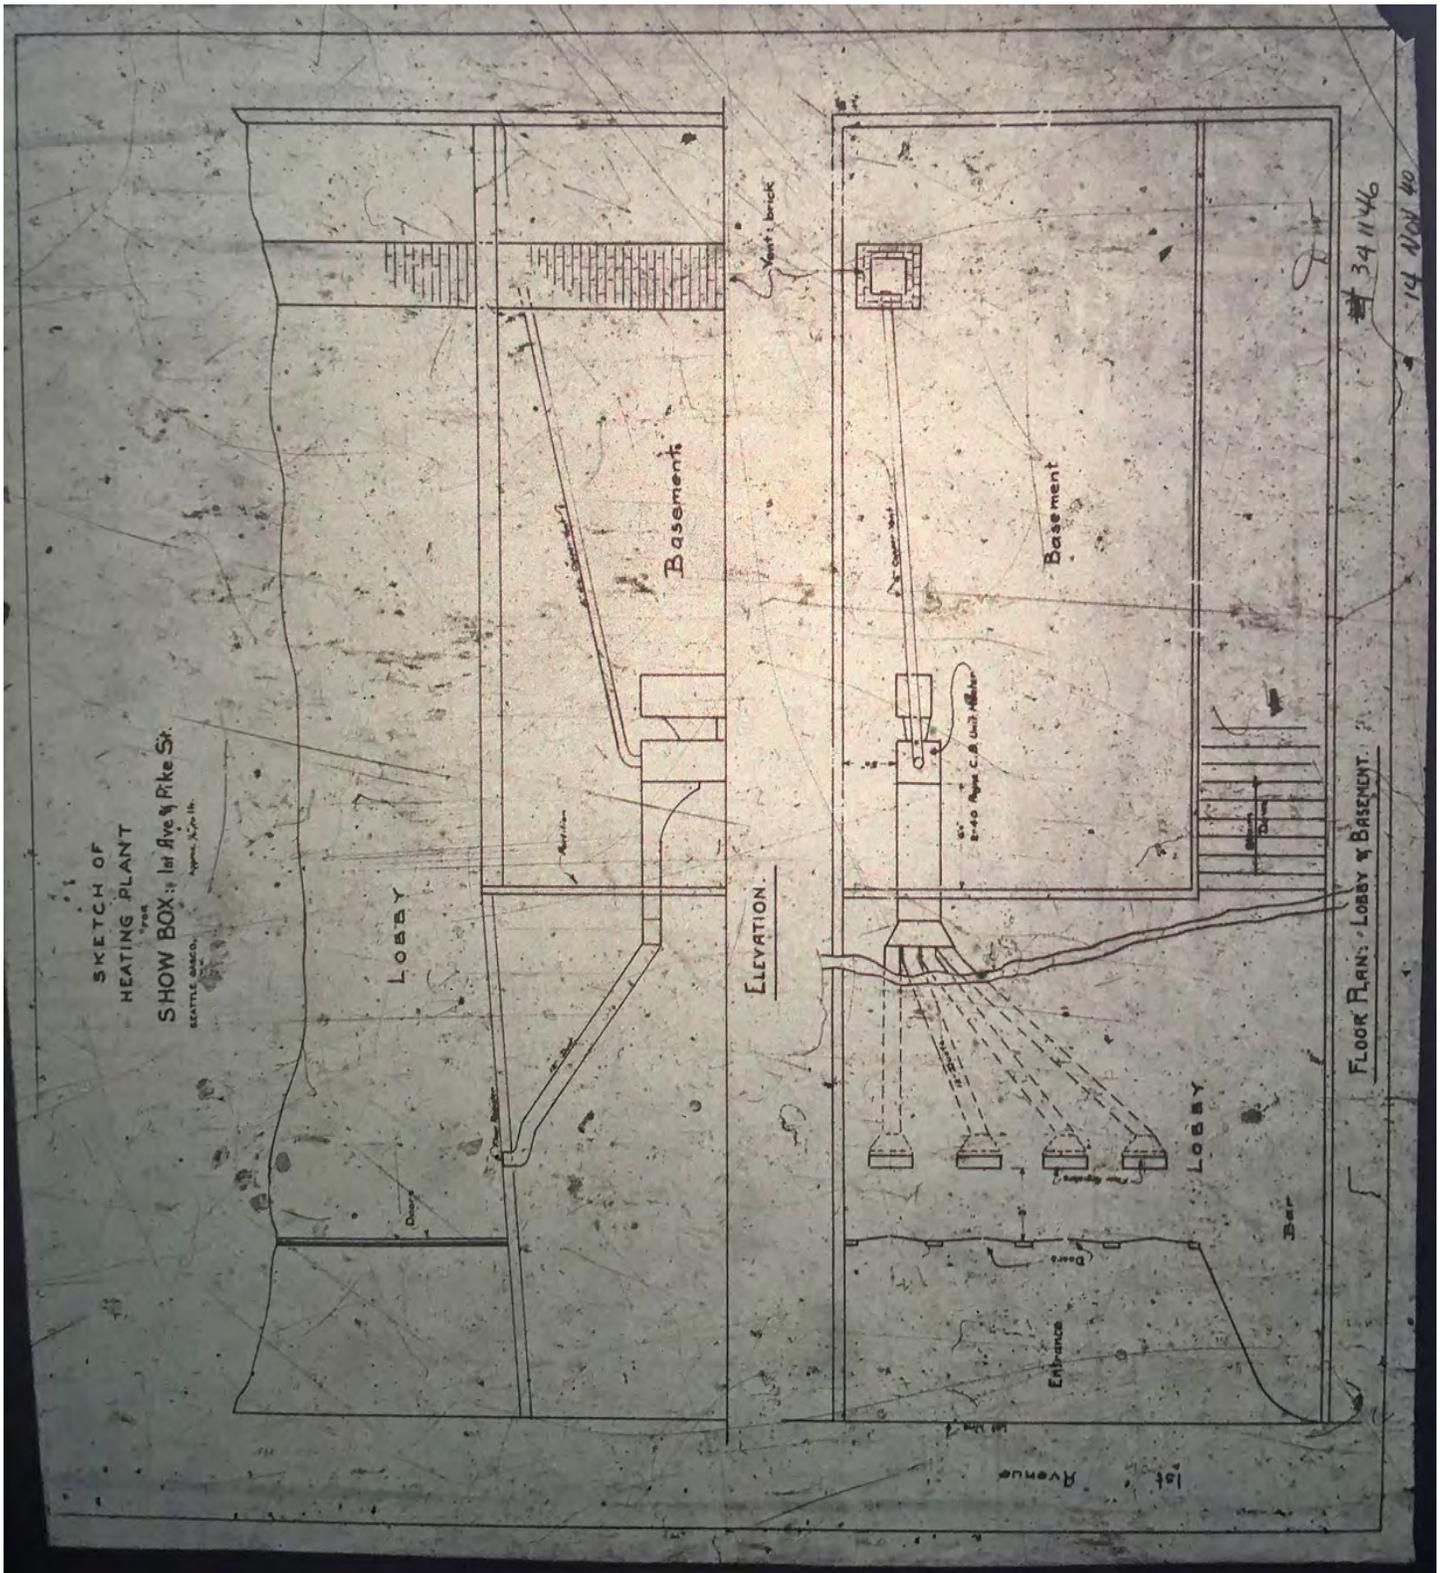
Figure 79. 1940 (November 14) drawing showing the mechanical system and heating provisions for the Showbox passageway. Courtesy Seattle Department of Construction and Inspections microfilm library.

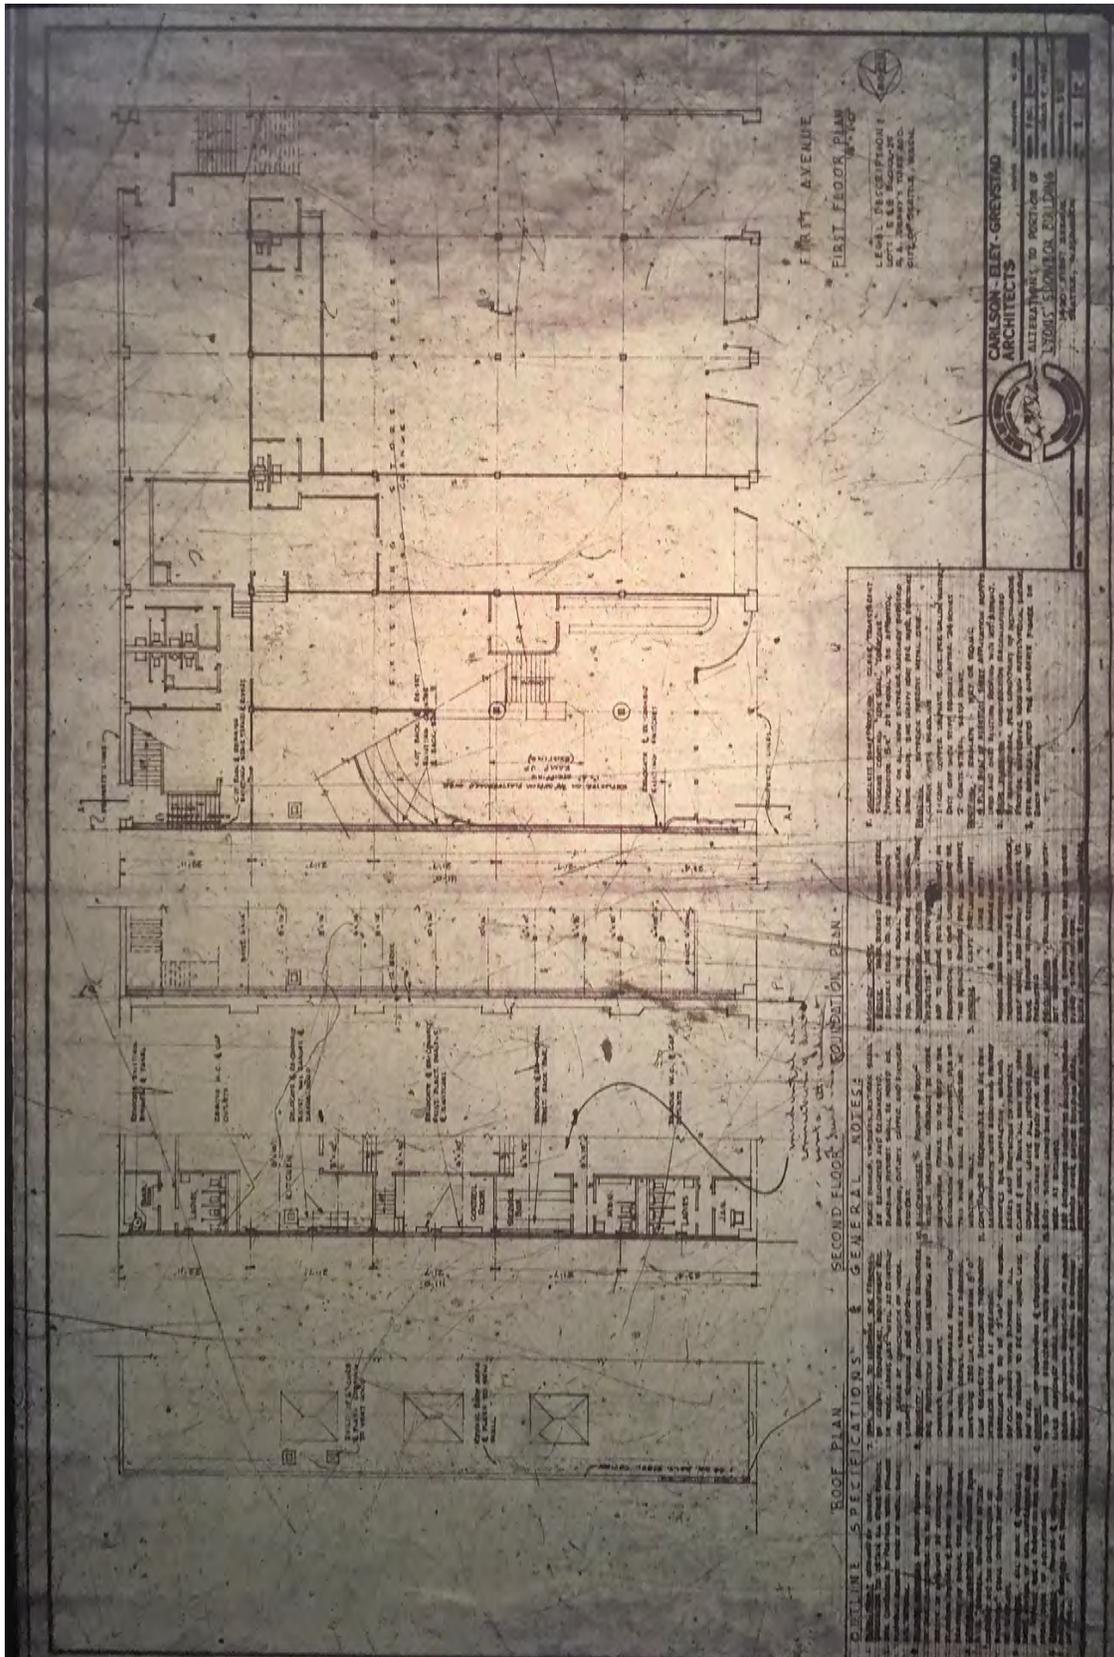
Figure 80. 1959 plans prepared by architects Carlson Eley Greystad as part of the north wall rebuilt following the demolition of the Regent Hotel in 1958.

- 1959: Architects Carlson, Eley, Grevstad designed the construction of a new north wall for the building. The building had originally used the south wall of the former building to the north. When that building was demolished, its south wall was left standing, but in an unusable condition. This required the construction of the

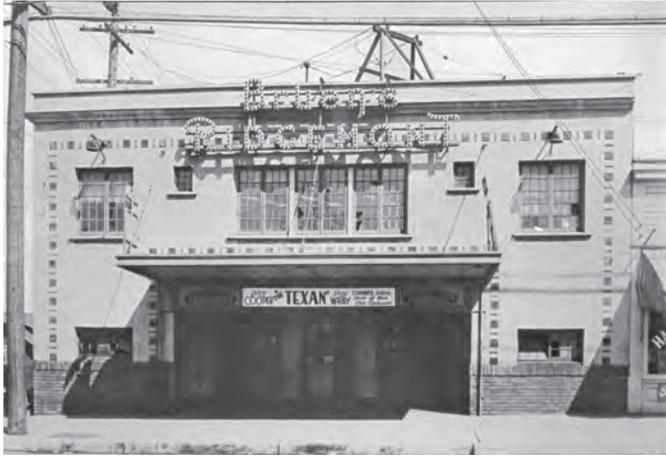
Figure 103. 1939 post card of the "Riviera" in Fort Lee, New Jersey that inspired Lyon's development of the Showbox.

While planning his new and larger venue, Lyons traveled back east to New York and New Jersey to tour popular nightclubs, theaters, and ballrooms. The Riviera nightclub in Fort Lee, New Jersey, caught Lyons' eye and was cited as the inspiration for his new venue.²² **See Figure 103.** Lyons hired architect Bjarne H. Moe (1904–1980), who was establishing his reputation as a theater designer in Seattle and the greater Pacific Northwest with his design for the Green Lake Theater (1937).²³ Moe also had a reputation for helping clients modernize their properties, with evidence of this skill mentioned in a 1932 article in *The Seattle Daily Times*.²⁴ In the article, Moe provided two different mock-ups of a simple wood-clad bungalow refaced with brick to completely modernize and refine the property. His eye for updating buildings continued with many of his theater remodels, including the Roman Theater in Red Lodge, Montana, the Capitol Theater in Walla Walla, and the Varsity Theatre and Show Box remodels in Seattle.

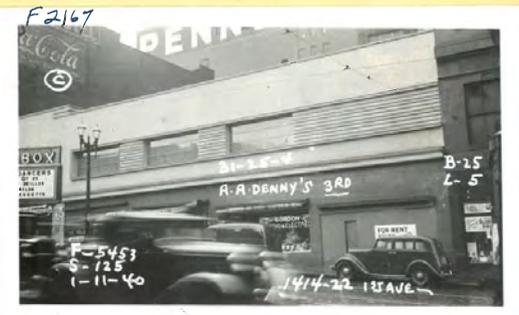
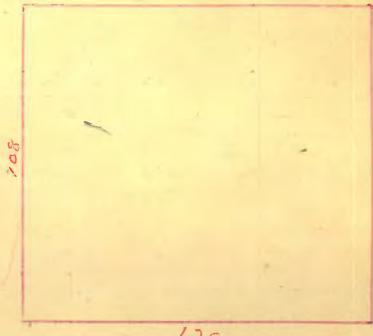
Figure 113. Pre 1973 property record card. Courtesy Puget Sound Regional Archives.

EXTRA FEATURES **380 Sprinklers**
 CONSTRUCTION **Ord. Masonry, Mill P&B, medium**
 REFRIGERATION
 7 CONDITION: EXTERIOR **Good** INTERIOR **Good** FOUND. **Good**
 8 MAIN SUPPORT COLUMN **X** FOOTING **SPAN** FT.
 9 FIRST FLOOR JOIST **INCH CENTER BRIDGED**
 10 **BUILDING Finished**
 11 GROSS INCOME \$ EXPENSE \$ NET INCOME \$
 12 DEPRECIATION: COND. **40** % OBSLSE. % ECON. SUIT. % TOTAL
 YEAR BUILT **1916** REMODELED **No**
 EFFECTIVE AGE **20** YEARS FUTURE LIFE **30** YEARS
 DIMENSIONS **108 x 120** x x SQUARE FT. AREA CUBIC FT.

WIRING **Knob & Tube.**
 HEATING **Central, steam**
P S L & P service.
 ELEVATORS **None**
 ENTRANCE **Conc.**
 CEILING - STORY HEIGHT
1st flr-12'
2nd flr-20'

18,960
 IMPROVEMENT VALUE
 MAIN BUILDING \$
 OTHER BUILDINGS \$
 TOTAL \$
 ASSESSED VALUE 50% \$ *14,000*
 DATE **10-22-37**
 LAND INFORMATION
 1. SIZE x **Level on grade**
 2. STREET - ROAD **Graded, paved**
alley paved.
 3. SIDEWALK **Conc. Sewer.**
City water
 4. LANDSCAPING **business.**
 5. TREND **LAND VALUE'S**
 6. USE
 7. DISTRICT **Medium Old**

REMARKS
Also 8
Part of 2 bldg Bldg Formerly A.V. to 25
A.A. Denny's 3rd
 Permit #333832, 8-23-39; Permit #332356, 5-27-39;
 Permit #332400, 6-2-39; alterations and installation of
 fixtures.

1966-1970 - 2 bldg - 25,400
25,400
50'40" FLOOR PLAN

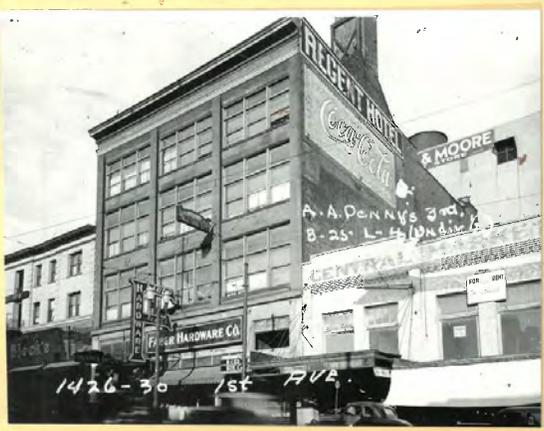
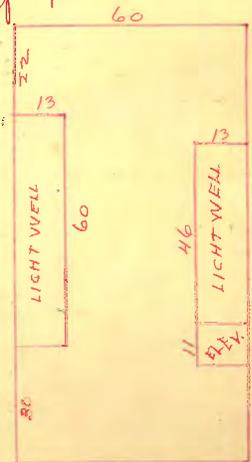
CONSTRUCTION Ord. Masonry, Mill P&B, Medium REFRIGERATION 7 CONDITION: EXTERIOR Good INTERIOR Good FOUND. Good 8 MAIN SUPPORT COLUMN FOOTING SPAN FT. 9 FIRST FLOOR JOIST IRON CENTERS BRIDGED 10 BUILDING Finished 11 GROSS INCOME \$ EXPENSE \$ NET INCOME \$ 12 DEPRECIATION: COND. % OBSLSE. % ECON. SUIT. % TOTAL % YEAR BUILT 1904 REMODELED NO EFFECTIVE AGE 30 YEARS FUTURE LIFE 18 YEARS DIMENSIONS x 60x 112 SQUARE FT. AREA CUBIC FT. 6,720

INTERIOR Plastered Papered Fir trim FLOORS Fir FIRE PLACE PLUMBING 91 Fixt. 12 Toilets, 62 Basins, 8 Sinks, 9 Baths, Cheap Class. TILE WORK WIRING Conduit. HEATING Steam. Oil burner "Ray" ELEVATORS 1 Passenger Entrance- Marble Flr. LOBBY CEILING-HEIGHT Bmt-10', 1st-21'-8", 2nd-8'-6", 3rd-15'-8", 4th-11'-11".

Figure 117. Pre 1973 property record card to the current surface parking lot, former Regent Hotel. The image includes a portion of the Showbox. Courtesy Puget Sound Regional Archives.
