Name: Hotel Elliott / Hahn Building **Year Built:** 1897, 1908 addition

Street and Number: 103 Pike Street, Seattle, WA 98101

HOTEL ELLIOTT / HAHN BUILDING

NORTHWEST VERNACULAR
February 2020

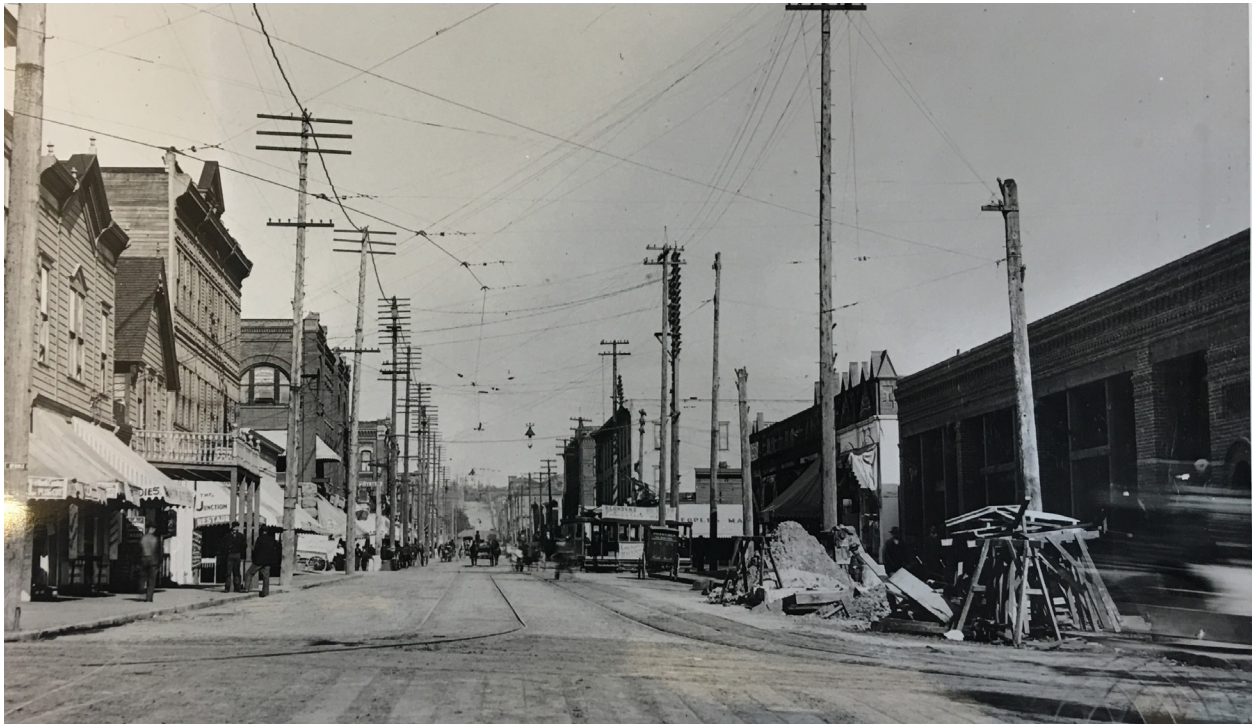
Figure 19. Ca. 1897 photograph.

Looking east along Pike Street from the 1st Avenue intersection with the one story brick building under construction at right. Source: Museum of History and Industry, negative no. 639.

east by 1893.²⁵ Around 1897, the three wood-frame commercial buildings and associated beer garden were torn down and replaced with a one-story brick building (see Figures 19 and 20). The new brick building had four storefronts and was oriented to Pike Street rather than First Avenue like the previous buildings. Early uses included a restaurant, saloon, and billiards hall.

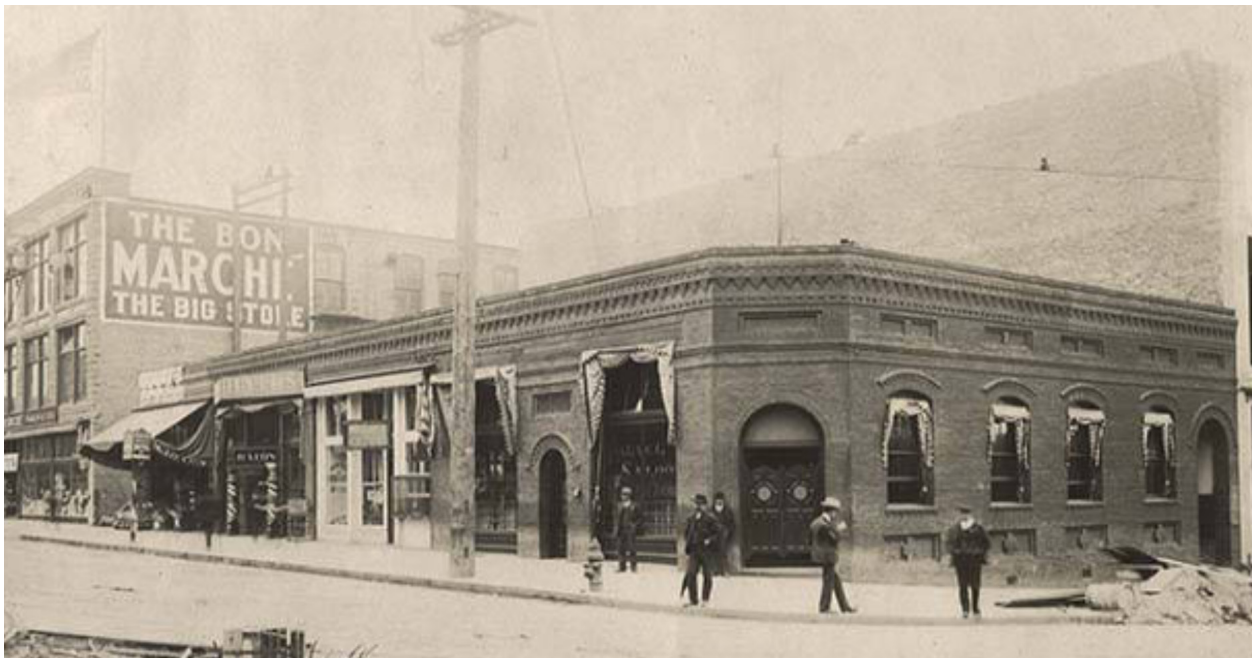
Figure 20. Ca. 1899 photograph.

Completed one story brick building. Source: Museum of History and Industry.

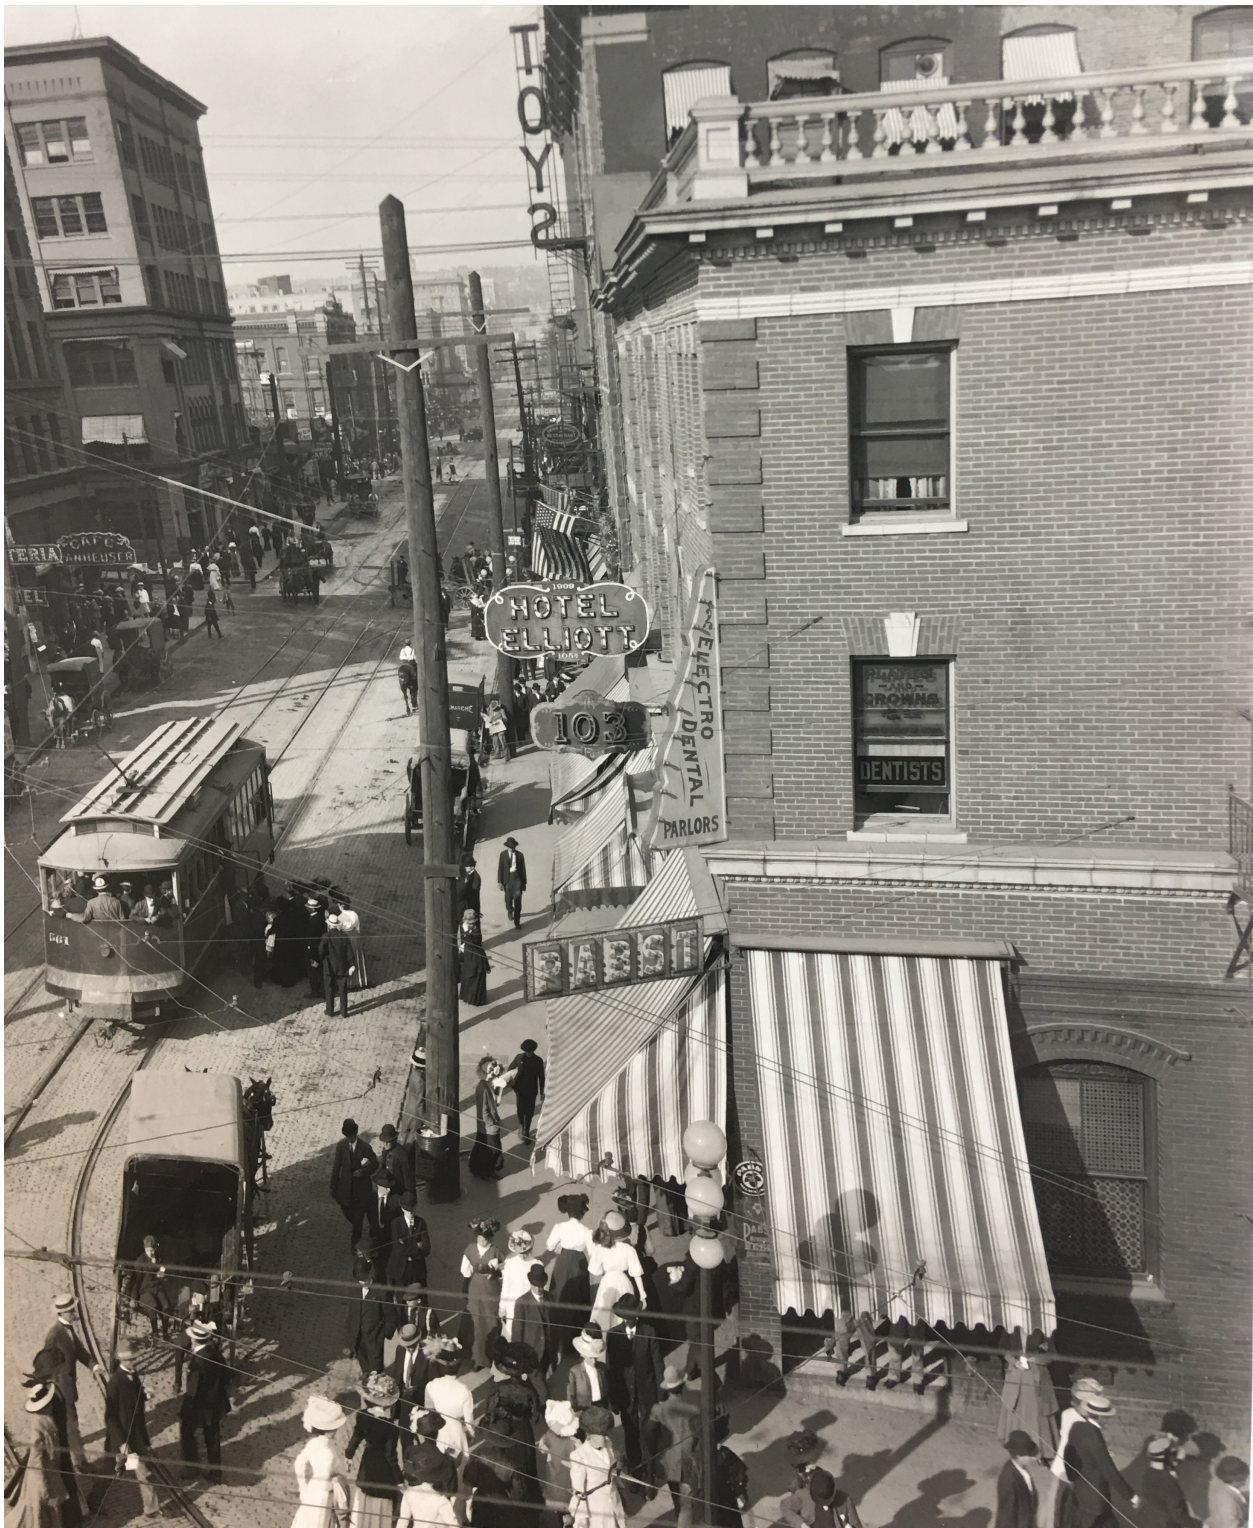
Figure 21. Ca. 1909 photograph detail.

Looking east along Pike Street with the recently completed two story addition to the Hahn Building at right. The transition from the one story building to the upper stories is visible on the west facade. Source: Museum of History and Industry, negative no. 83.10.8258.

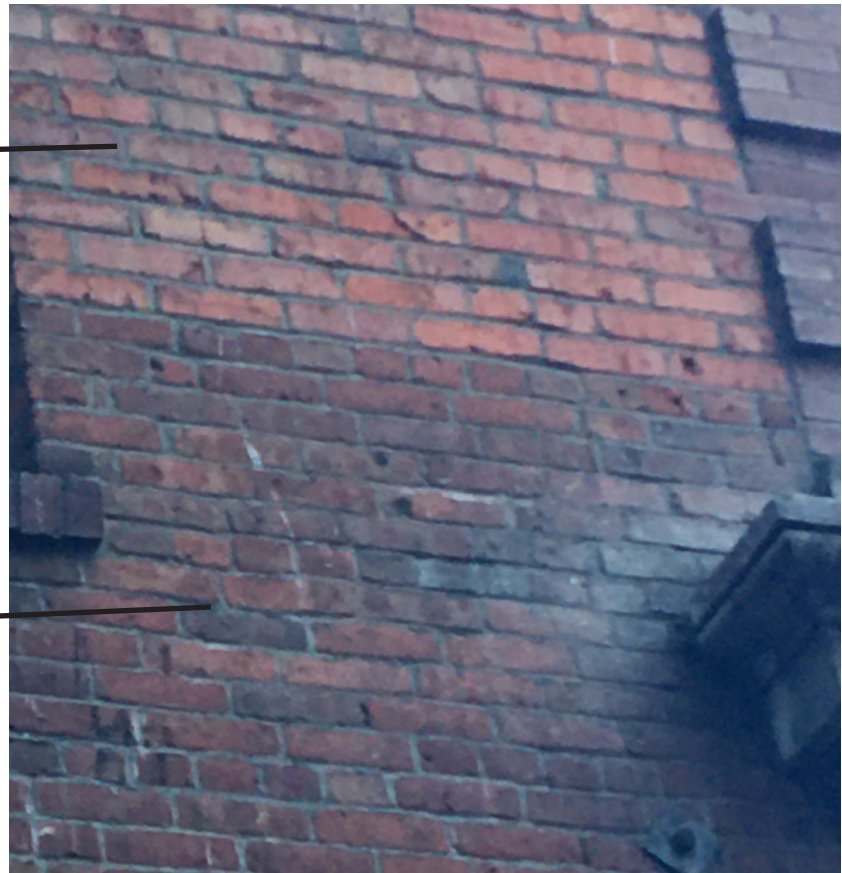
Figure 74. East facade showing the 1897 and 1908 brick transition at the second story. The 1897 brick extend the full length of the facade at the first story, with the 1908 brick at the upper two stories.

**1908
brick**

**1897
brick**

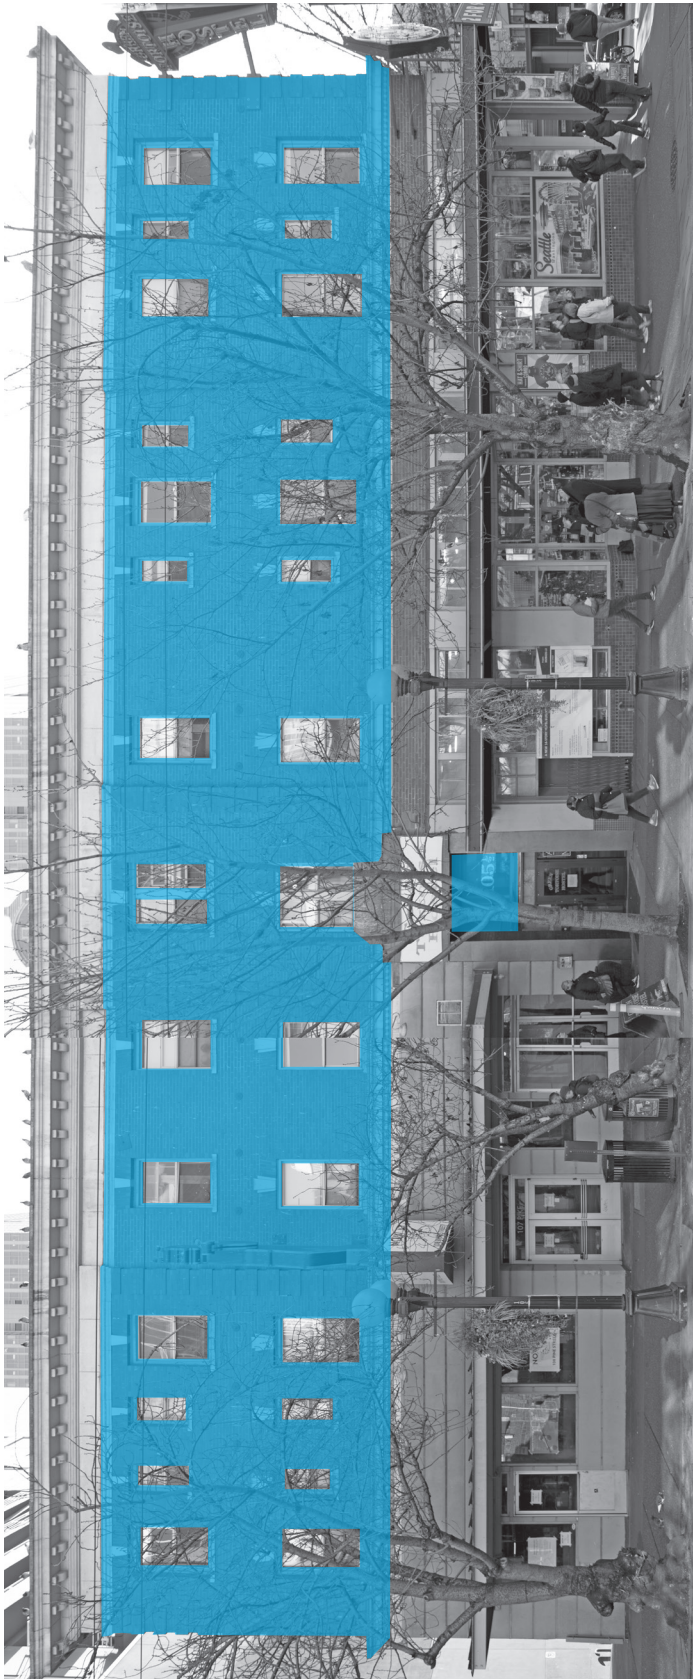
Figure 75. North facade, intact features.

Intact original
features

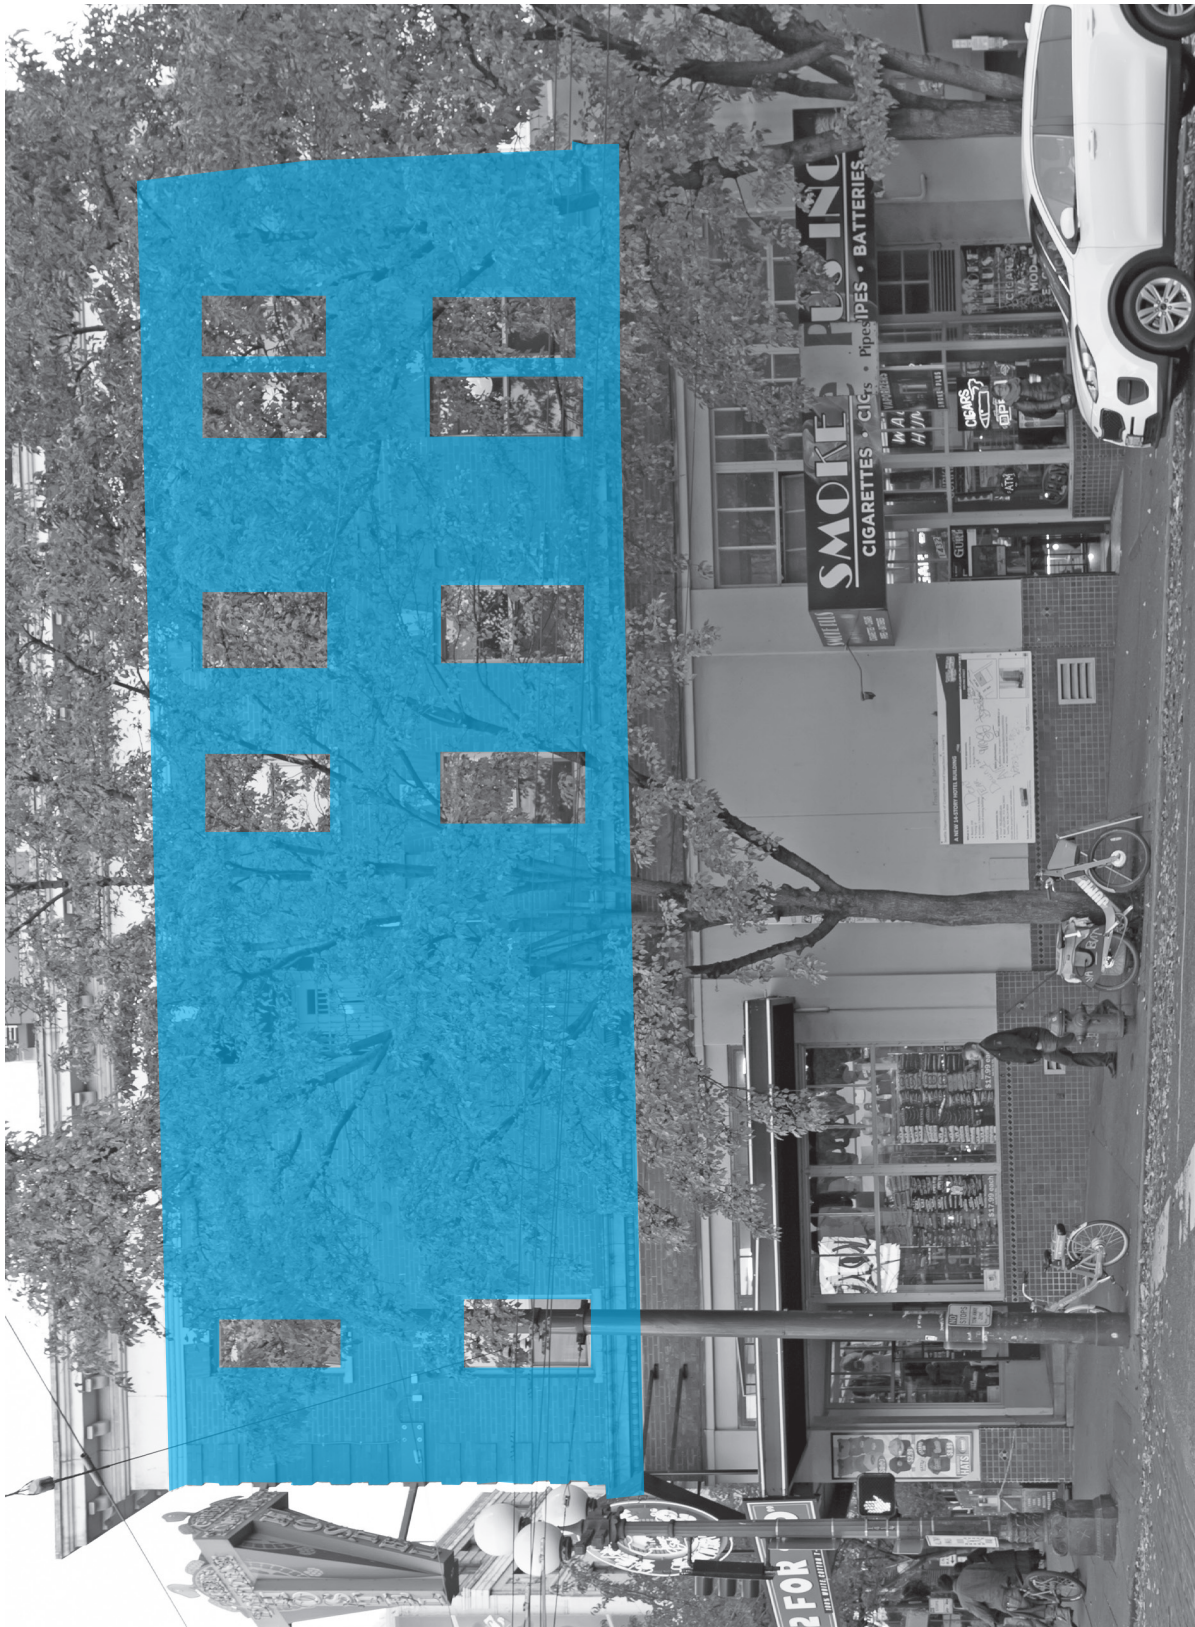
Figure 76. West facade, intact features.

Intact original features

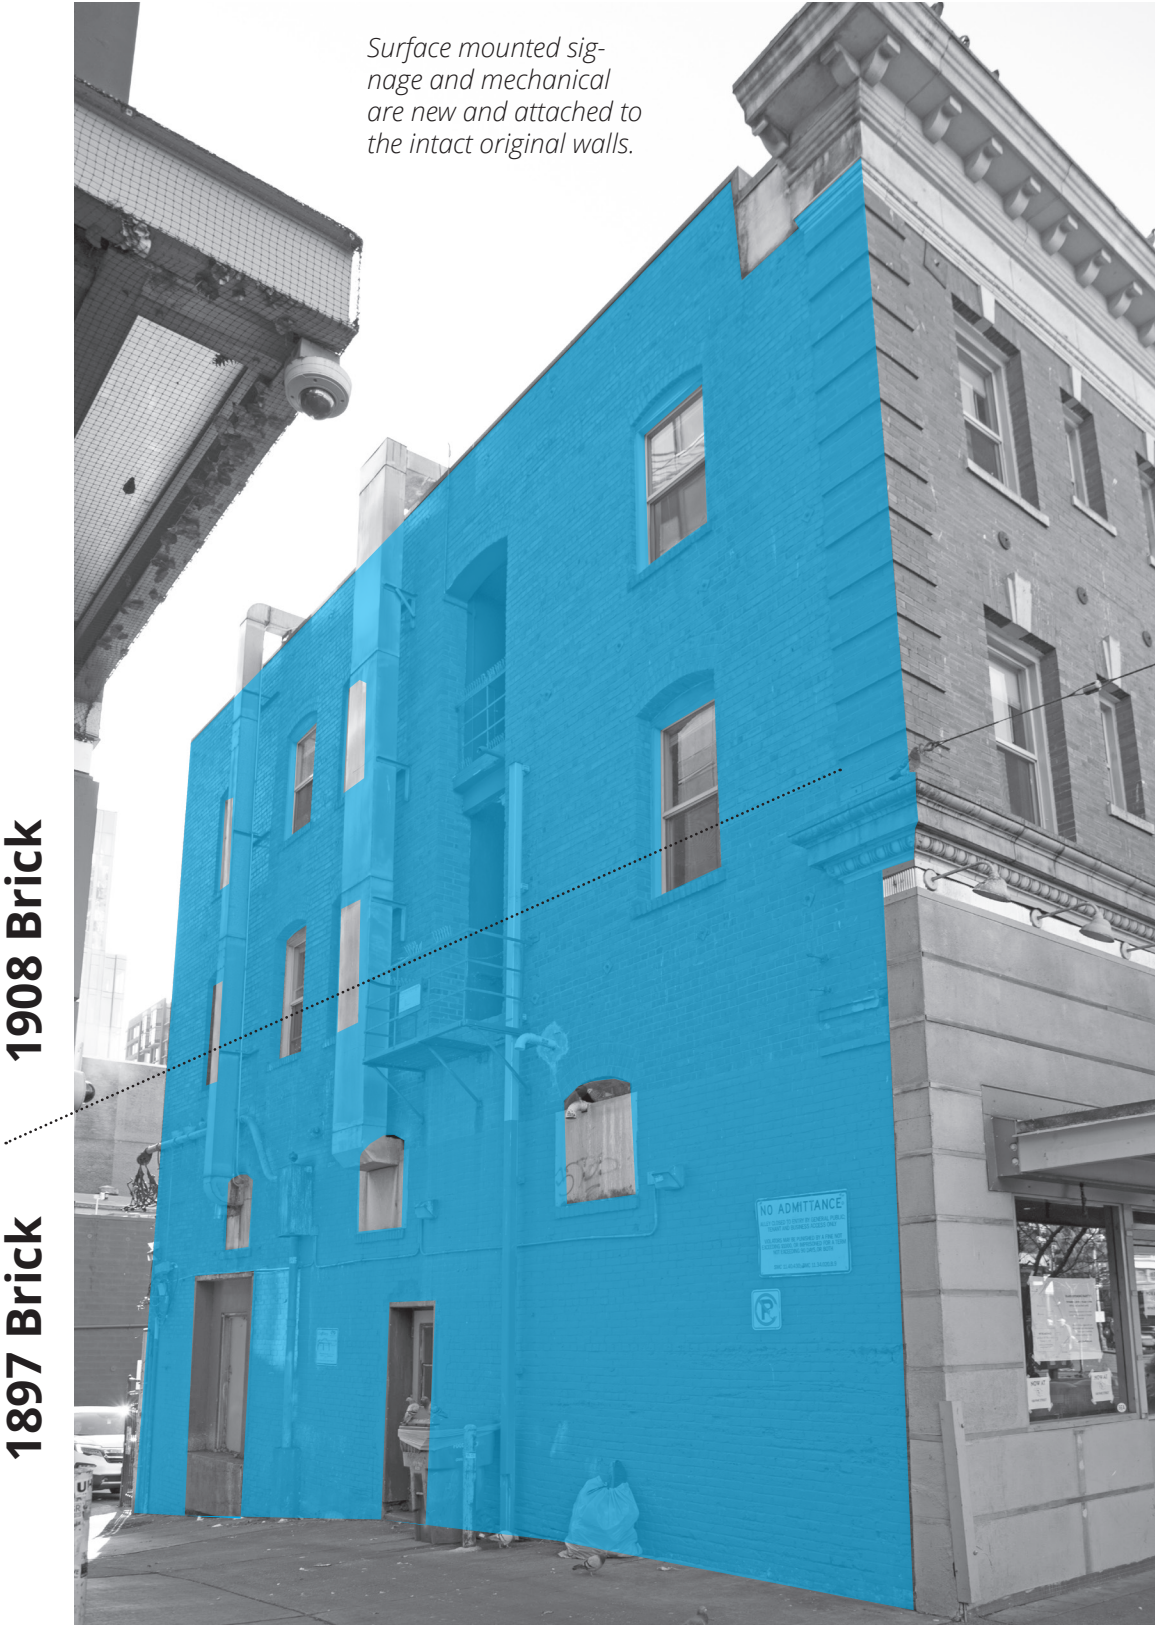
Figure 77. East facade, intact features.

Intact original features
